REPORT ON LAKE BOULEVARD BLUFF EVALUATION

LAKE BOULEVARD BETWEEN PARK STREET AND WATER STREET ST. JOSEPH, MICHIGAN

**SME Project No. KG59313
July 15, 2009**

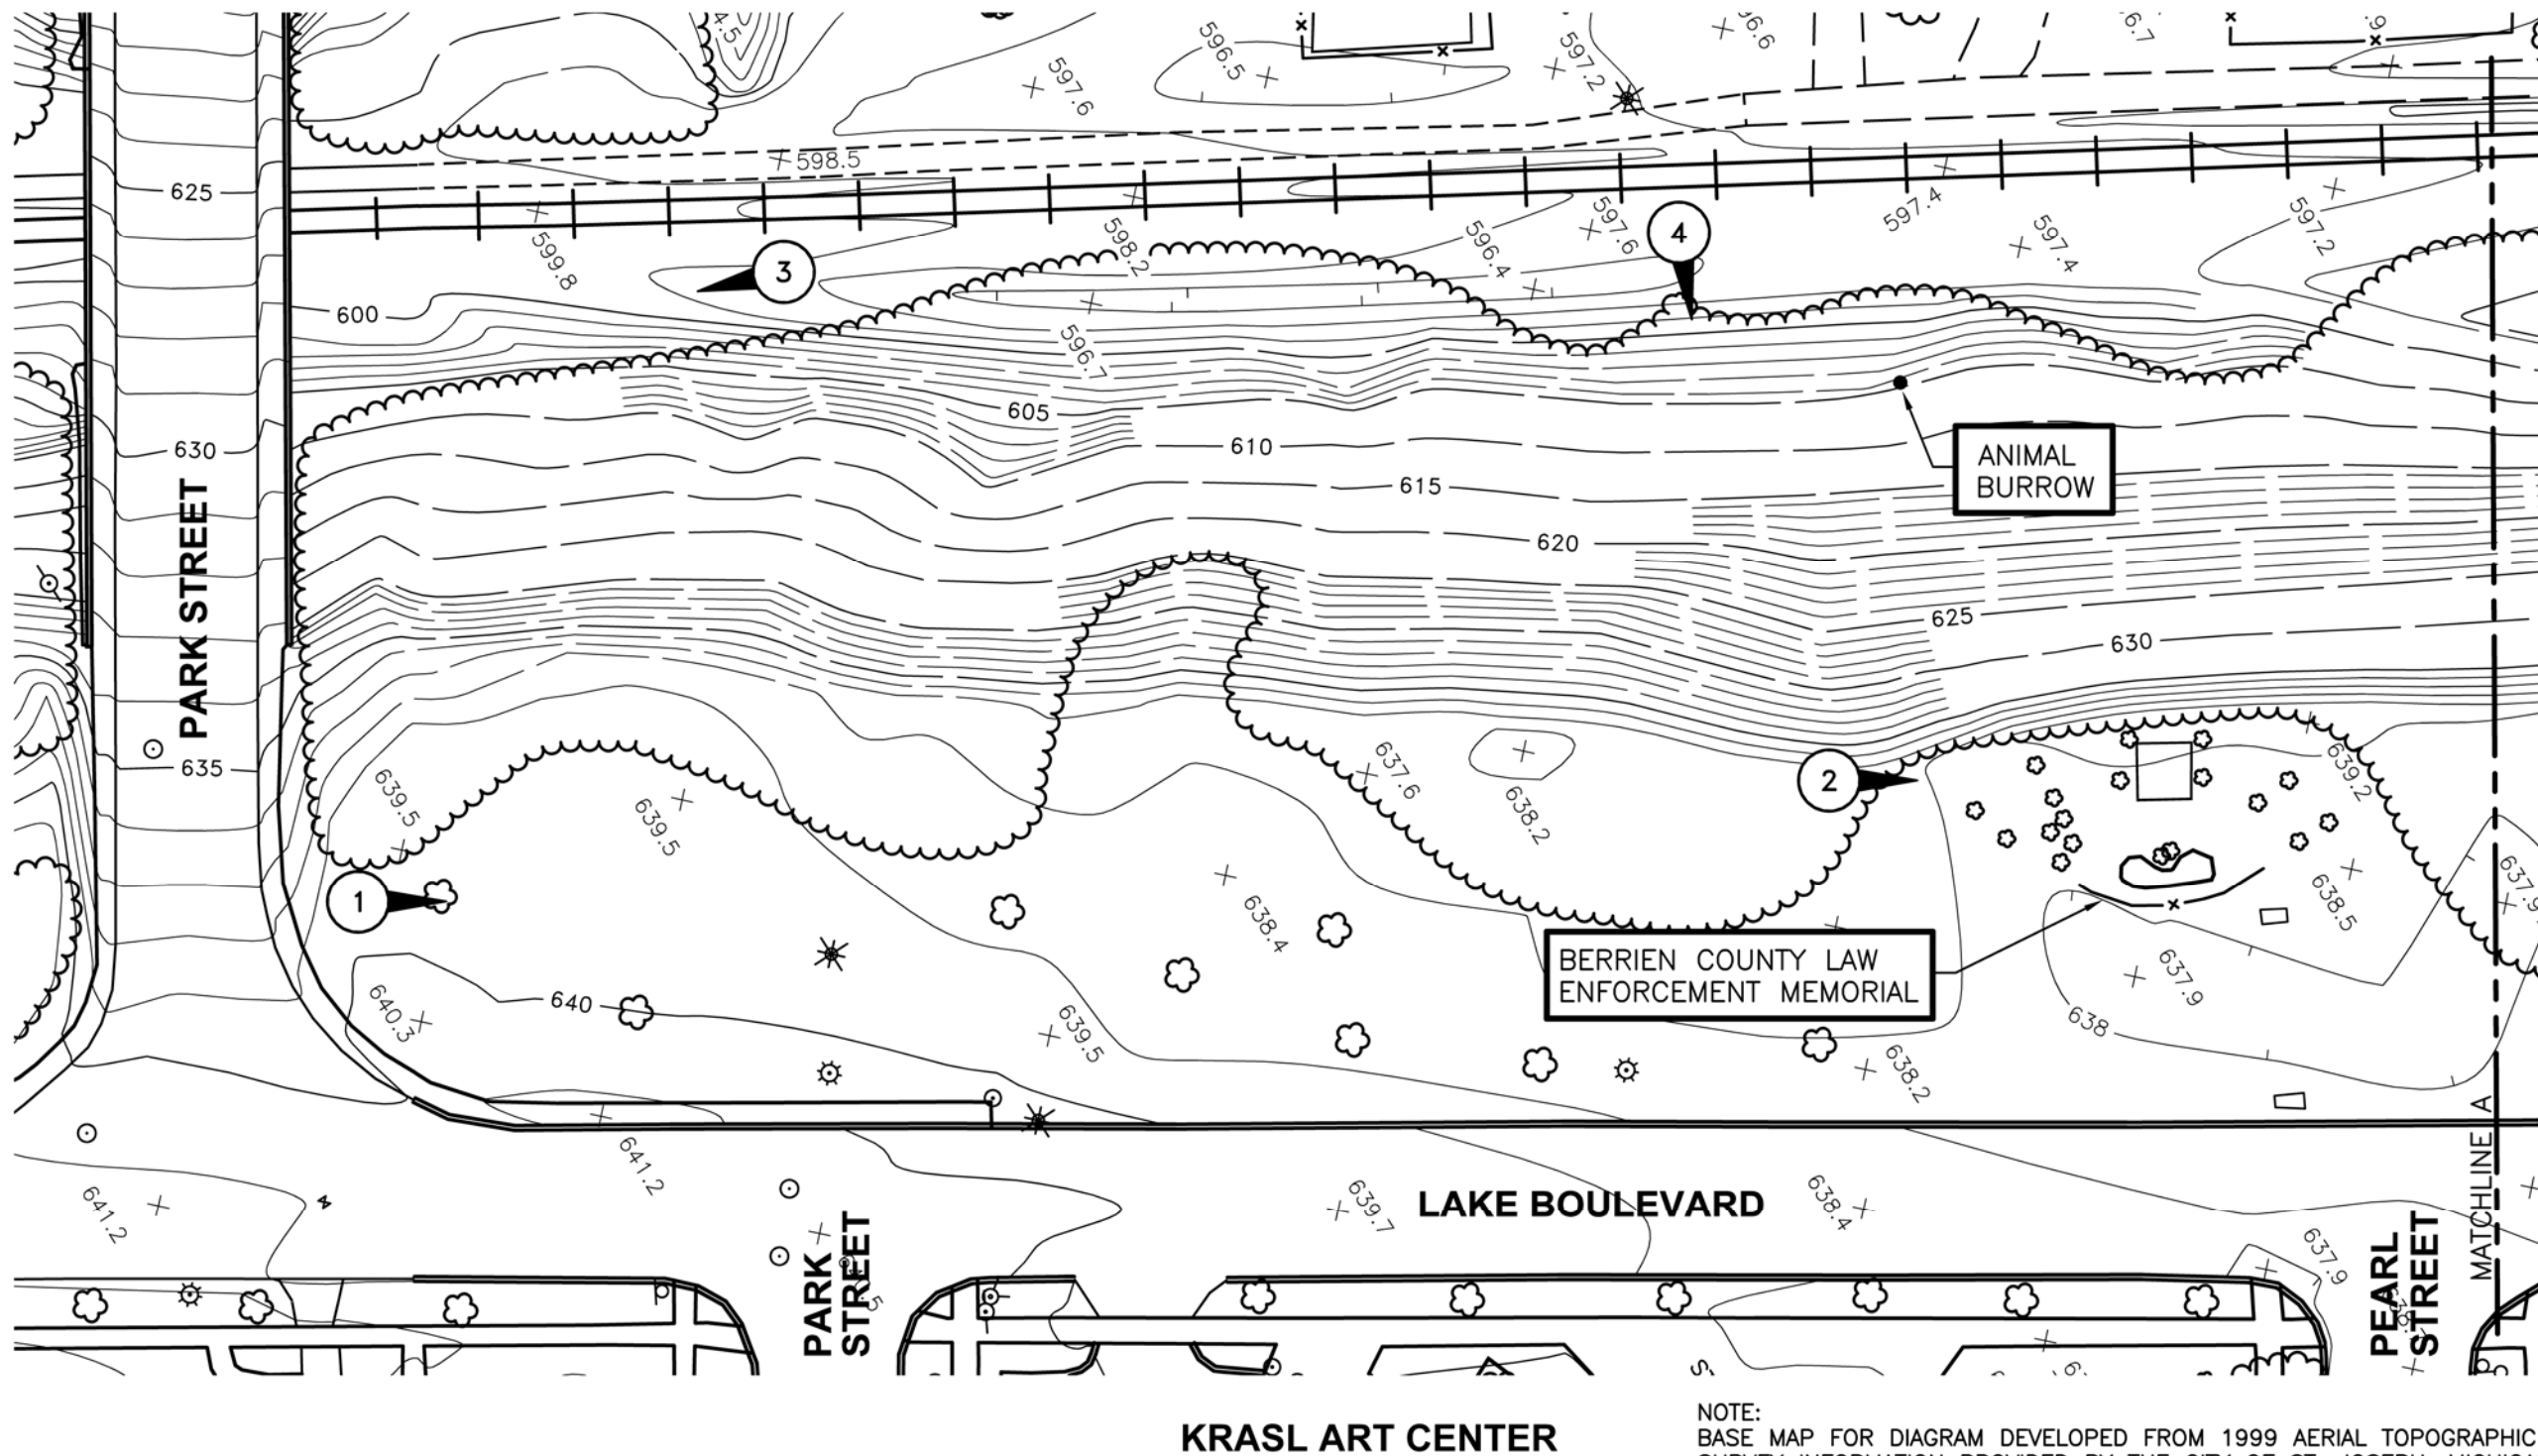
1. SIDEWALK AND WALKWAY IMPROVEMENTS HAVE BEEN COMPLETED SINCE PREPARATION OF TOPOGRAPHIC SURVEY.
2. ELECTRICAL ACCESS BOXES AND AN ELECTRICAL LINE ARE LOCATED ALONG TOP OF BLUFF.
3. SURFACE DRAINAGE AT TOP OF BLUFF IS GENERALLY DIRECTED AWAY FROM THE TOP OF THE SLOPE.
4. SEEPAGE WAS NOT OBSERVED ALONG THE BLUFF FACE OR BLUFF TOE.
5. BLUFF FACE IS GENERALLY VEGETATED WITH TREES AND BRUSH.

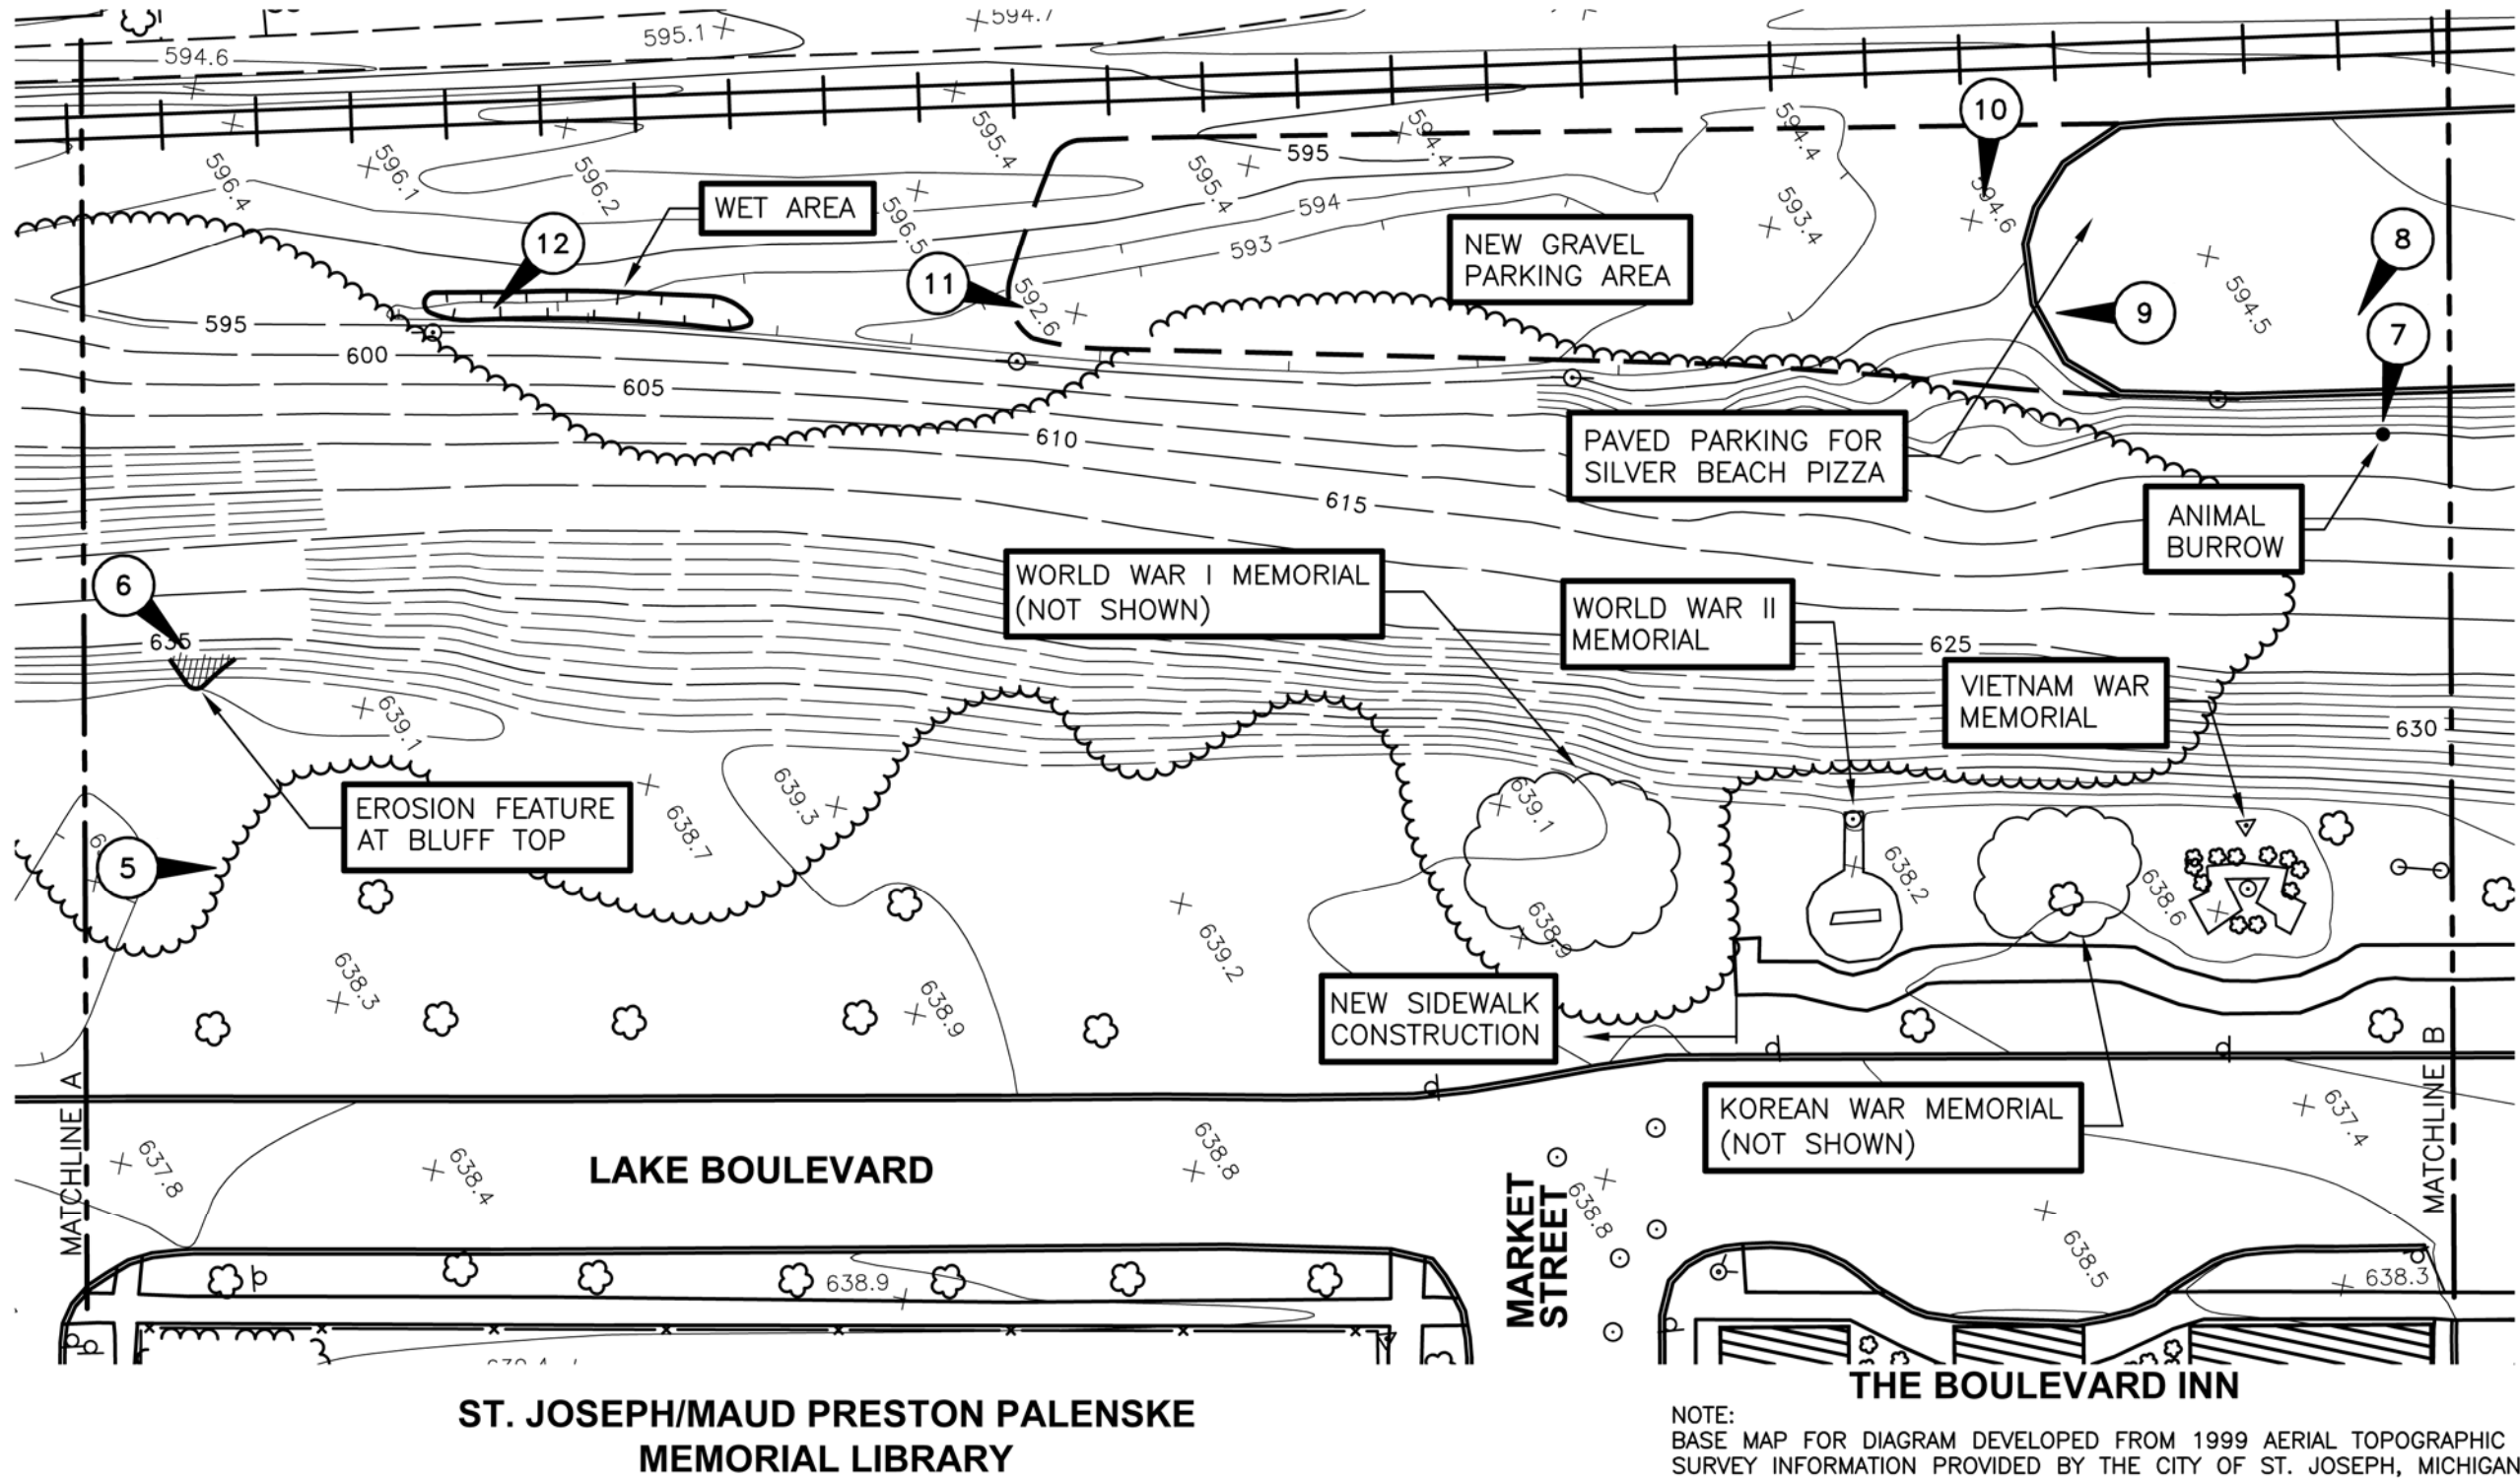
1. SIDEWALK AND WALKWAY IMPROVEMENTS HAVE BEEN COMPLETED TO THE SOUTH OF THE WORLD WAR II MEMORIAL SINCE PREPARATION OF TOPOGRAPHIC SURVEY.
2. ELECTRICAL ACCESS BOXES AND AN ELECTRICAL LINE ARE LOCATED ALONG TOP OF BLUFF. ROOTS OF TREES HAVE BEEN CUT WHEN ELECTRICAL LINE TRENCHED IN ALONG BLUFF TOP.
3. SURFACE DRAINAGE AT TOP OF BLUFF IS GENERALLY DIRECTED AWAY FROM THE TOP OF THE SLOPE.
4. SEEPAGE WAS NOT OBSERVED ALONG THE BLUFF FACE OR BLUFF TOE, BUT AN AREA OF PONDED WATER AT THE TOE WAS OBSERVED (SEE PHOTO NO. 12).
5. BLUFF FACE IS GENERALLY VEGETATED WITH TREES AND BRUSH. THERE IS EVIDENCE OF TREE CUTTING AND BRUSHING AT NORTH END OF THIS SHEET.

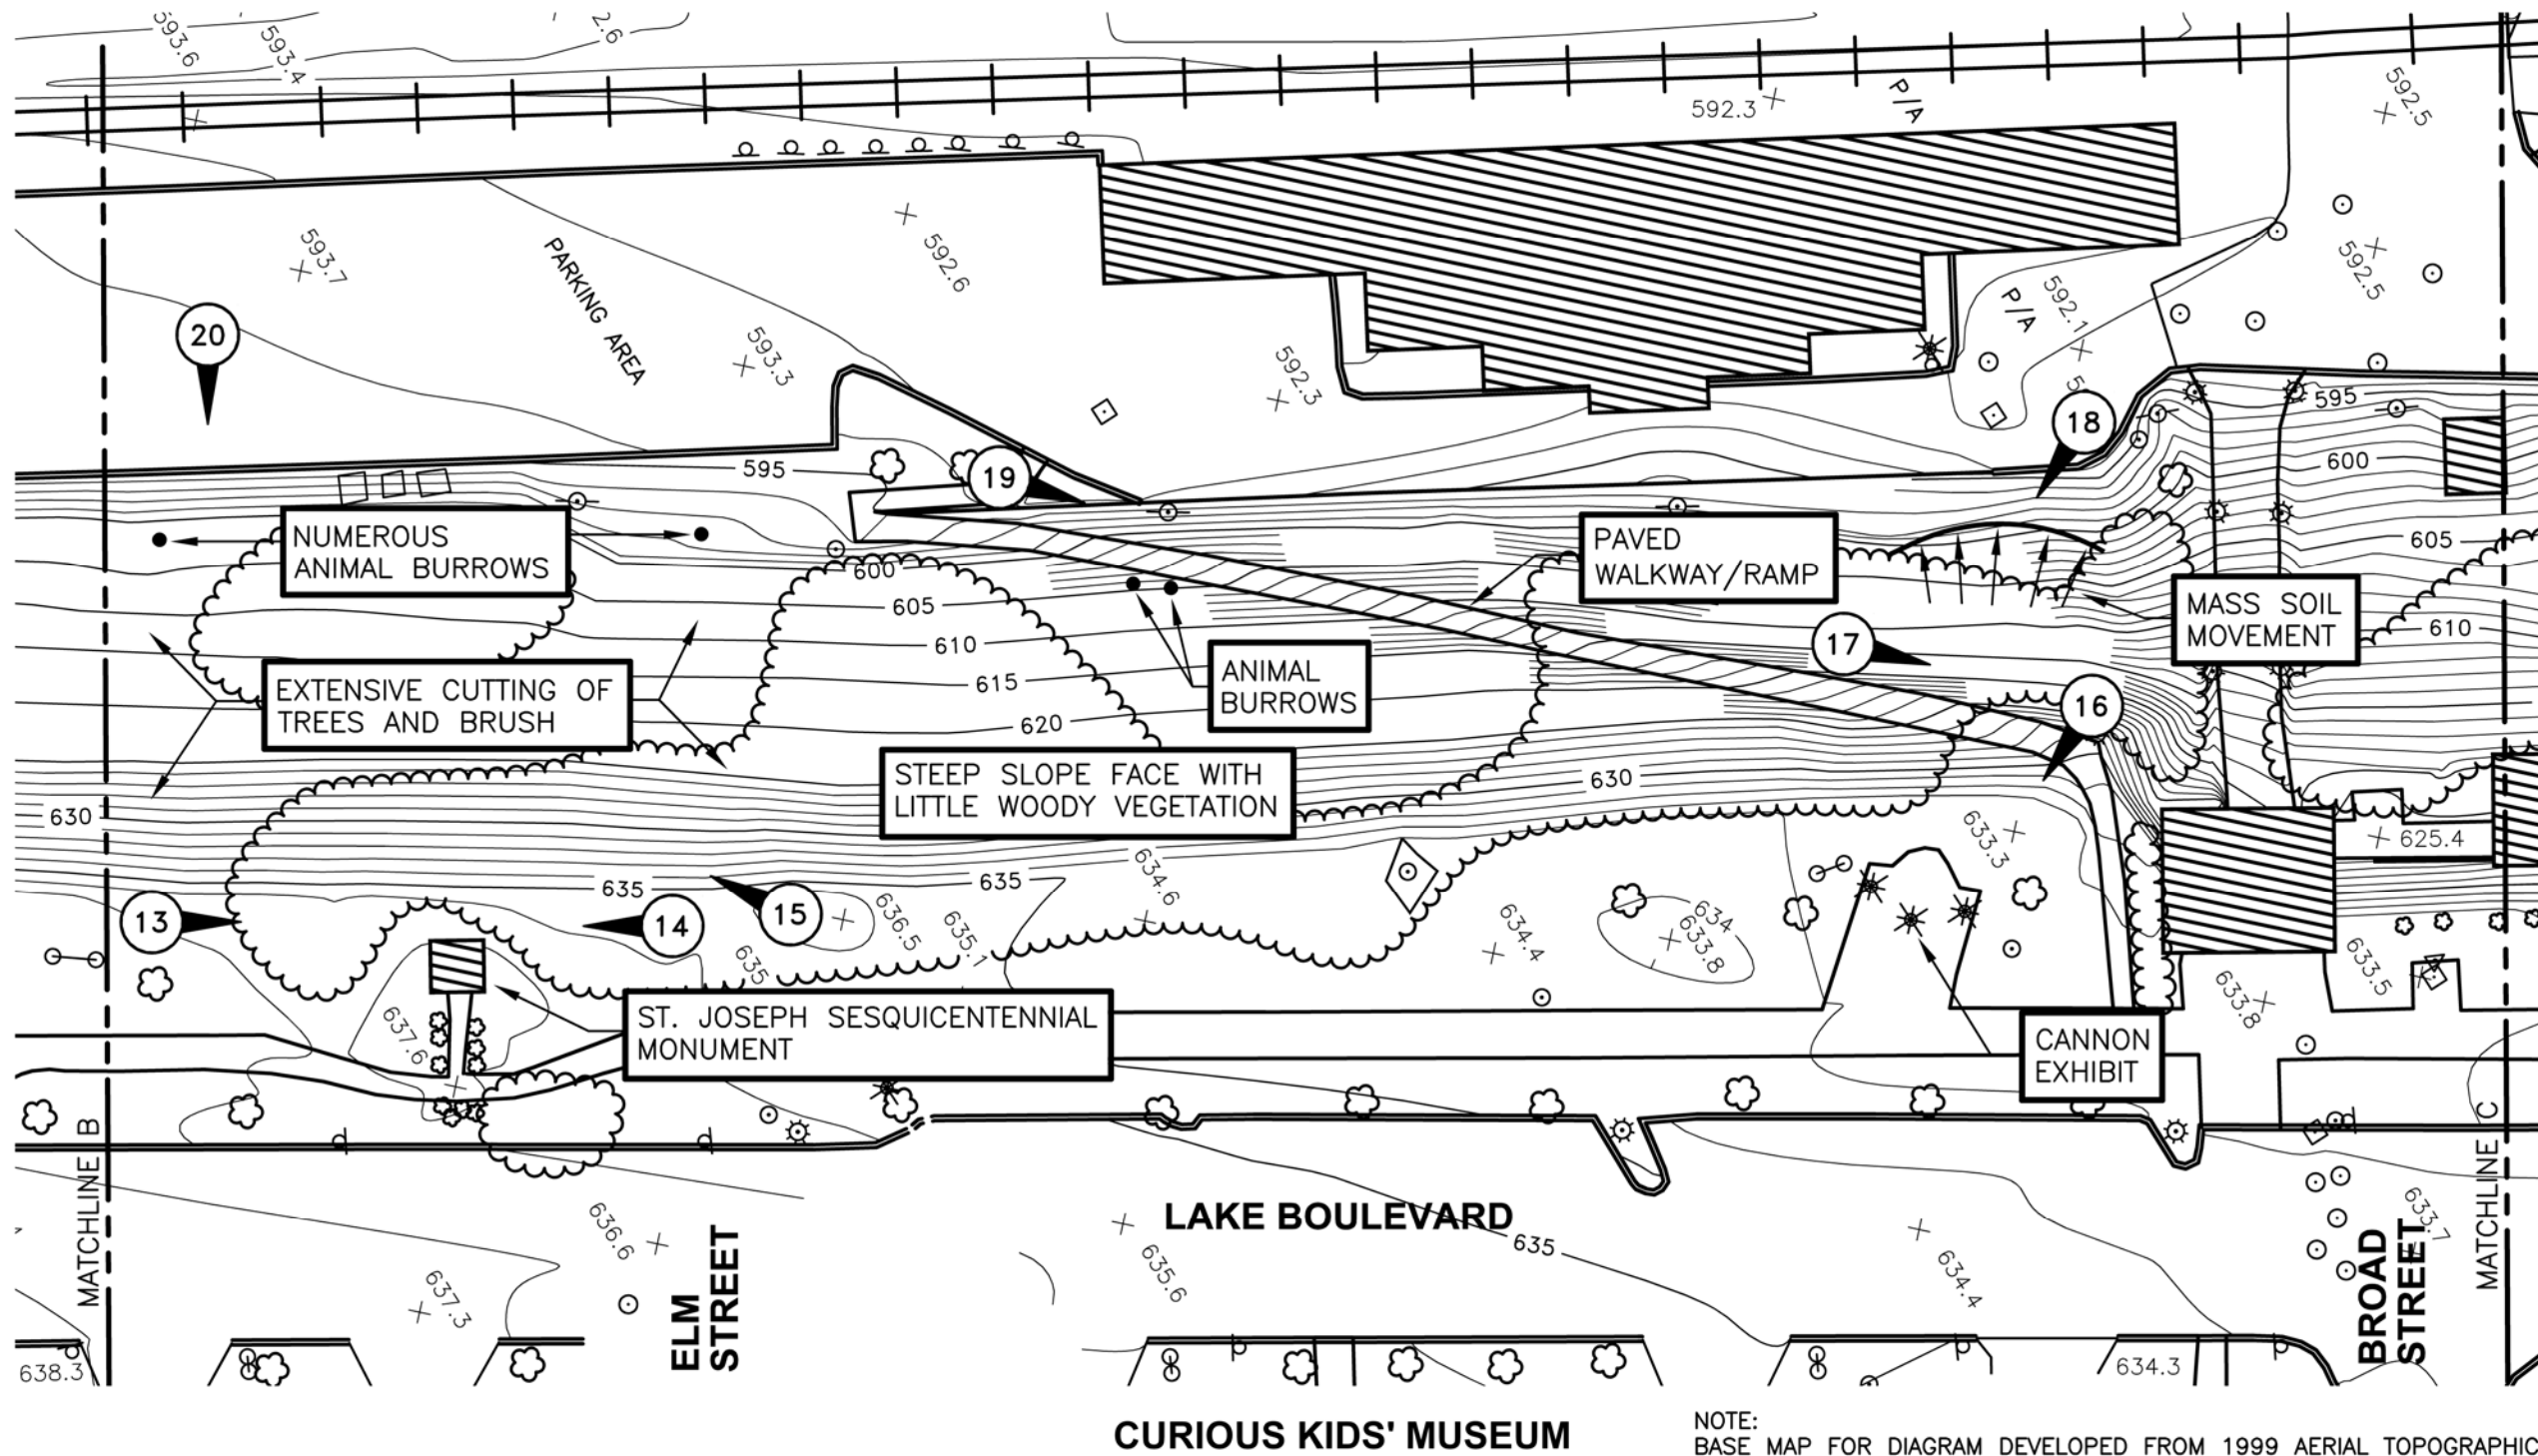
1. ELECTRICAL ACCESS BOXES AND AN ELECTRICAL LINE ARE LOCATED ALONG TOP OF BLUFF.
2. SURFACE DRAINAGE AT TOP OF BLUFF IS GENERALLY UNDEFINED.
3. SEEPAGE WAS NOT OBSERVED ALONG THE BLUFF FACE OR BLUFF TOE.
4. NUMEROUS ANIMAL BURROWS OBSERVED IN THIS AREA OF THE BLUFF.
5. EXTENSIVE TREE CUTTING AND BRUSHING HAVE OCCURRED IN THIS AREA OF THE BLUFF.
6. DISTRESS FEATURES, SUCH AS ROTATION, CRACKING AND SEPARATIONS ARE APPARENT IN THE CONCRETE RETAINING WALL THAT SUPPORTS THE WALKWAY/RAMP TO BASE OF BLUFF. REPAIRS HAVE BEEN MADE TO THE WALL.
7. RUNOFF FROM STAIRWAY AND RESTROOM FACILITY HAS LED TO LOCALIZED EROSION.

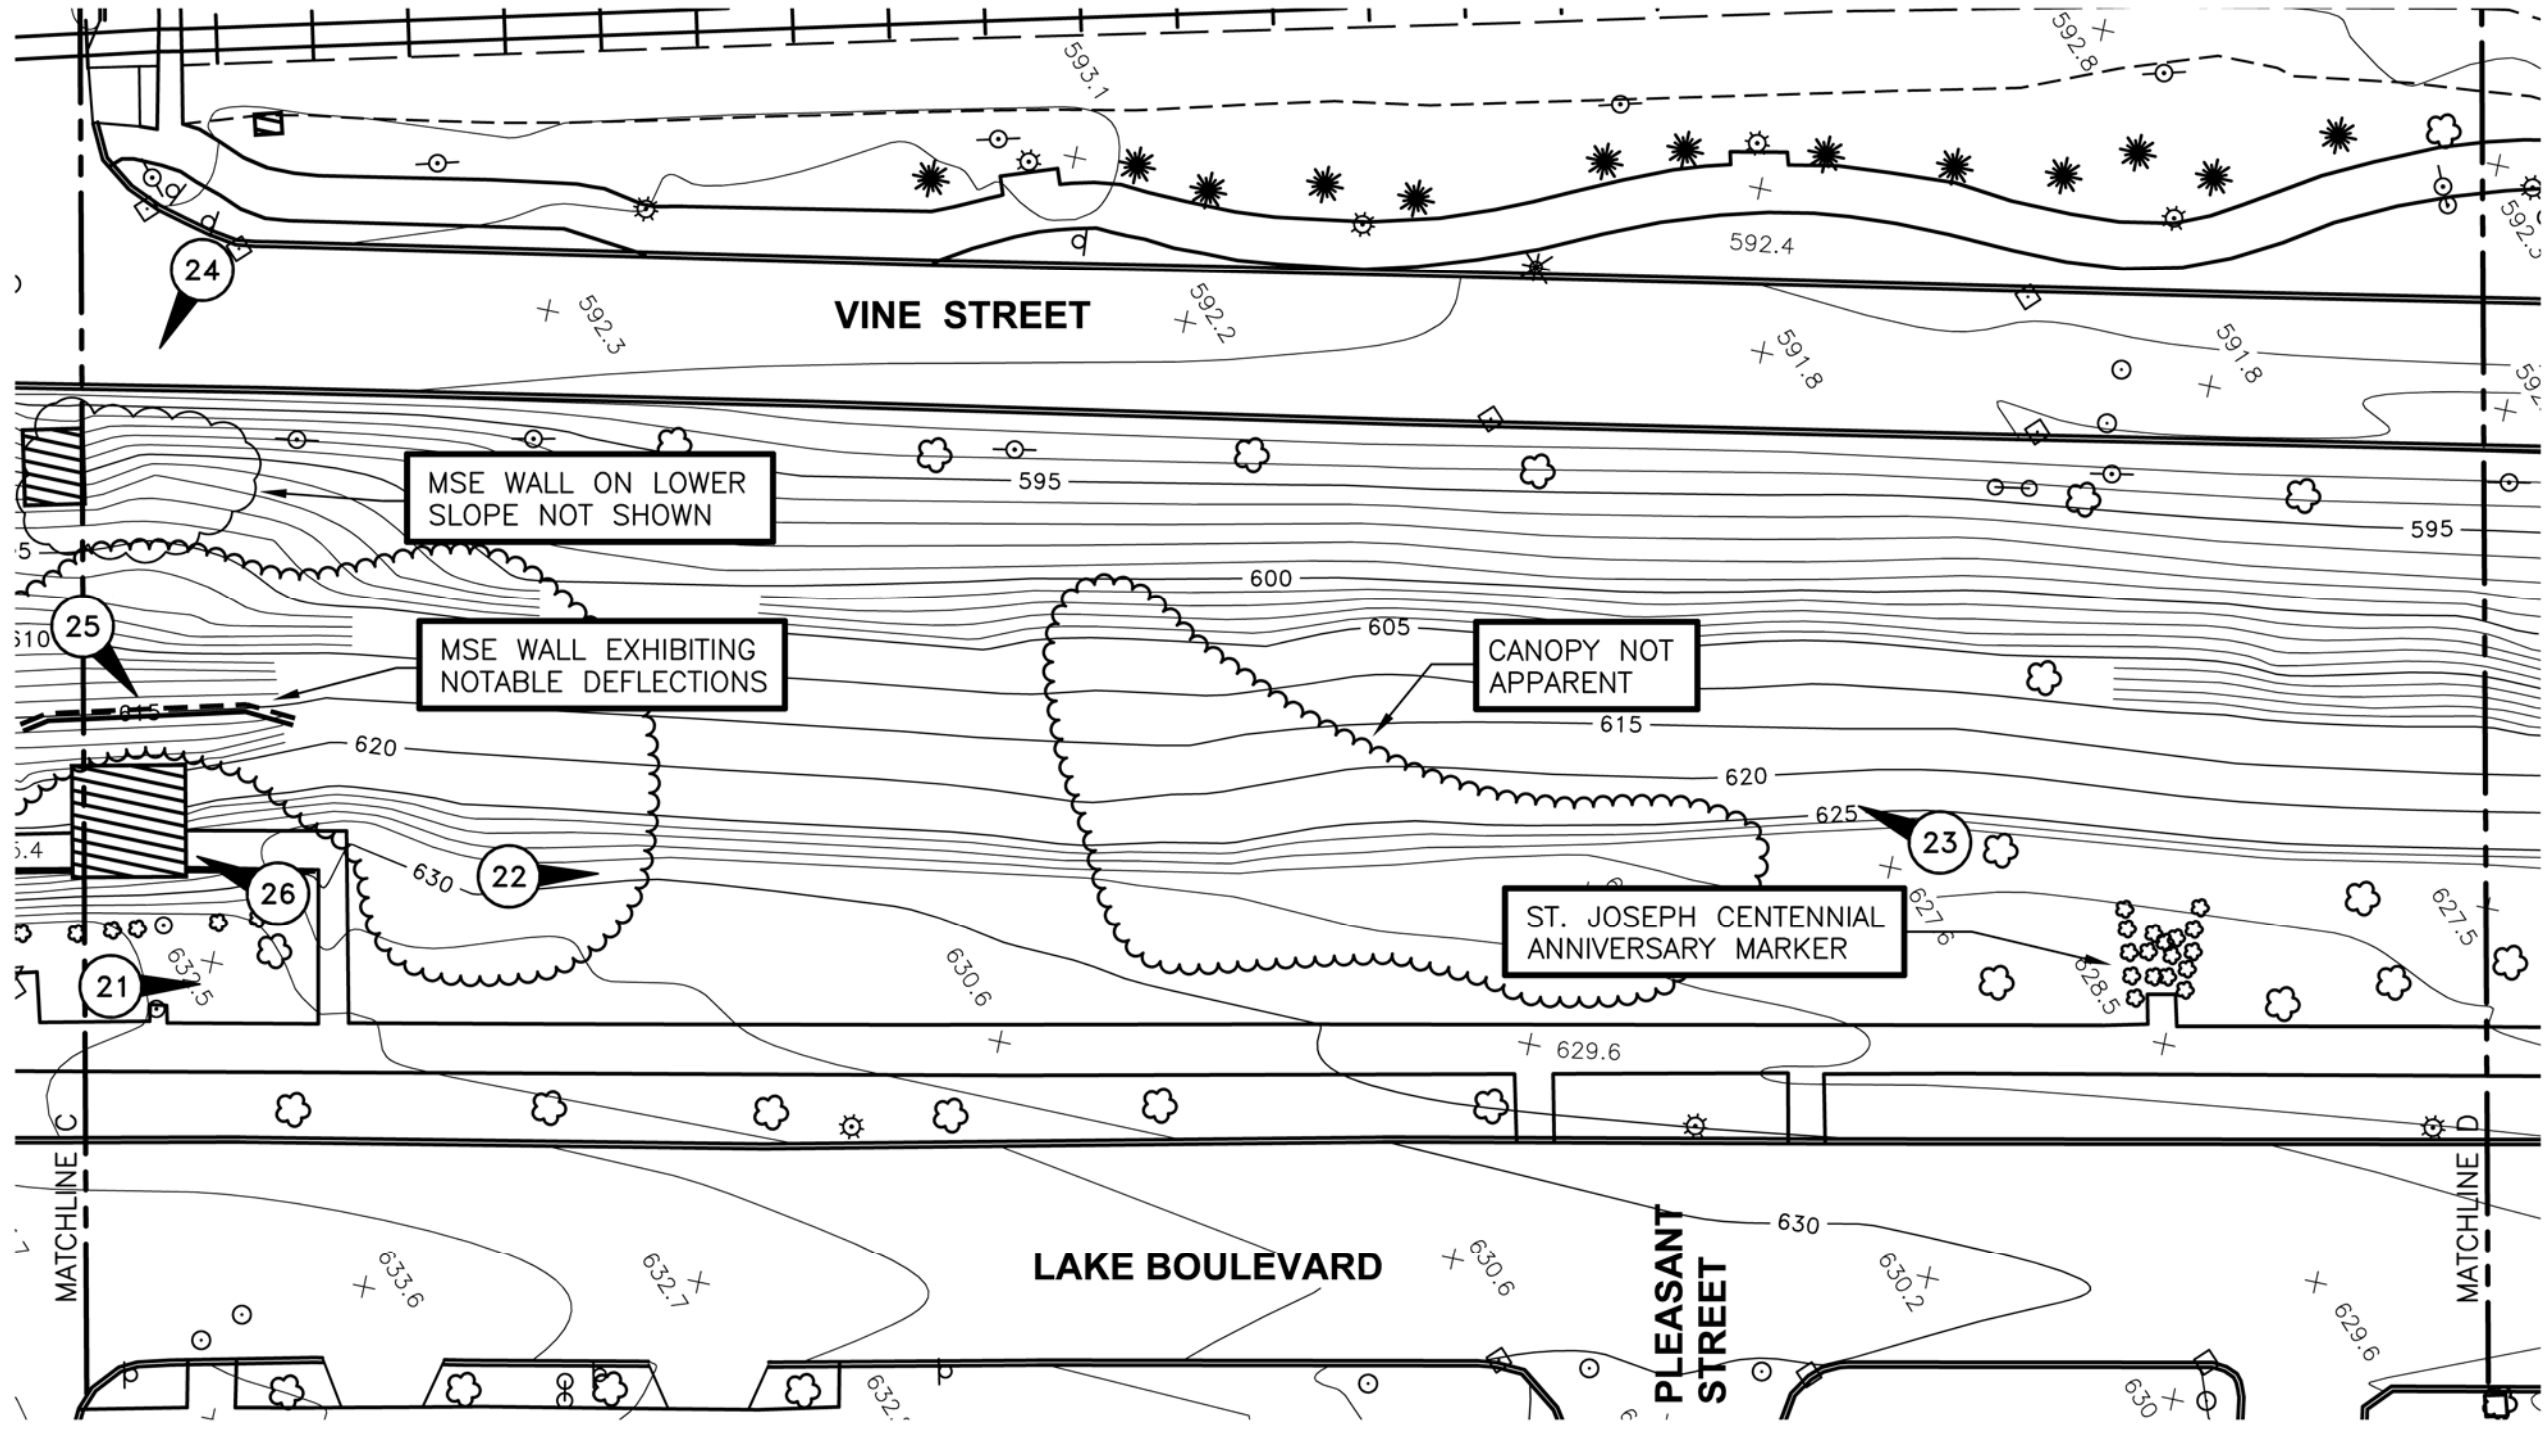
1. SEEPAGE WAS NOT OBSERVED ALONG THE BLUFF FACE OR BLUFF TOE.
2. BLUFF FACE IS MORE UNIFORM IN INCLINATION IN THIS AREA.
3. MOST OF BLUFF FACE IS VEGETATED WITH GRASS.
4. MSE RETAINING WALL IN UPPER PORTION OF BLUFF JUST NORTH OF THE STAIRWAY IS DEFLECTING/MOVING (SEE PHOTO NO. 25). LOWER MSE WALL FOR UTILITY PAD IS IN GOOD CONDITION (SEE PHOTO NO. 24).
5. ONLY A FEW ANIMAL BURROWS OBSERVED IN THIS AREA OF THE BLUFF.

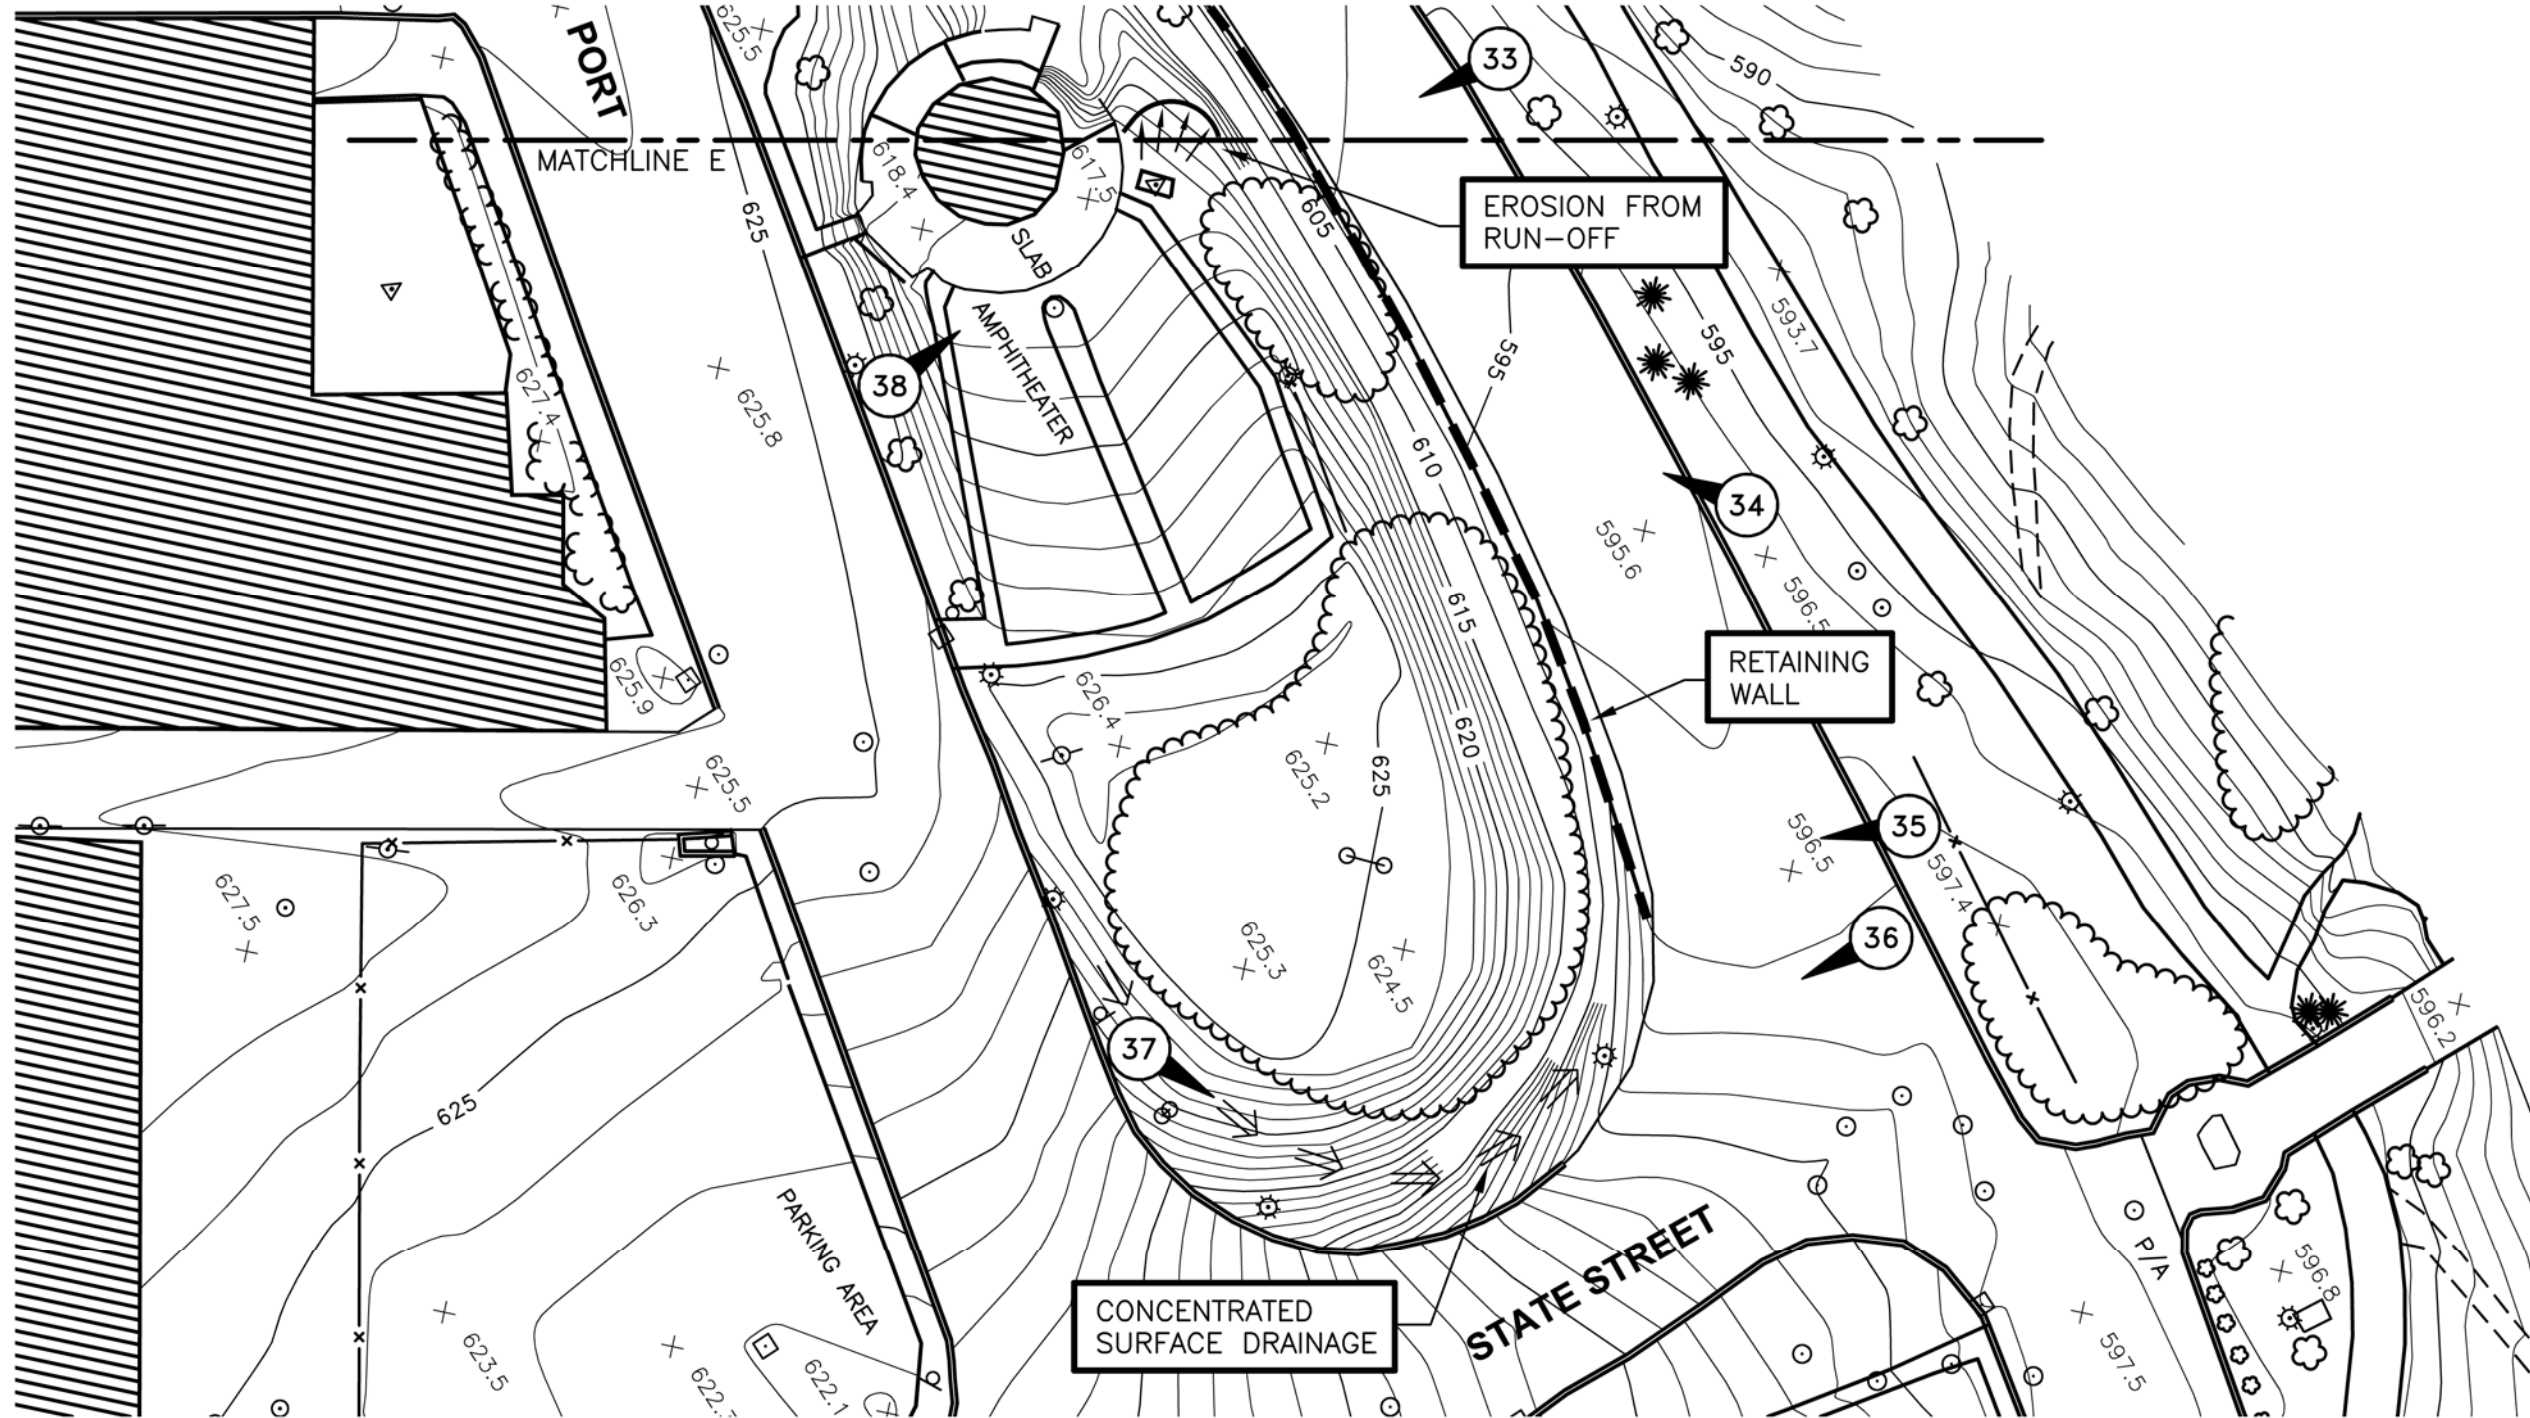
1. MOST OF BLUFF FACE IS VEGETATED WITH GRASS. THERE ARE ALSO SEVERAL LARGE TREES PRESENT.
2. SEEPAGE WAS NOT OBSERVED ALONG THE BLUFF FACE.
3. CONCRETE RETAINING WALL ALONG WATER STREET HAS CRACKS AND SEEPAGE IS EVIDENT AT SOME OF THESE CRACKS.
4. BLUFF FACE ABOVE THE RETAINING WALL IS VERY STEEP IN THIS AREA. SOME OF THE GRASSY AREAS ARE ERODING IN THE STEEPEST SLOPE AREAS.
5. THERE IS CONCENTRATED SURFACE DRAINAGE IN THE GRASS AREA BEHIND THE CURB ON THE WEST SIDES OF PORT AND STATE STREETS. (SEE PHOTO NO. 37).
6. THERE WAS PONDED WATER IN THE AMPHITHEATRE AREA AT THE TIME OF OUR SITE VISIT (SEE PHOTO NO. 38).

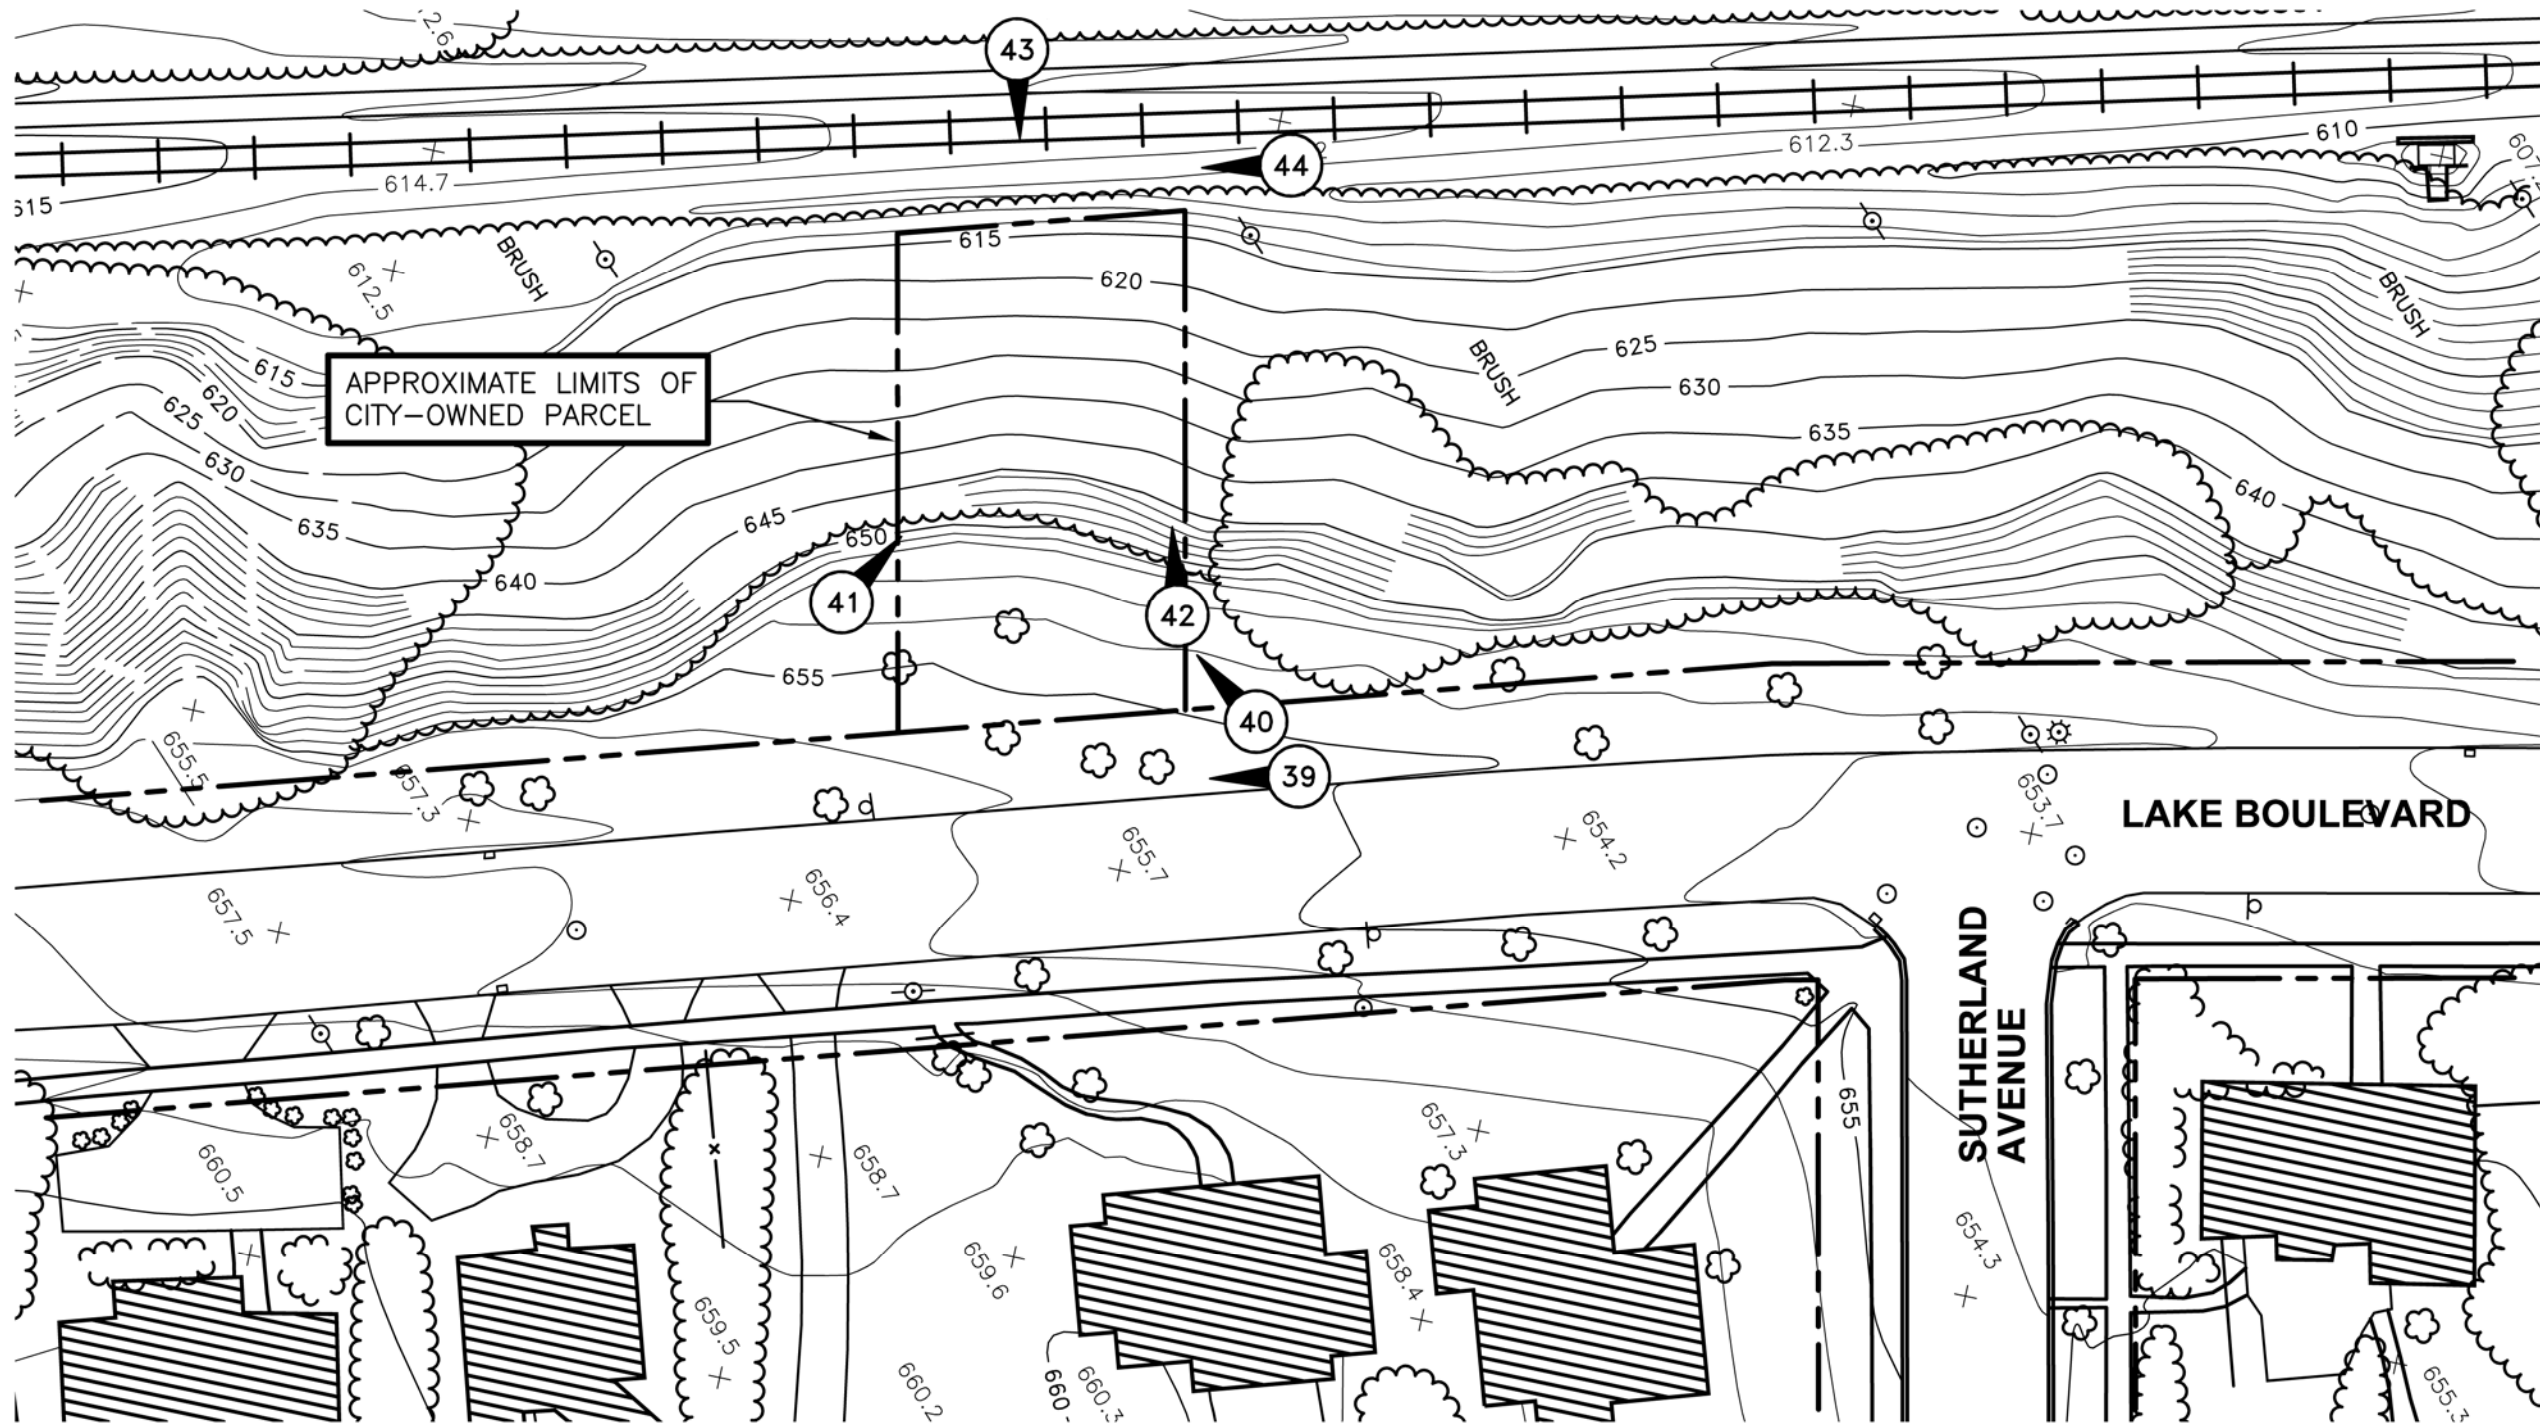
1. MOST OF BLUFF FACE IS VEGETATED WITH BRUSH THAT HAS RECENTLY BEEN TRIMMED/CUT.
2. AREA AT THE TOP OF THE BLUFF IS A MAINTAINED GRASS LAWN WITH SCATTERED LARGE HARDWOOD TREES.
3. DEBRIS SUCH AS YARD WASTE AND CONCRETE WASTE HAS BEEN CAST OVER THE TOP OF THE BLUFF.
4. SEEPAGE WAS NOT OBSERVED ALONG THE BLUFF FACE OR AT THE BLUFF TOE.
