REPORT ON LAKE BOULEVARD BLUFF EVALUATION

LAKE BOULEVARD BETWEEN PARK STREET AND WATER STREET ST. JOSEPH, MICHIGAN

**SME Project No. KG59313
July 15, 2009**

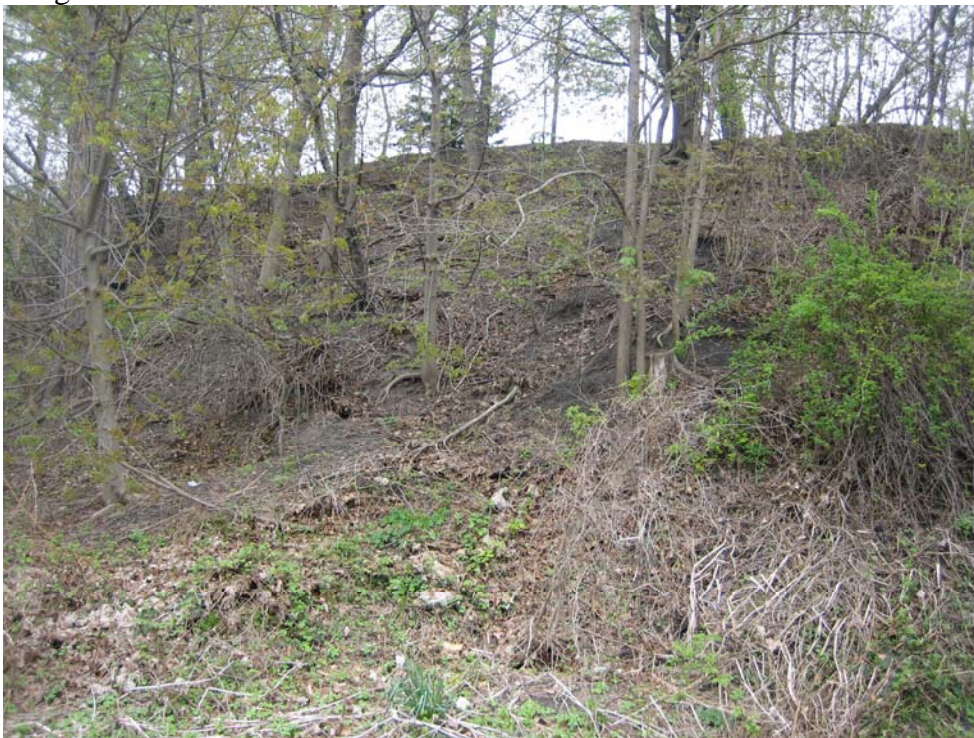
The bluff face in this area is relatively heavily vegetated with trees and brush (Photo Nos. 3 and 4). This vegetative cover is generally indicated on the topographic base for Sheet 1. The inclination of the bluff face in this area generally ranges from about 3:1 to 1½:1. Seepage was not observed emanating from the bluff face or from the area near the bluff toe. Although not noted on the topographic base for Sheet 1, a storm drain that extends down the bluff from Lake Boulevard discharges into an energy dissipater just beyond the bluff toe near the northern limits of the area covered by this sheet. An active railroad line is located just beyond the bluff toe in this area of the bluff.

PHOTO NO. 4: Note the relatively dense tree and brush cover along the bluff face.

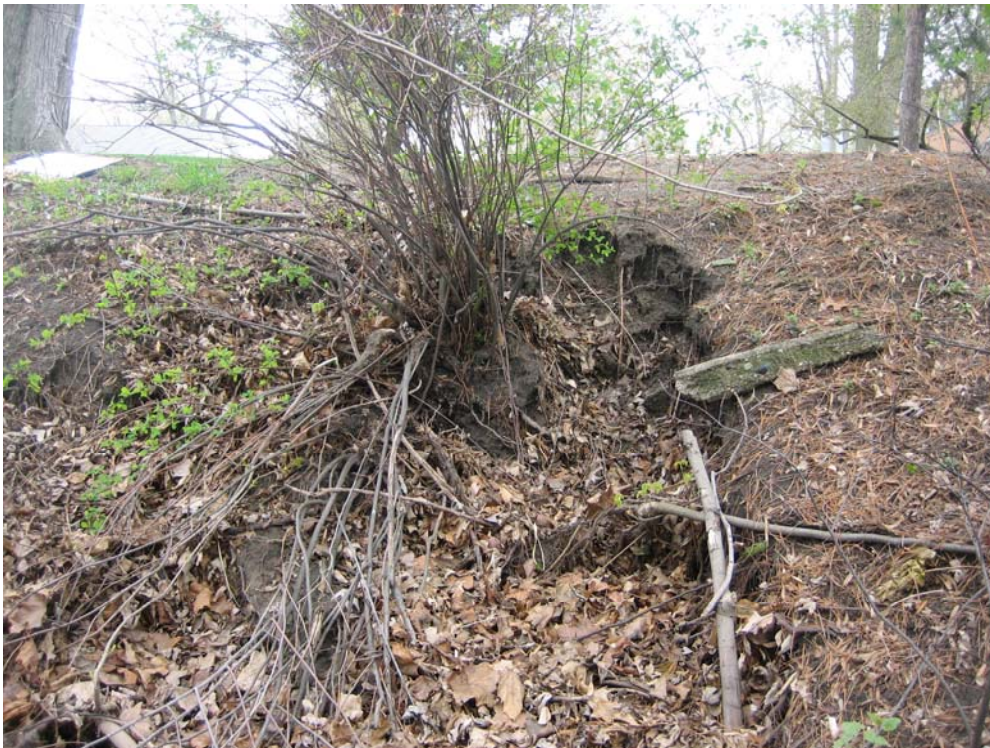
PHOTO NO. 6: Erosion just beyond the top edge of the bluff.

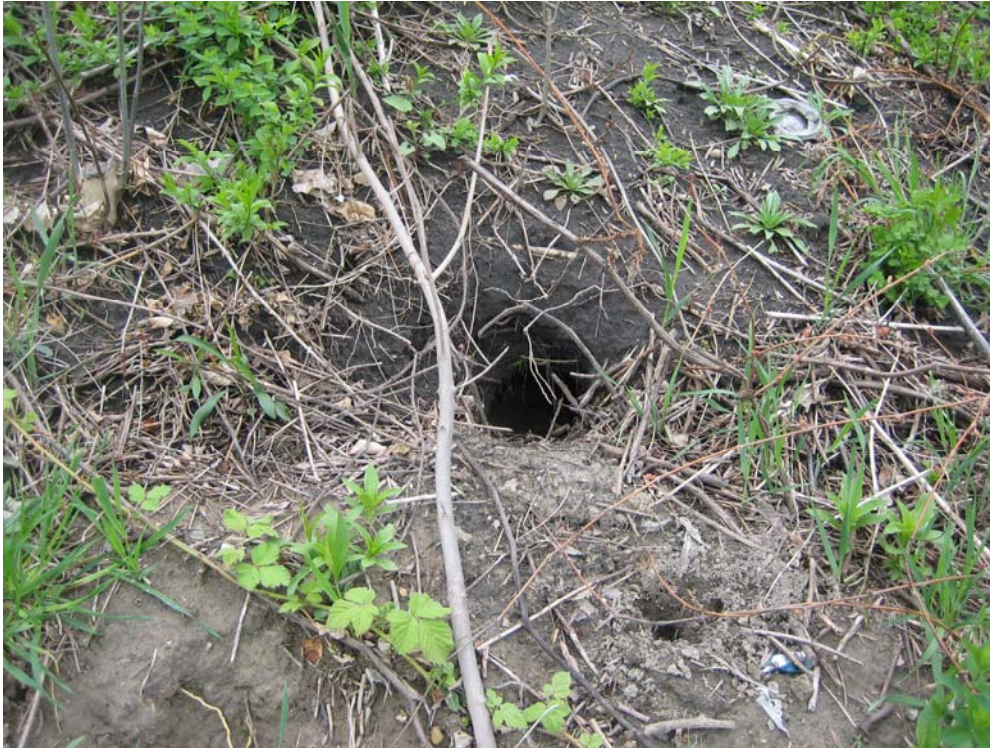
PHOTO NO. 7: Animal burrow near the bluff toe.

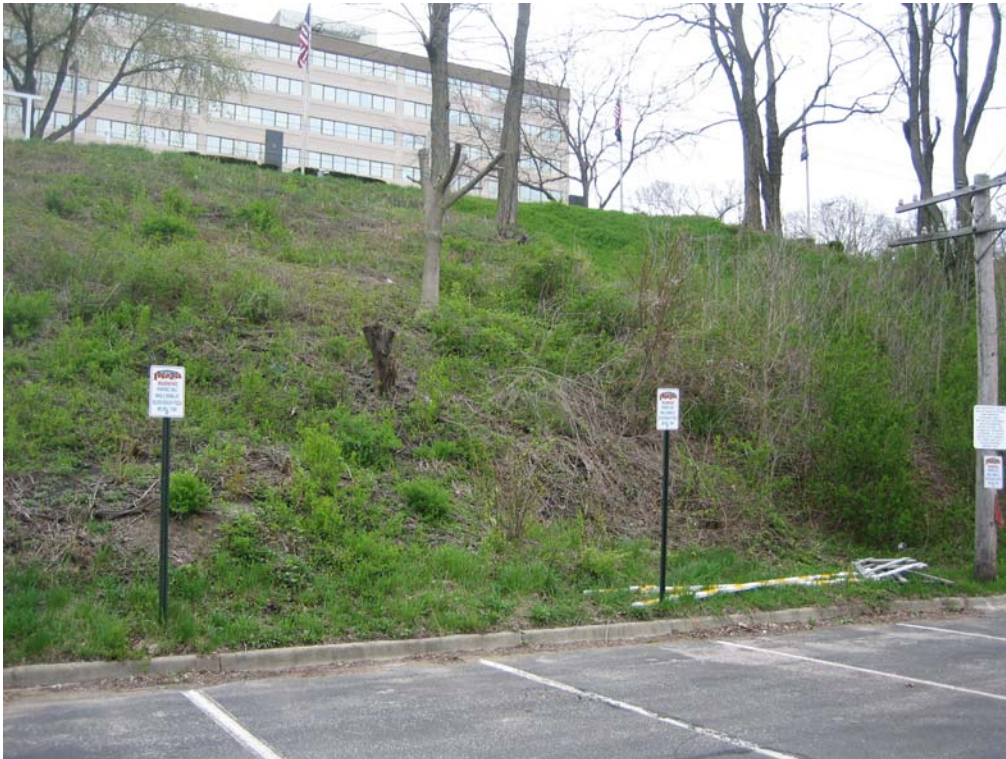
The bluff face in this area is relatively heavily vegetated with trees and brush (Photo No. 10). However, at the northern limits of the area covered by this sheet, there is evidence of past clearing of brush and cutting of trees (Photo No. 8). The inclination of the bluff face in this area generally ranges from about 3:1 to 1:1. Seepage was not observed emanating from the bluff face or from the area near the bluff toe. However, an area of standing water was noted in the area near the bluff toe within the southern portion of the area covered by this sheet (Photo No. 12). It appears that storm water that is discharged or directed to the bluff toe area simply ponds in this area and does not have a dedicated outlet.

PHOTO NO. 8: Note the brush and tree removal in the left portion of the photo.

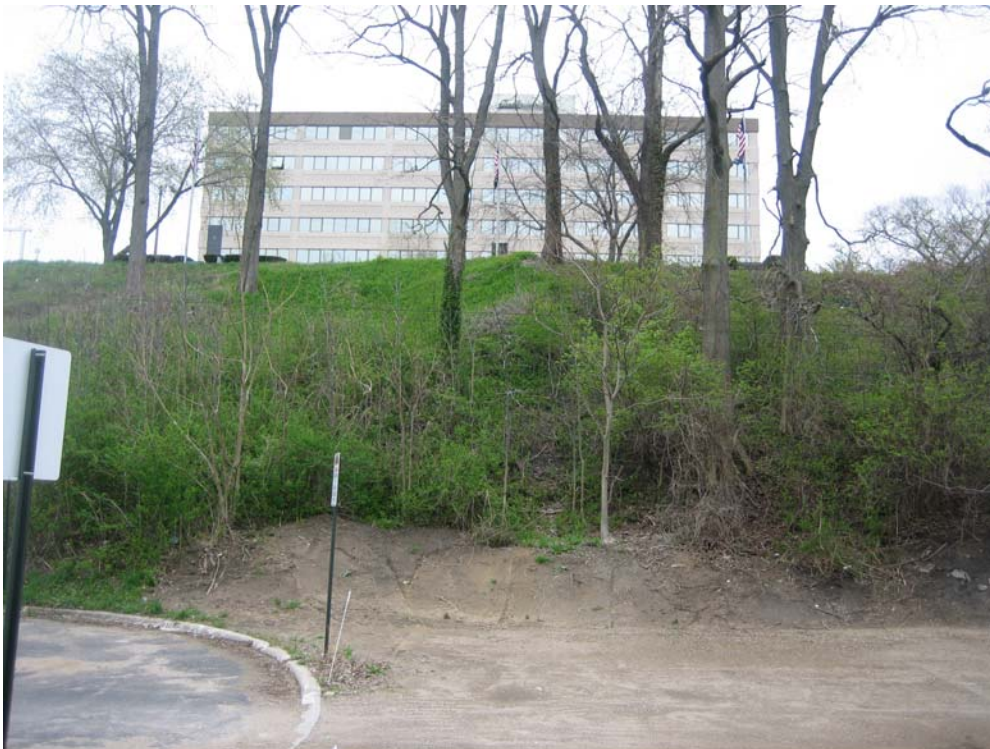
PHOTO NO. 10: Note the presence of more trees and brush on the bluff face in this area compared to Photo No. 8.

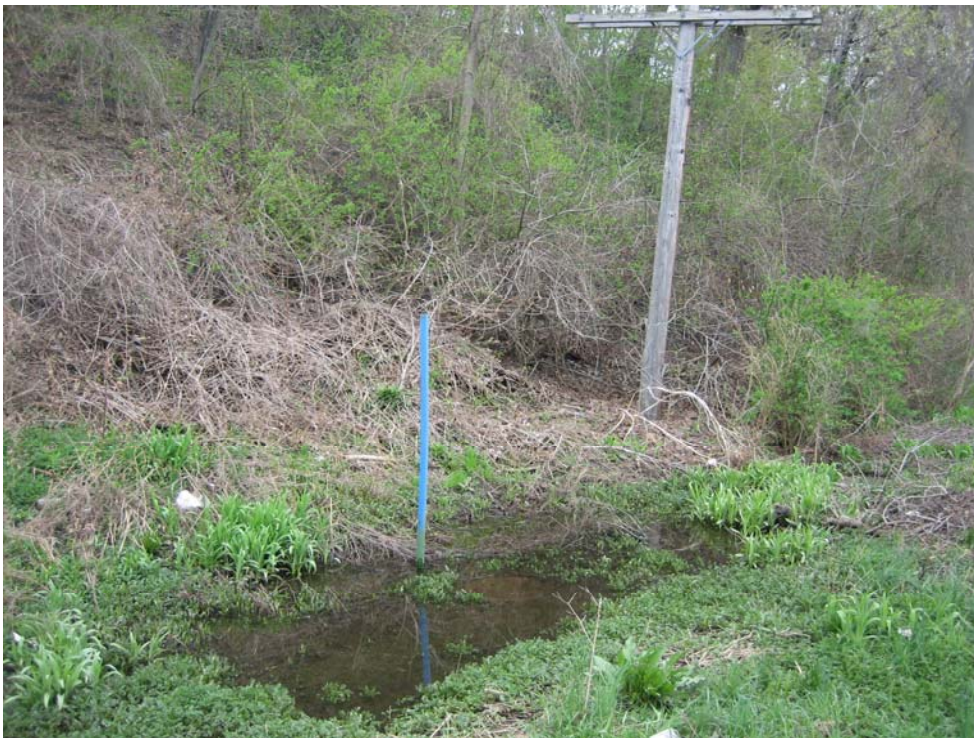
appears the grading performed to construct this gravel parking area may have exacerbated the poor drainage conditions along the bluff toe as denoted by Photo No. 12. These parking areas generally are located just beyond the bluff toe within the northern portion of the area covered by Sheet 2. An active railroad line is located just beyond the bluff toe within the southern portion of the area covered by Sheet 2.

PHOTO NO. 12: Wet area at toe of bluff likely due to poor surface drainage.

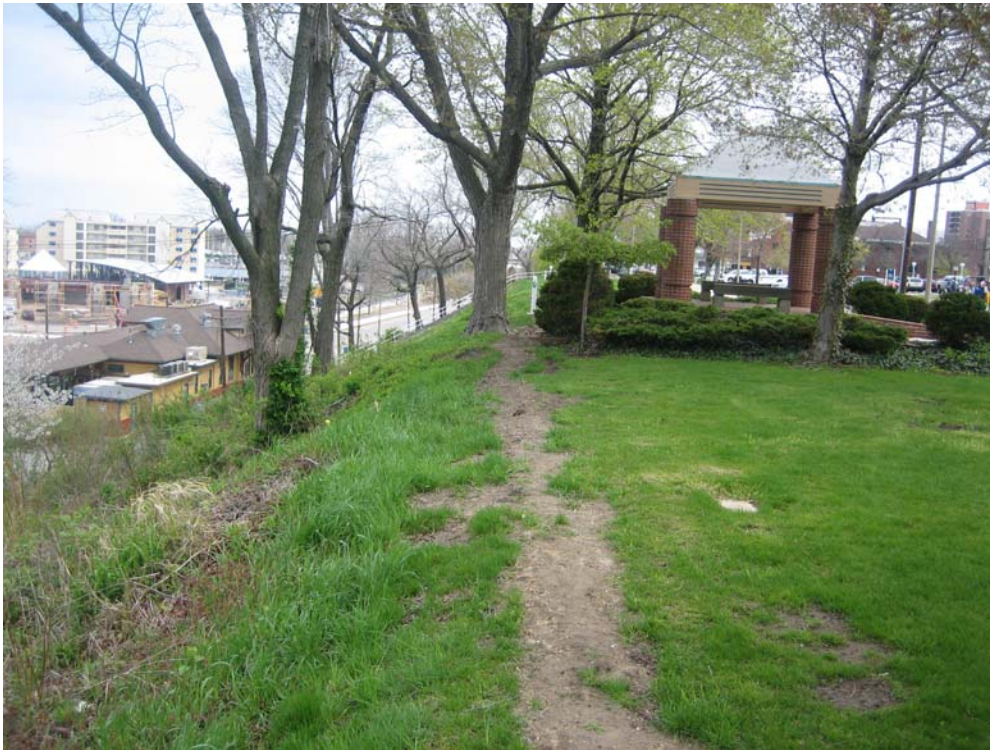
PHOTO NO. 13: Looking northeast along the top edge of the bluff. Note the scar from the utility trench running parallel with the top edge of the bluff.

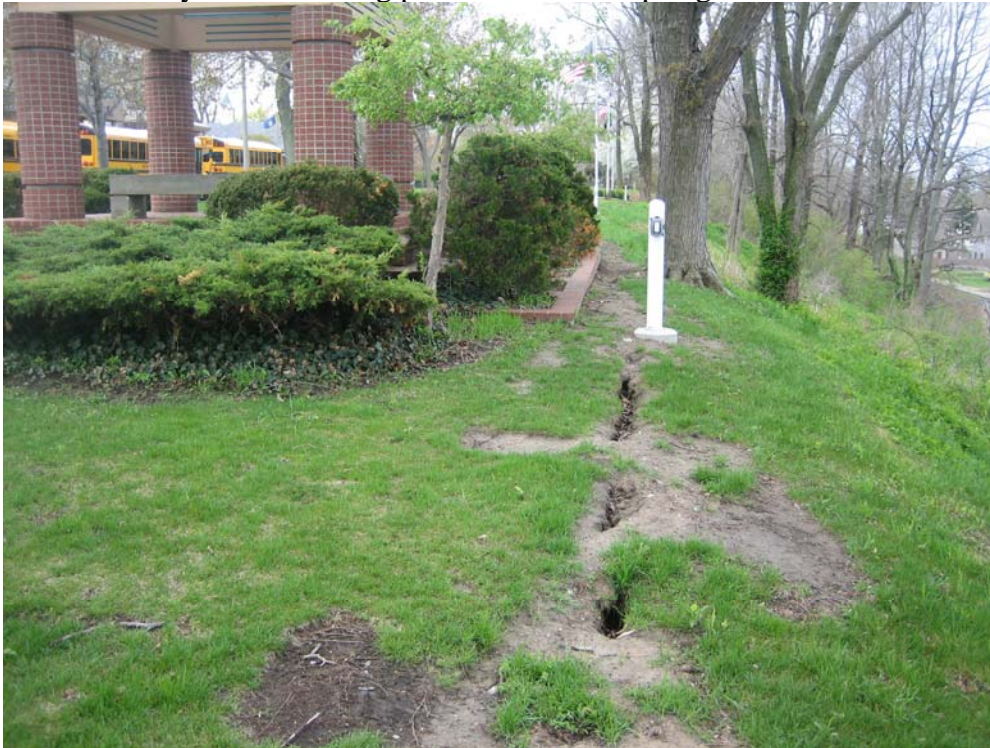
PHOTO NO. 14: Looking southerly at the utility trench scar along the top edge of the bluff.

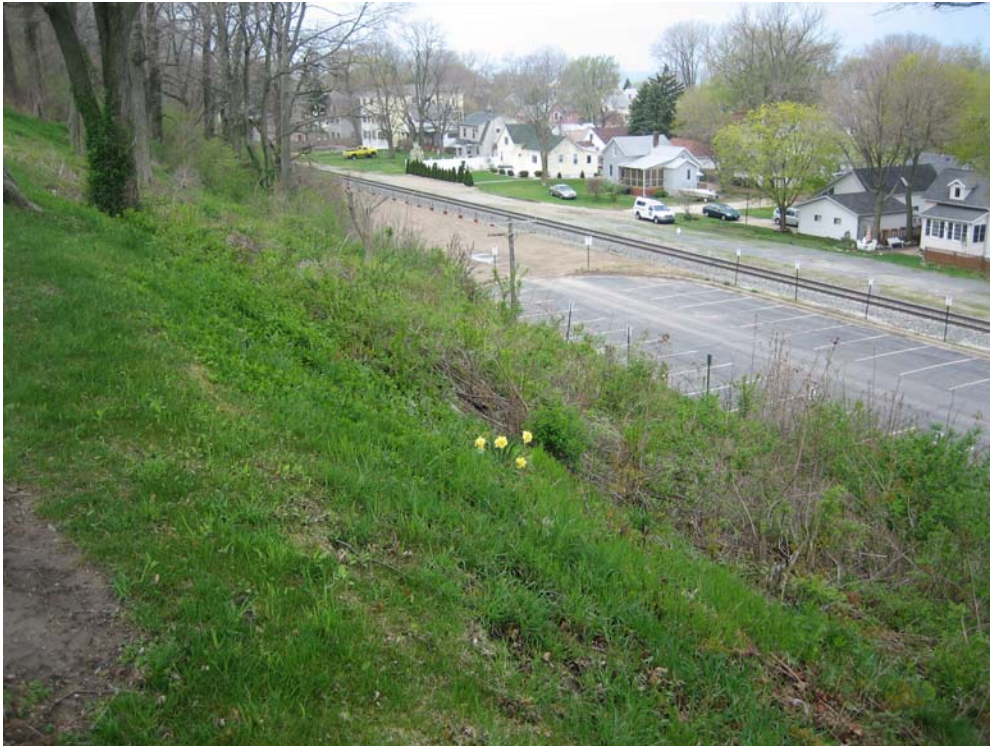
PHOTO NO. 15: Looking southwest. Note the lack of tree and brush cover except for in the far left of the photo.

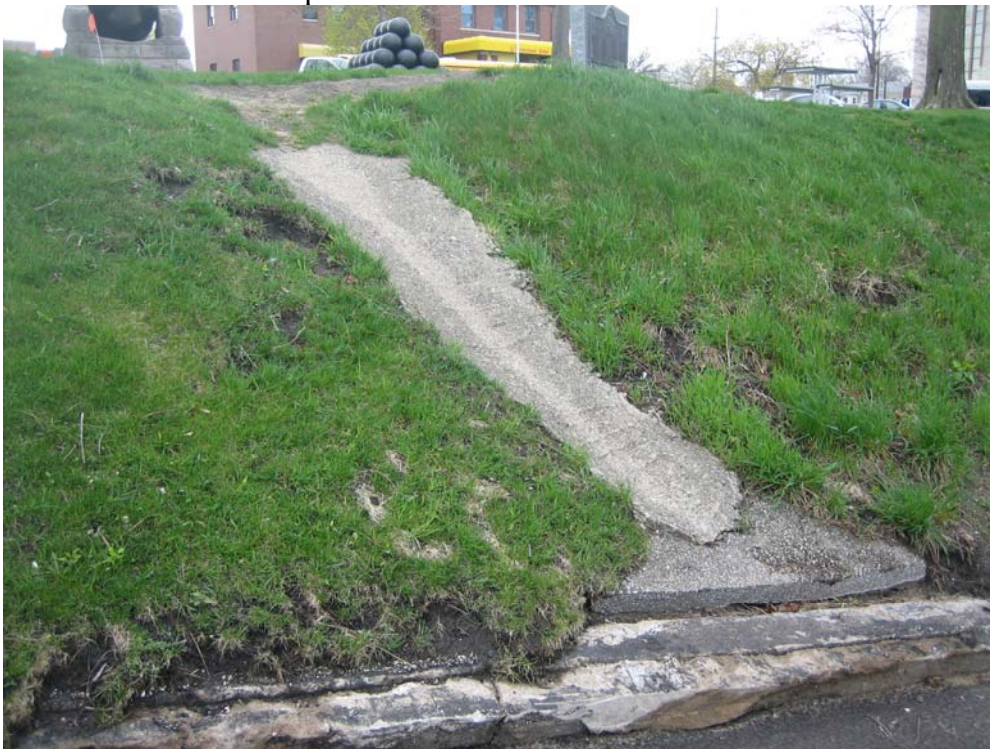
PHOTO NO. 16: Looking south from the walkway toward the cannon exhibit. Note the paved spillway where surface runoff is being directed over the bluff edge and to the walkway.

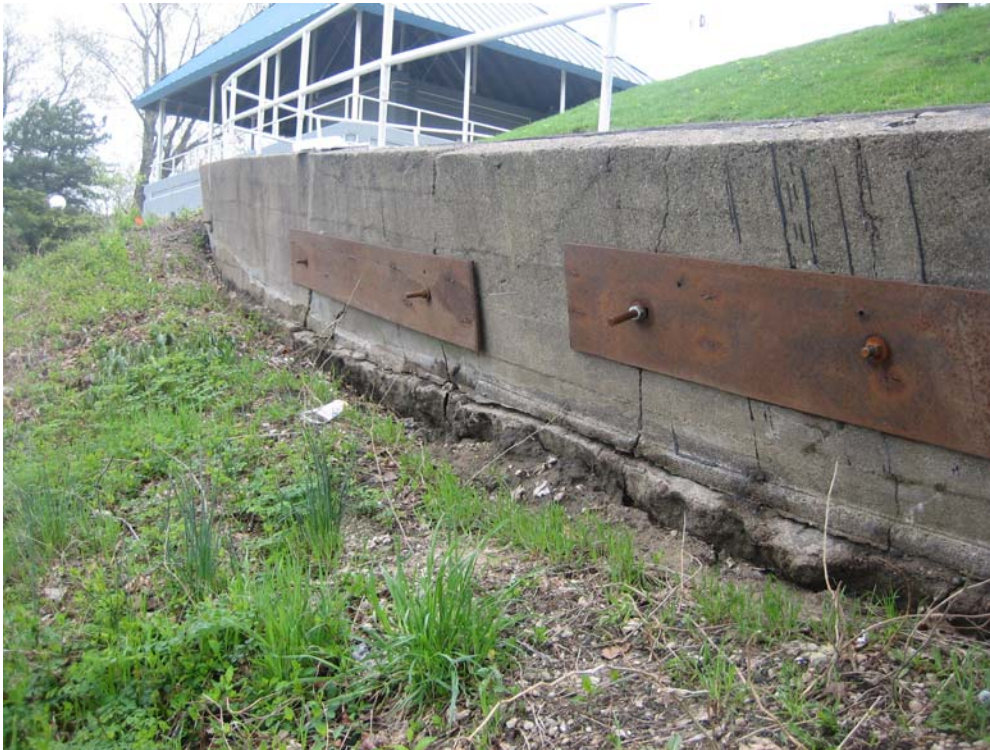
An existing paved walkway/ramp extends down the bluff face to the southwest from the pavilion area. This walkway is about 260-feet long and appears to have been constructed by using a concrete retaining wall system to laterally support the walkway on the downslope side. Considerable distress features such as rotation of the retaining wall, cracks in the wall, separations in the wall, and mass movement of the wall are apparent (Photo Nos. 17 and 19). It

appears past repairs to the retaining wall have included the addition of steel plates attached to soil anchors that extend into the backfill behind the retaining wall (into the slope). The retaining wall system that supports the walkway is judged to be in relatively poor condition, but the repairs completed appear to have stabilized the wall and the associated walkway on at least an interim basis.

PHOTO NO. 17: Looking northeast at the upper portion of the walkway retaining wall. Note the steel plates and anchorages.

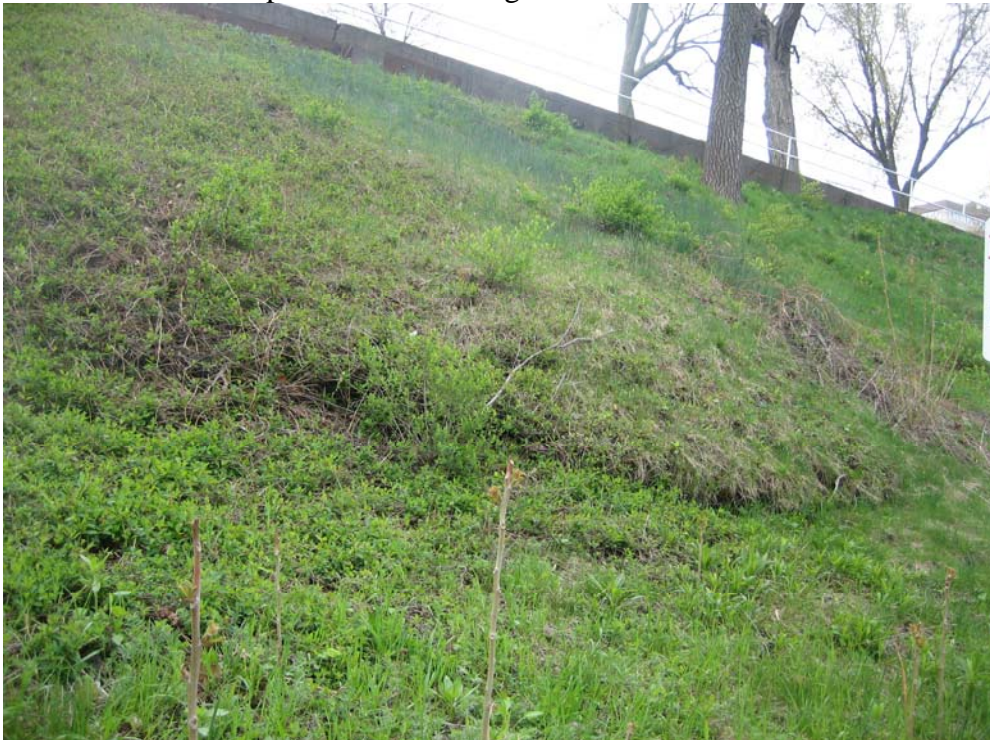
PHOTO NO. 18: Mass soil movement near the base of the bluff below the walkway. Note the leading edge of the mass protrudes above the bluff face below.

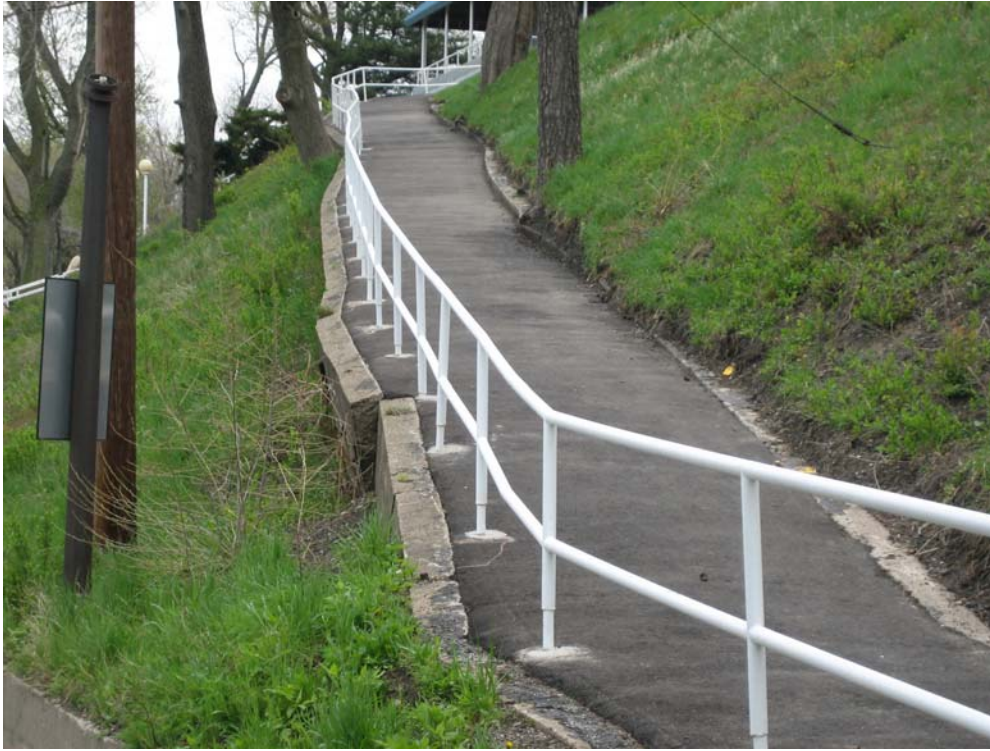
PHOTO NO. 19: Looking northeast up the walkway. Note the retaining wall movements.

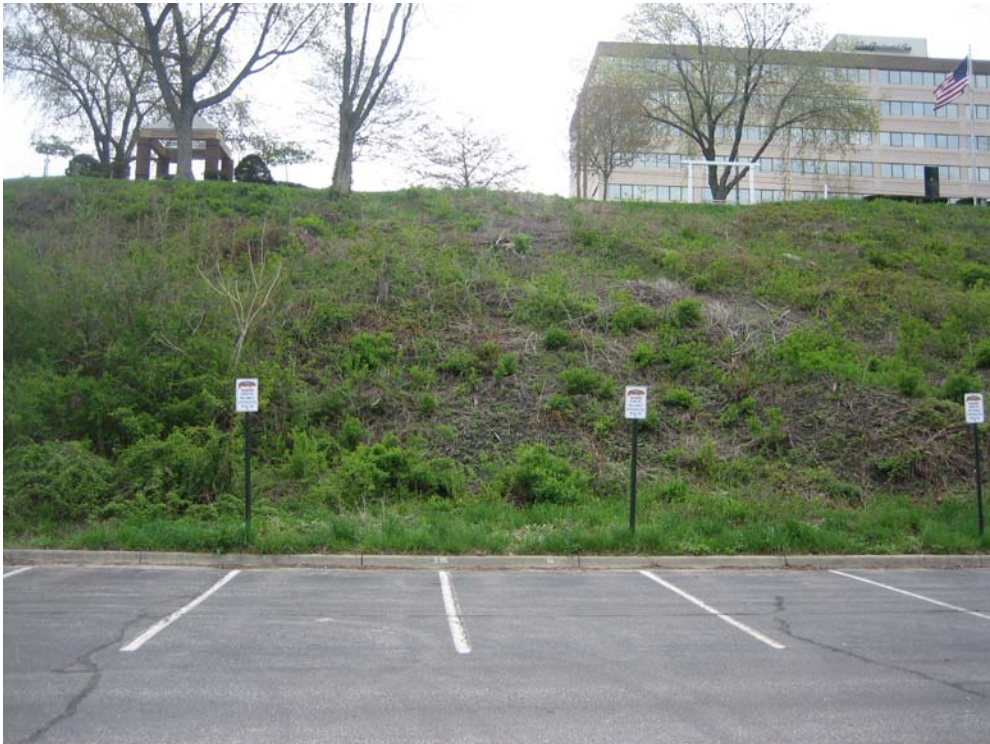
PHOTO NO. 20: Note the general lack of tree and brush cover on the bluff face.

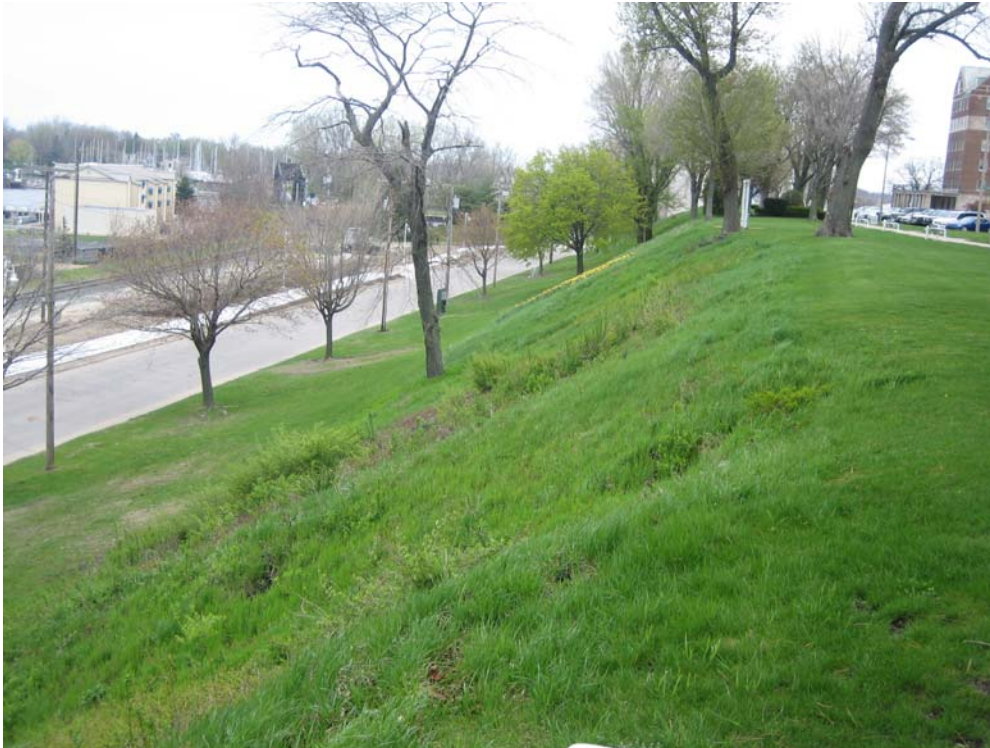
PHOTO NO. 22: Looking northeast along the bluff face. Note most of the bluff cover is grassy.

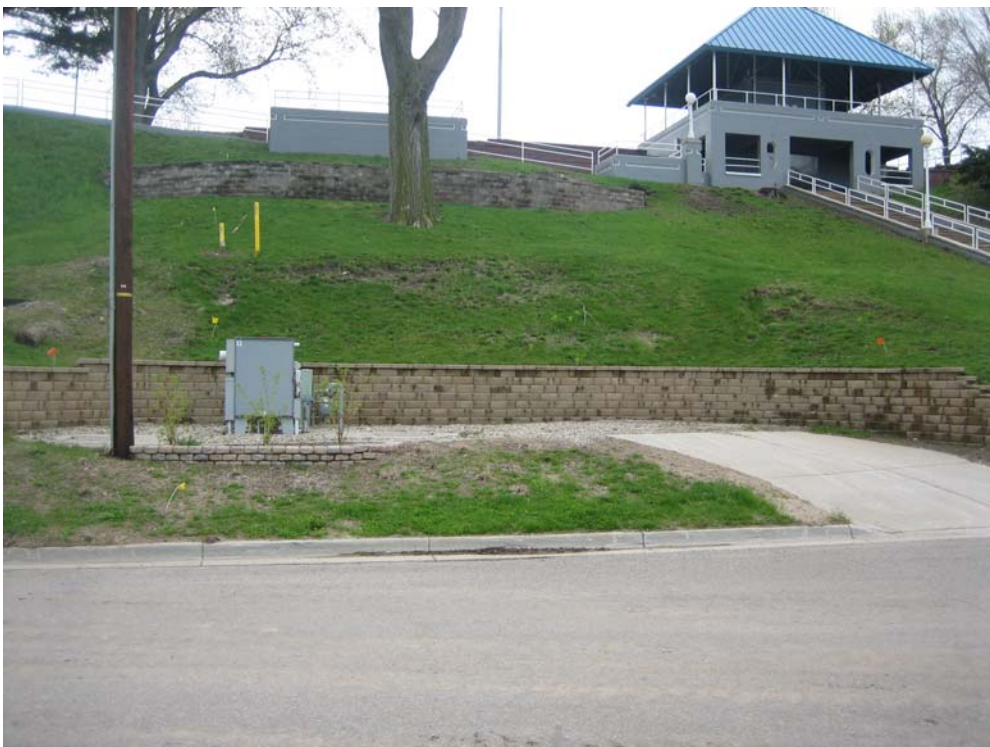
PHOTO NO. 24: Looking southeast. The lower MSE wall is in good condition. The upper MSE wall (behind the tree) is experiencing excessive deflections at the top.

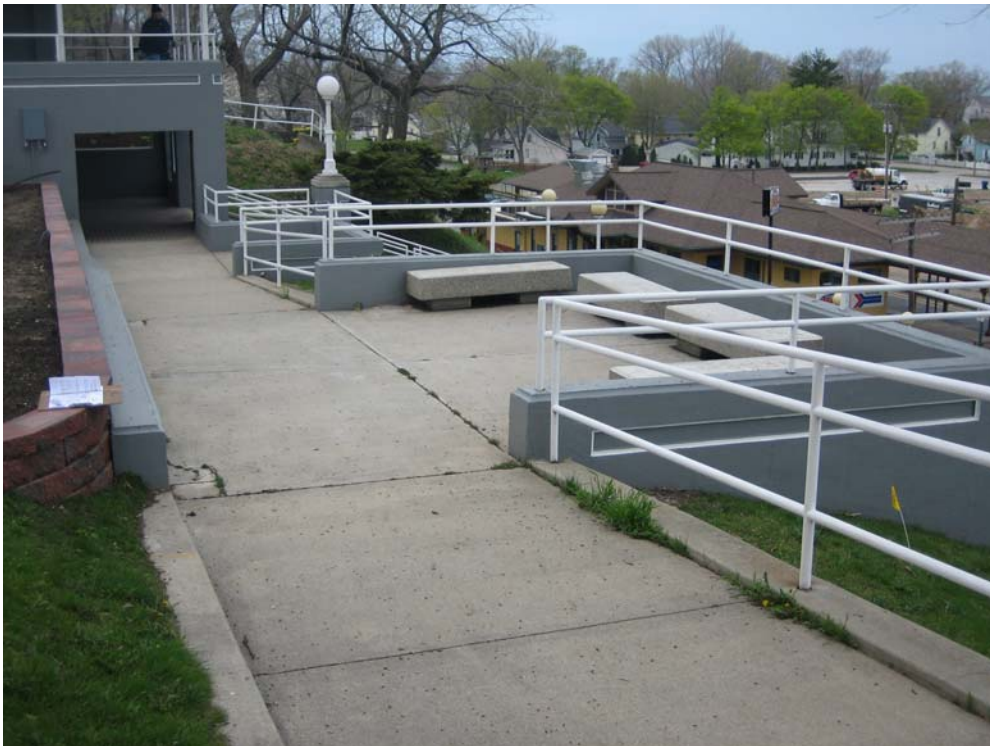
The area between Lake Boulevard and the edge of the bluff is generally a lawn area associated with a public park (Photo No. 21). In general, surface drainage from the lawn area appears to be directed toward the edge of the bluff in this area, although areas with concentrated discharge were not observed. Surface water collected from concrete flatwork areas along the promenade area to the north of the pavilion is discharged onto the bluff face through scuppers in the surrounding retaining walls (Photo No. 26).

PHOTO NO. 26: Surface drainage from flatwork is being discharged onto the bluff face through scuppers in the walls.

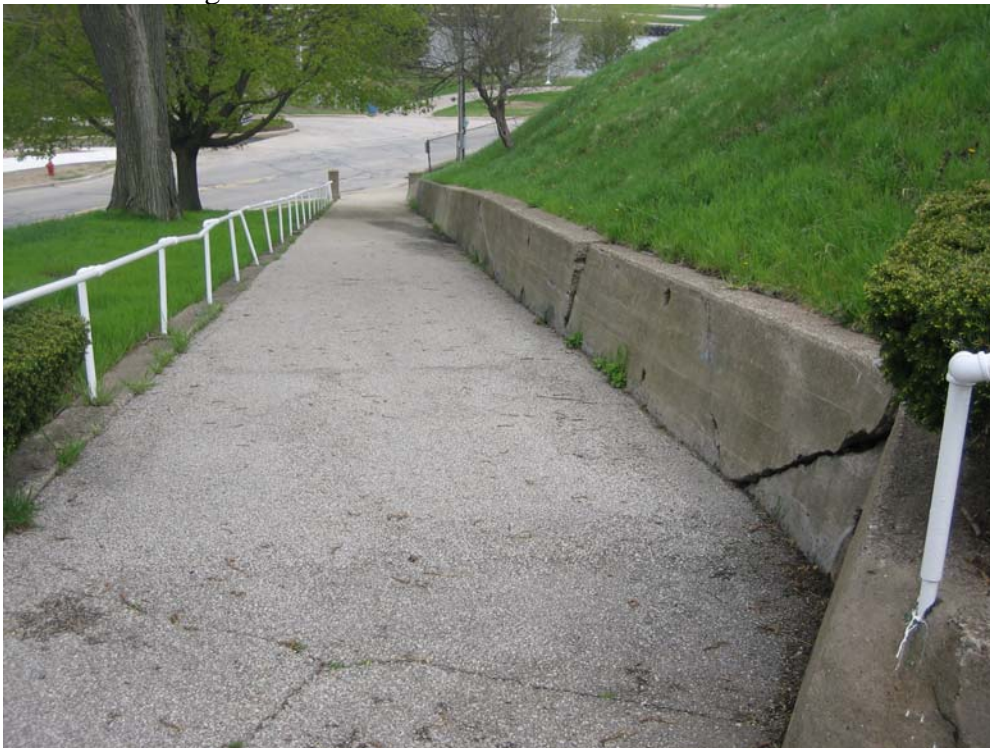
PHOTO NO. 28: Looking down (to the north) along the former “moving walkway”. Note the cracking in the retaining wall to the right.

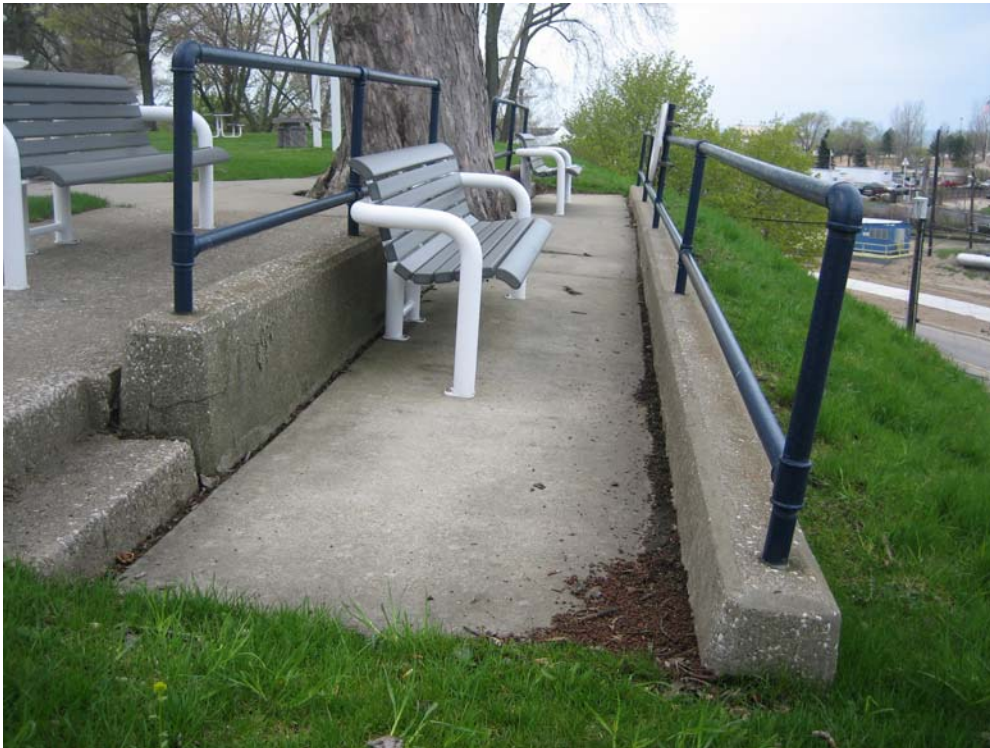
PHOTO NO. 29: Note the lean (downslope) in the wall and handrail at right.

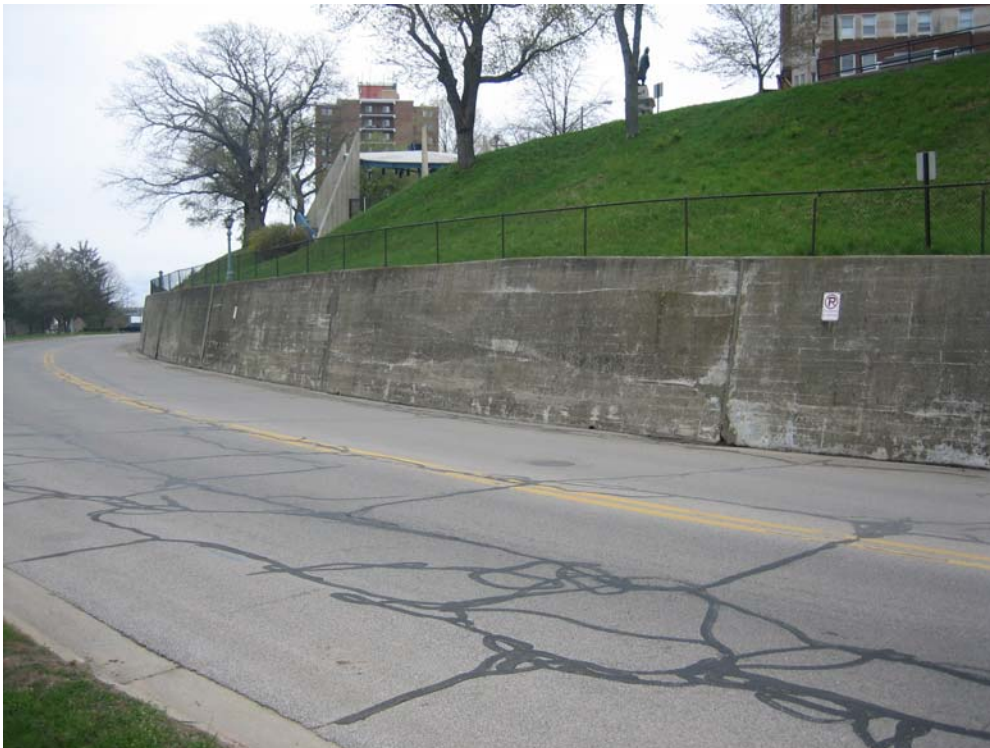
A retaining wall extends along Water Street beginning at the base of the walkway (Photo Nos. 30 and 31). The overall length of this wall is about 470 feet and this wall extends into the area covered by Sheet 6 and terminates near State Street. This retaining wall appears to be a concrete gravity wall and the wall provides grade separation between the bluff face and the shoulder area along Water Street below. The maximum height of the wall is about 12 feet. The reinforced concrete wall contains numerous cracks and appears to be in generally fair condition.

PHOTO NO. 30: Concrete retaining wall along Water Street. Note cracks in the concrete.

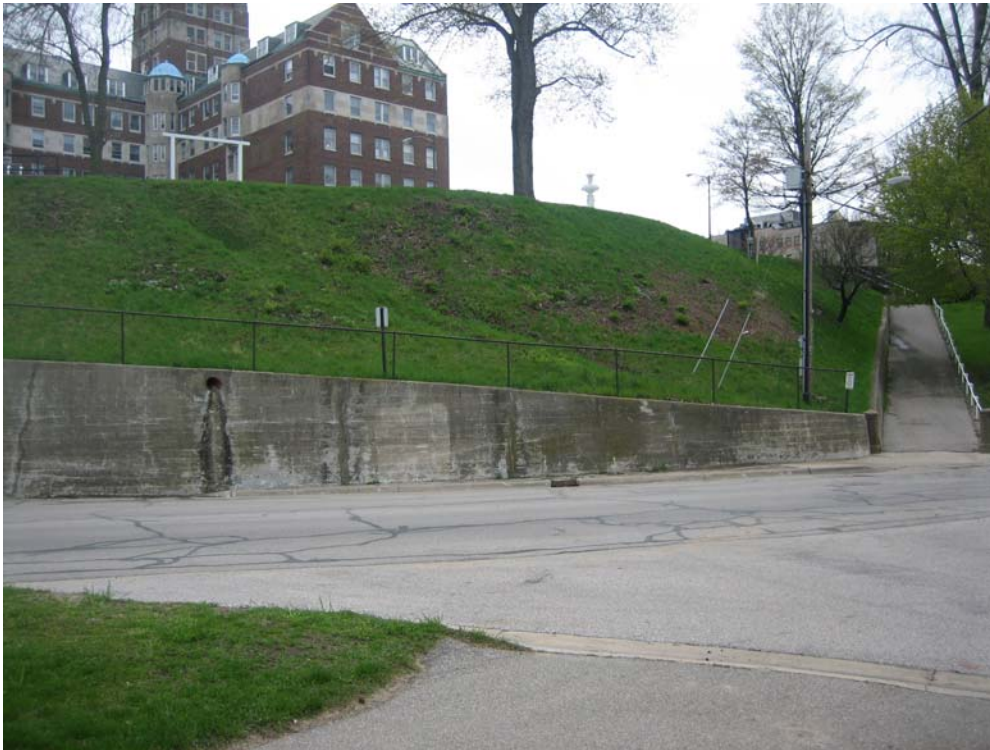
PHOTO NO. 31: Concrete retaining wall along Water Street near base of walkway. Note water stains at drain discharge location.

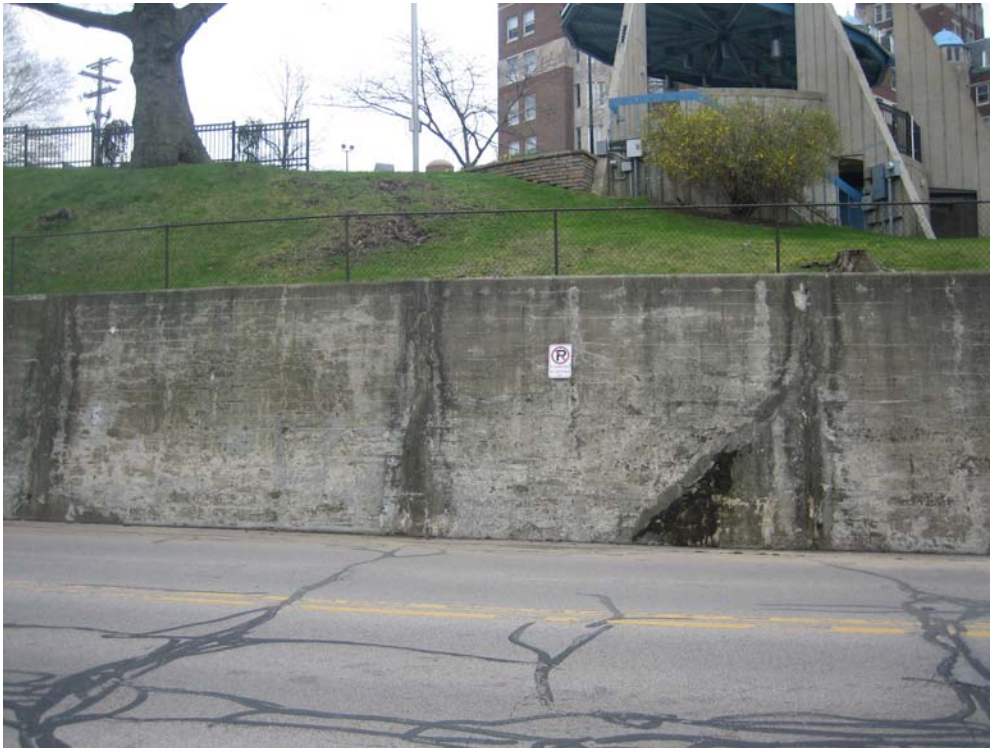
PHOTO NO. 33: Note the cracking and concrete deterioration in the retaining wall.

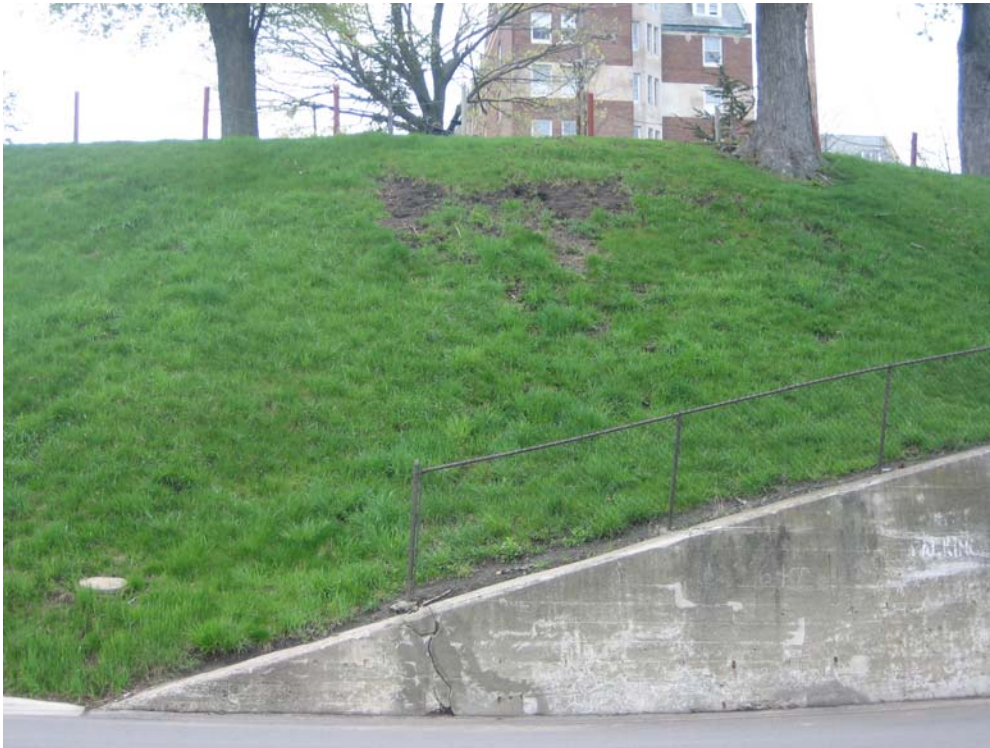
PHOTO NO. 35: Note cracking near the end of the concrete wall and erosion along grassy slope face.

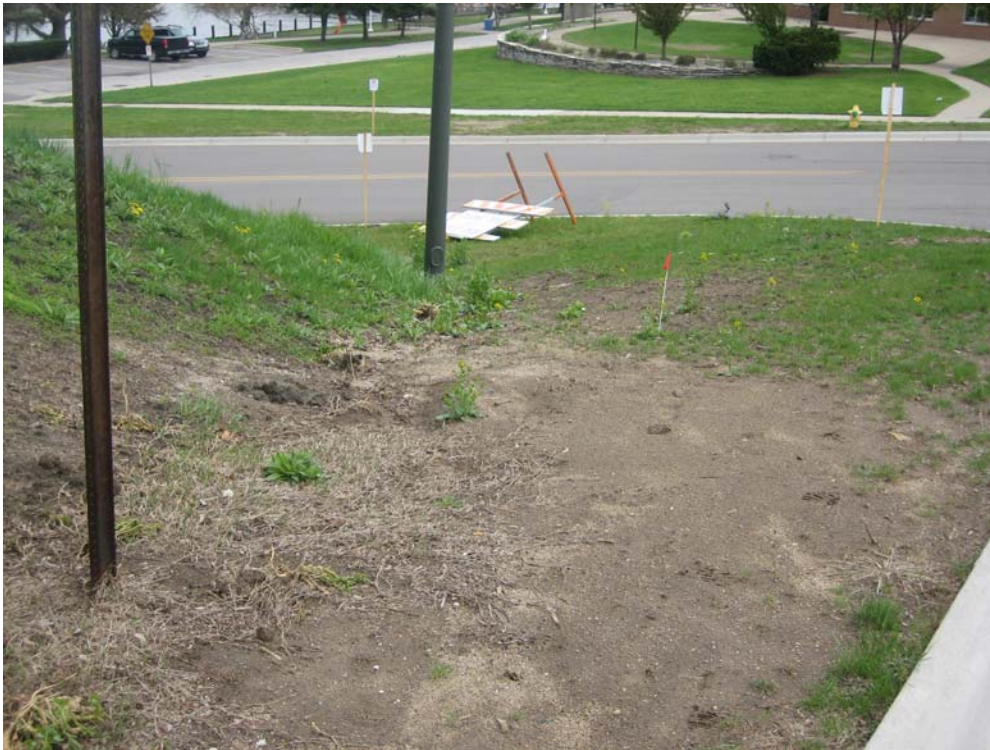
PHOTO NO. 37: Erosion due to concentrated surface drainage.

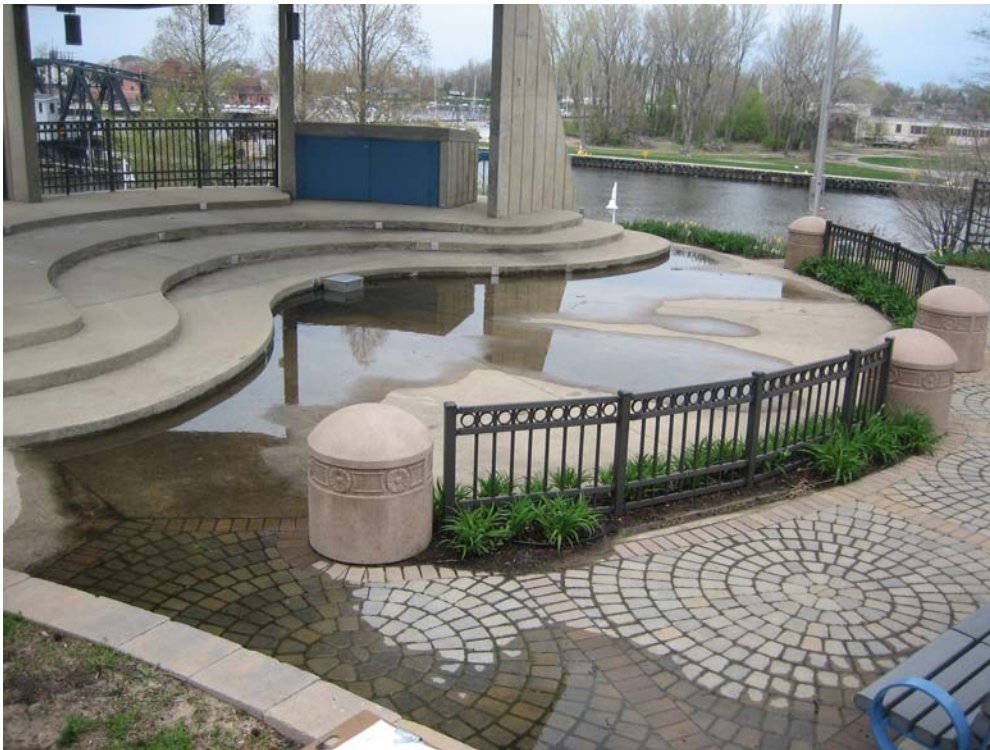
1. MOST OF BLUFF FACE IS VEGETATED WITH GRASS. THERE ARE ALSO SEVERAL LARGE TREES PRESENT.
2. SEEPAGE WAS NOT OBSERVED ALONG THE BLUFF FACE.
3. CONCRETE RETAINING WALL ALONG WATER STREET HAS CRACKS AND SEEPAGE IS EVIDENT AT SOME OF THESE CRACKS.
4. BLUFF FACE ABOVE THE RETAINING WALL IS VERY STEEP IN THIS AREA. SOME OF THE GRASSY AREAS ARE ERODING IN THE STEEPEST SLOPE AREAS.
5. THERE IS CONCENTRATED SURFACE DRAINAGE IN THE GRASS AREA BEHIND THE CURB ON THE WEST SIDES OF PORT AND STATE STREETS. (SEE PHOTO NO. 37).
6. THERE WAS PONDED WATER IN THE AMPHITHEATRE AREA AT THE TIME OF OUR SITE VISIT (SEE PHOTO NO. 38).

PHOTO NO. 38: Ponded water in the flatwork area of the Howard band shell.

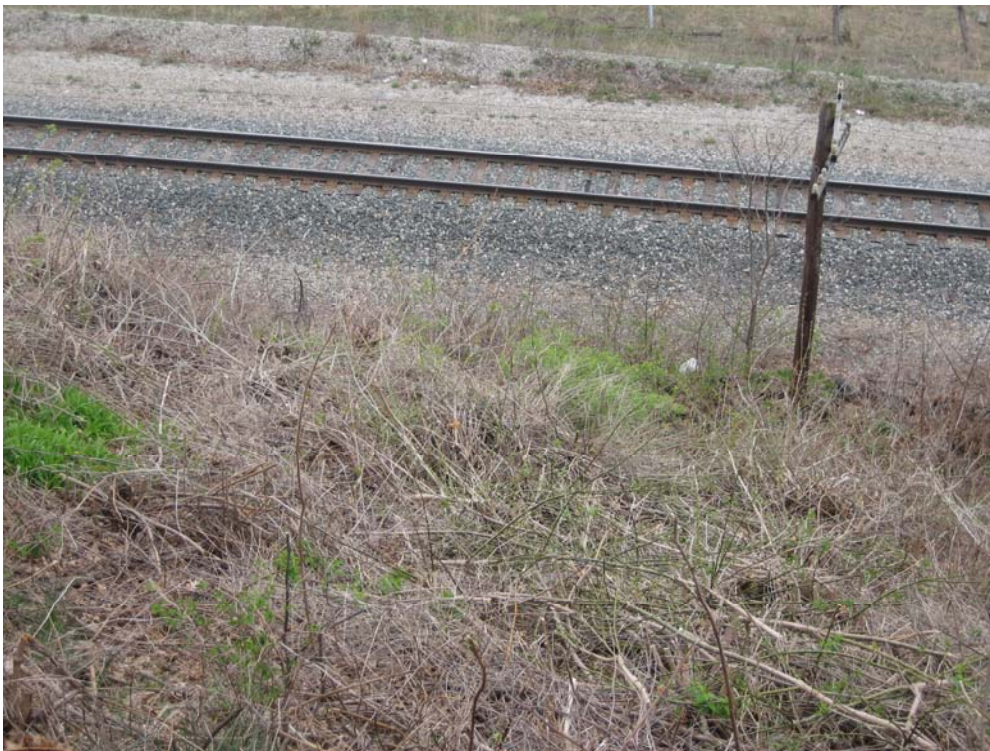
PHOTO NO. 42: Looking northwest down the bluff face. Note the brush that has been cut.

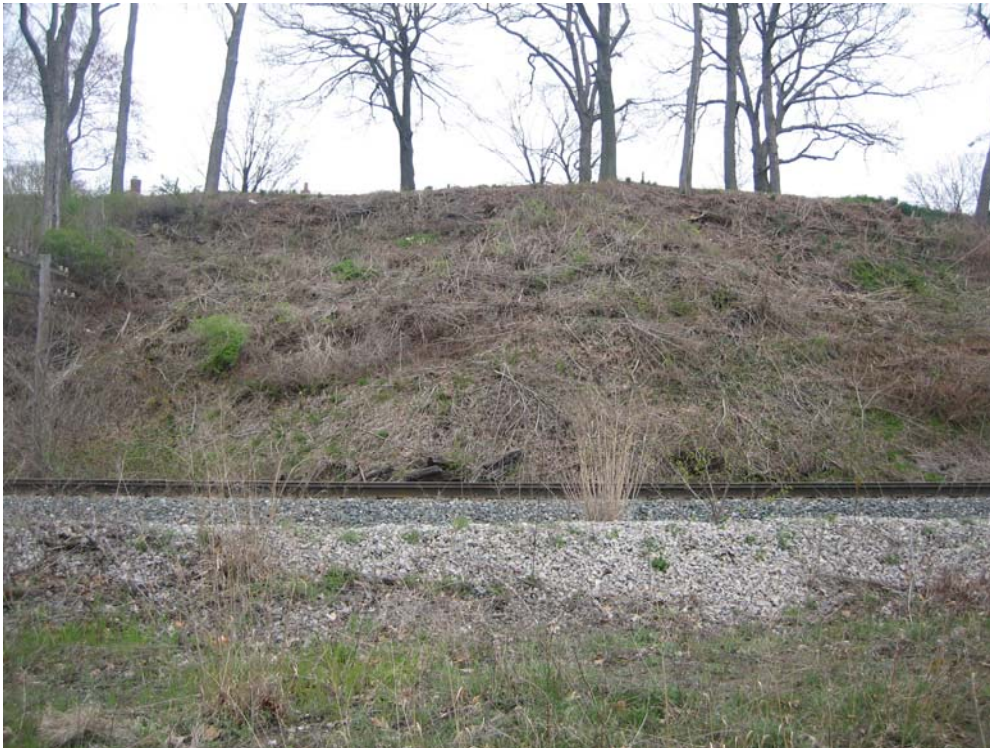
PHOTO NO. 43: Looking southeast at the bluff face from beyond railroad tracks. Note lack of tree cover and that brush has been cut.
