*Strategic Capital Improvement Plan*

# Drinking Water System

Prepared for  
City of St. Joseph,  
Michigan

November 2014

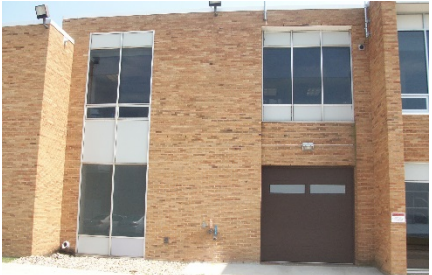
<p>Replace 1974 Windows</p>	<p>Replace 3 aluminum window walls.</p>	<p>Original windows deteriorated and energy inefficient</p>

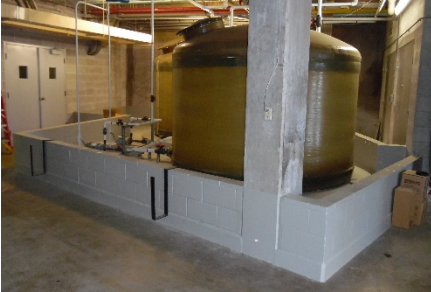
New Sodium Hypochlorite System	Replace existing chlorine system with new code compliant sodium hypochlorite system including sprinkler system, occupancy fire separation from the rest of the building, leak detection and safety shower/eyewash.	Chlorine room is dangerous and not code compliant

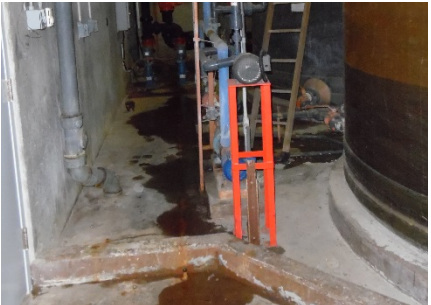
New Fluoride Storage	Add new code compliant fluoride storage and feed room including sprinkler system, occupancy fire separation from the rest of the building, leak detection and safety shower/eyewash.	Fluoride system is dangerous and not code compliant

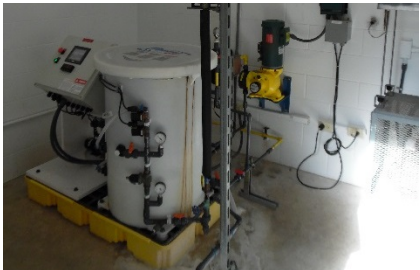
Repaint Piping and Equipment Remove insulation, clean off rust and surface prepare steel, and repaint with coating compatible with existing finish.	Piping and equipment rusting and corroding.

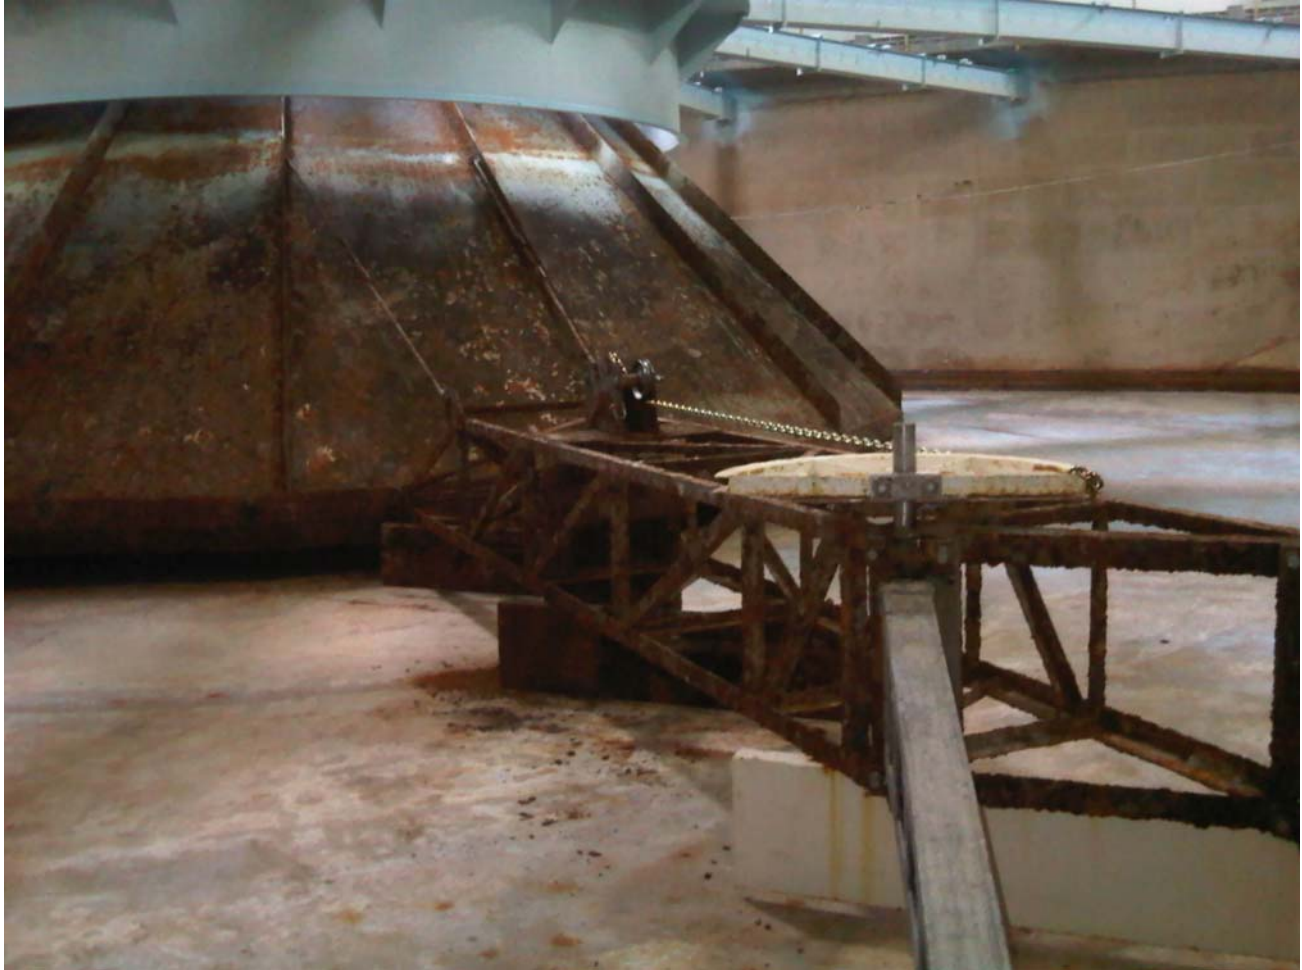
**Solids Contact Clarifier No. 2 Dewatered**

This type of clarifier is typically utilized in lime softening plants where the high sludge density facilitates sludge settling and effluent water clarification. Due to the relatively low raw water turbidity levels, low alum sludge density and fluctuating water temperatures, these clarifiers are not ideally suited for Lake Michigan water. As mentioned previously, the clarifiers can experience upsets if water quality, flow rate or temperature changes rapidly or the solids concentration in the sludge blanket is not maintained adequately. This can cause very high turbidity levels going to the filters resulting in short filter runs and higher filtered water turbidity. During average water quality conditions and constant water temperature, these clarifiers can produce acceptable water quality.

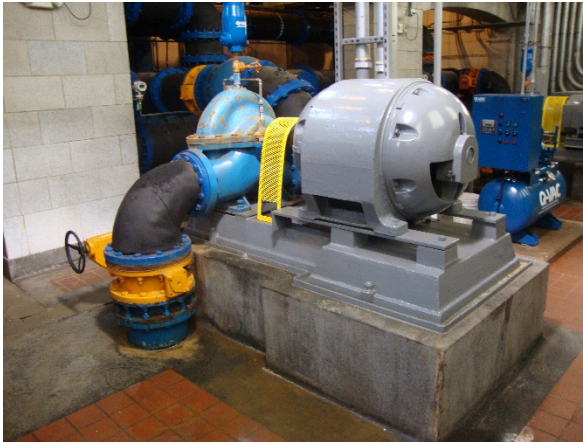
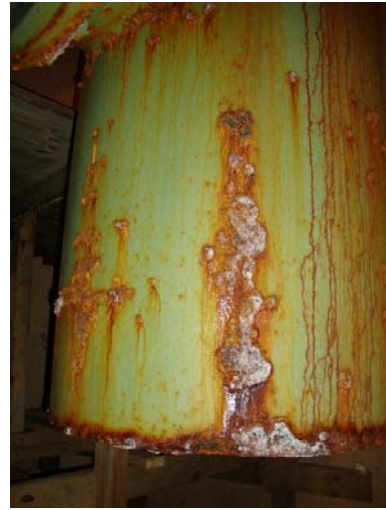
**Photos of High Service Pumps**

- The high service pump station is old and in poor condition. Some pumps, piping and valves are corroded and difficult to access. Pump suction piping is below the floor and inaccessible. The condition of this piping cannot be assessed and repair would be costly and time consuming. Pump suction hydraulics are poor and pumps need to be primed with a vacuum pump. This poor pump suction condition also limits storage in the reservoirs. There is potential for flooding due to corroded pipes, filter water located above the pumps, and the pump floor located below grade. Failure of this pump station would interrupt water service to customers. Flooding and loss of water service occurred in Benton Harbor, Michigan when a valve broke (1977), then a pipe broke (2007) in the pump station. This occurred when their pump station was much newer than St. Joseph's pump station. Replacement of this pump station should be considered in the next 10 years. Piping improvements from the filters, reservoirs and pump station would also be done to improve reliability and operations.

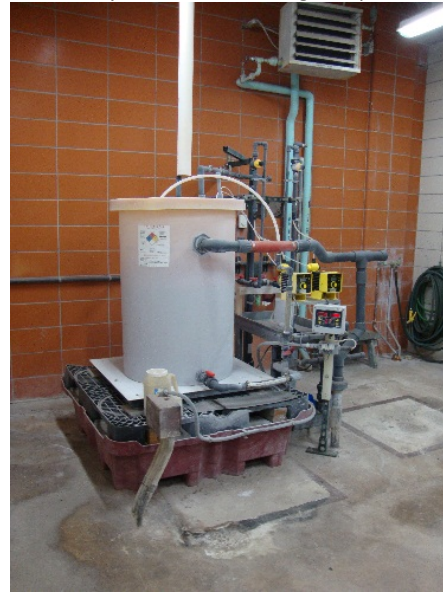
Day Tank and Metering Pumps

- The fluoride feed system (day tank and feed pumps) is in poor condition and should be replaced. Building code issues for ventilation and containment should be addressed. The fluoride storage system is relatively new and in good condition.

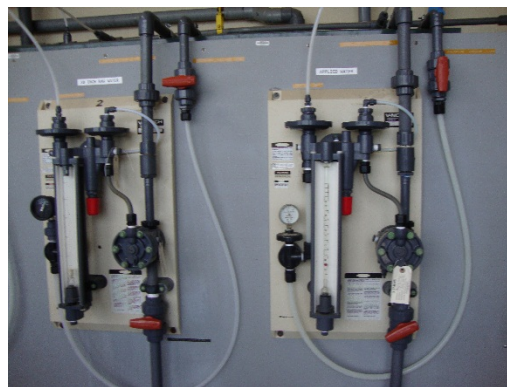
V-notch chlorinators

- The gas chlorine system needs upgrades to comply with codes, and a scrubber is recommended to protect against a chlorine leak. Converting to liquid sodium hypochlorite is recommended to improve safety.

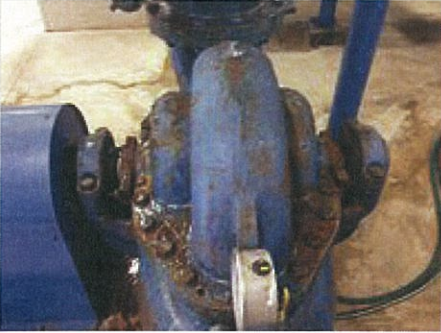
Corrosion

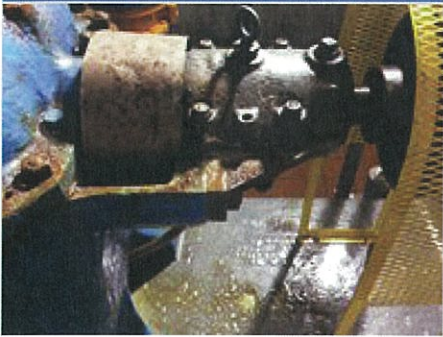
Oil on pump pedestal

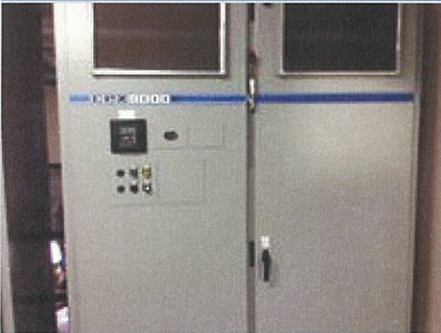
No cooling fans for VFD. Line reactor cooling only.

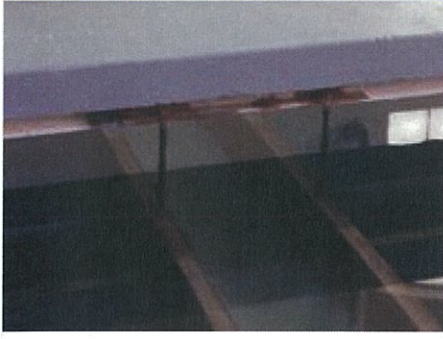
Typical of all trough supports

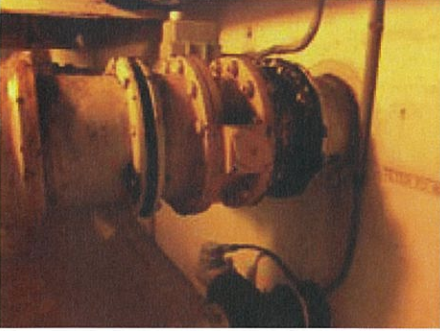
Typical corrosion on valve flanges. Older actuator

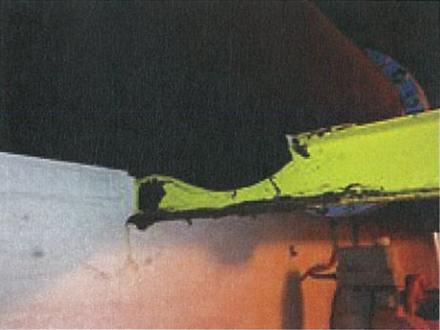
Main support corroded

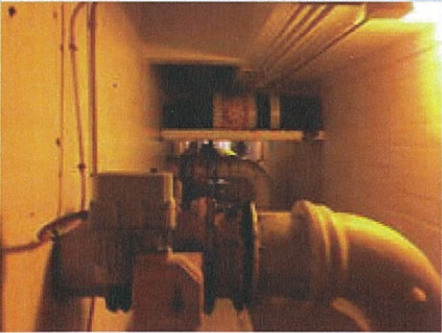
Corrosion at flanges. Typical

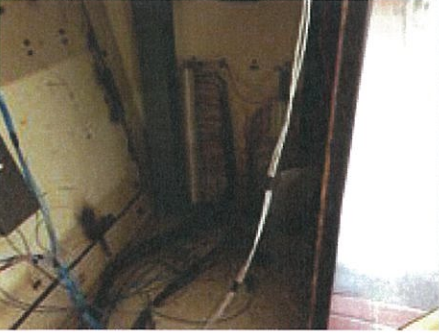
No wire labeling and debris

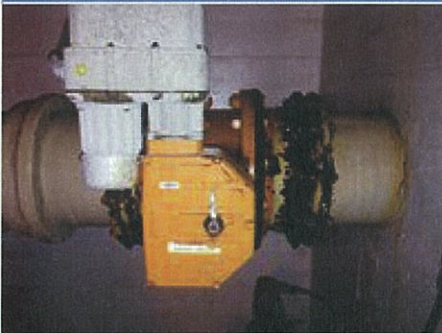
Typical condition

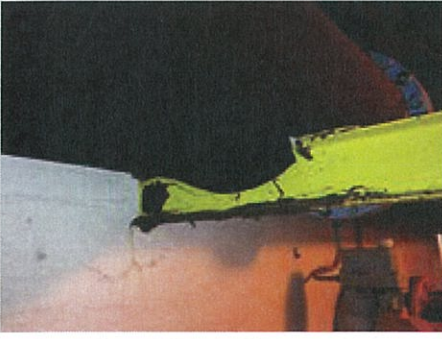
Main support corroded

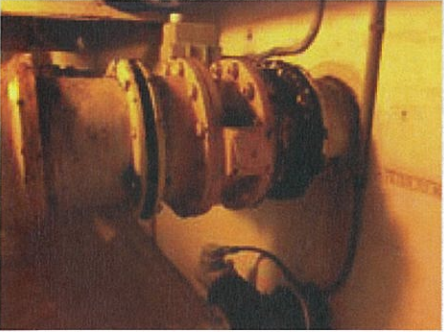
Typical condition

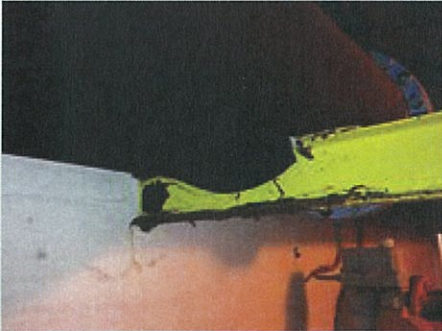
Main support corroded

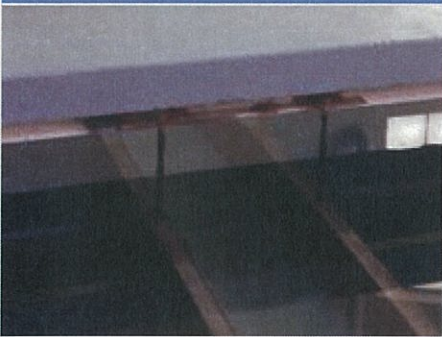
Typical off all supports

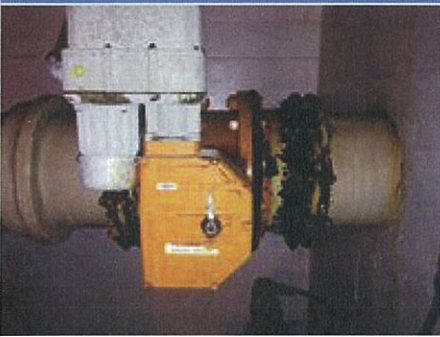
Typical valve and actuator condition

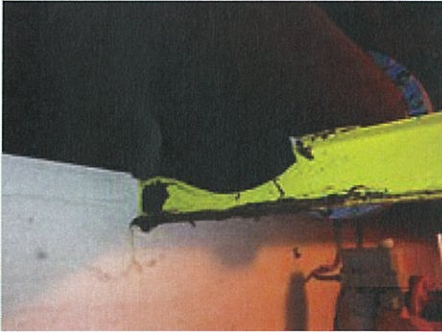
Main pipe support corroded
