# City of St. Joseph Coastal Engineering Study Update 2017

**December 21, 2017**

This report is intended to re-evaluate the Lake Michigan coastal conditions within the St. Joseph City Limits and to verify recommendations for shoreline management set forth in the 2012 St. Joseph Coastal Engineering Study.

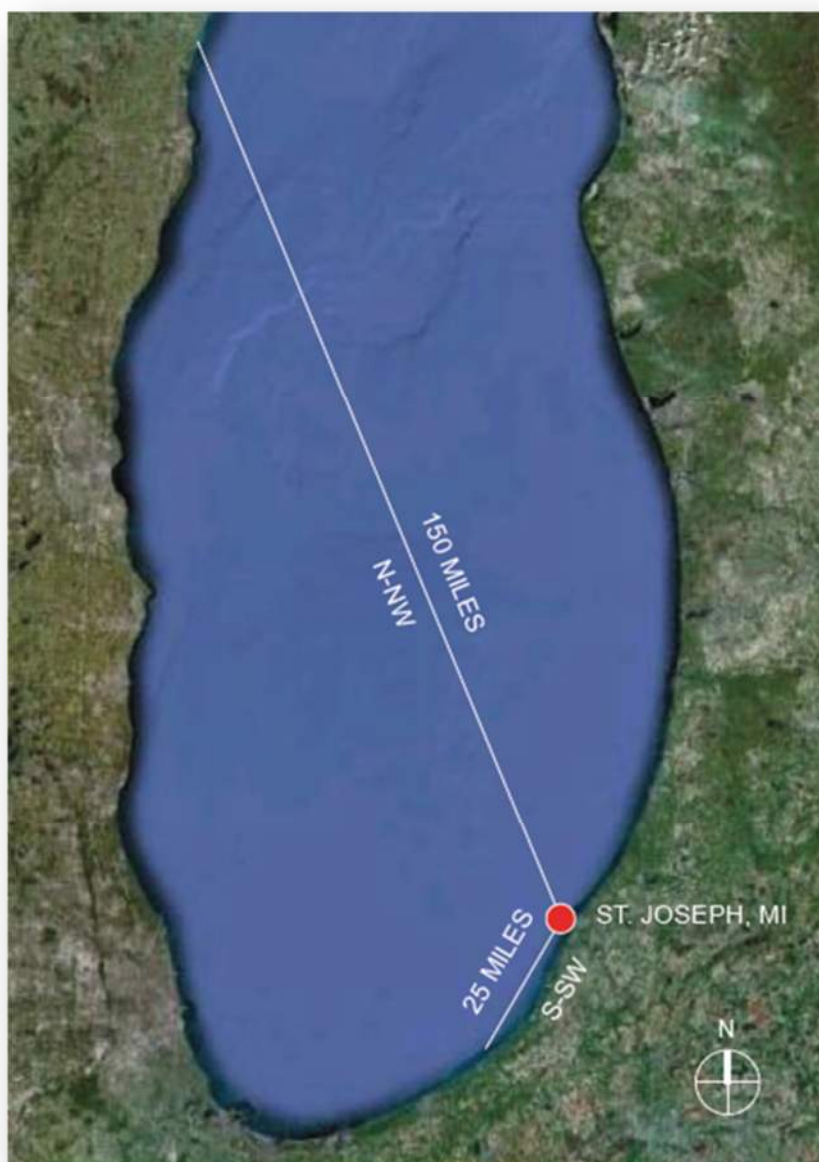
Figure 9: Fetch Distances for St. Joseph

Wave fetch is the distance which wave-generating winds travel over water. In St. Joseph, although winds come from the south-southwest most frequently, the fetch in that direction is only 25 miles, so waves have a relatively short distance to form. This relatively short fetch means that the duration of the wind event needs to be significant to generate waves and the waves that are generated have a smaller significant wave height due to the limited amount of force transferred to the water. When winds come from the north-northwest, the fetch distance is 150 miles and extreme waves can be generated due to the longer duration of wind and water contact to allow for the transfer of more energy. Figure 9 illustrates the St. Joseph fetch distances for each of the two most predominant wind directions.

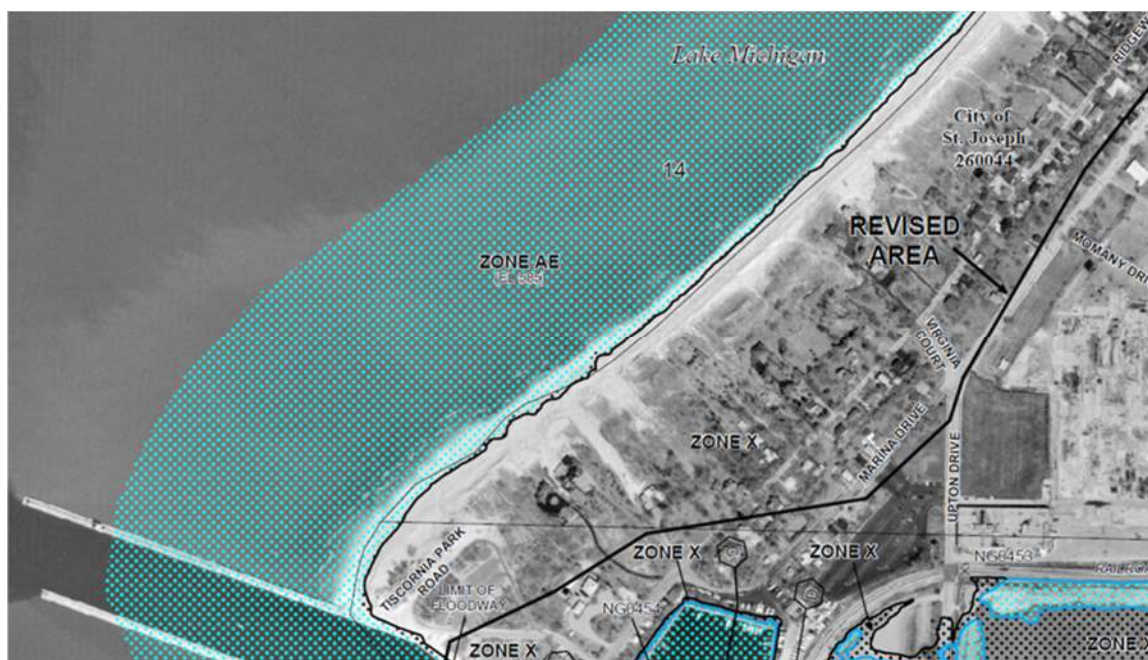
**Figure 15: Part of FEMA Flood Insurance Rate Map Number 26021C0101C, Revised March 1, 2007**

Number 26021C0101C, revised March 1, 2007, indicates a Base Flood Elevation of 584.0' IGLD 1985 (converted from 585.0' NGVD 1929) along the shoreline, within the study limits. This map is shown as Figure 15.

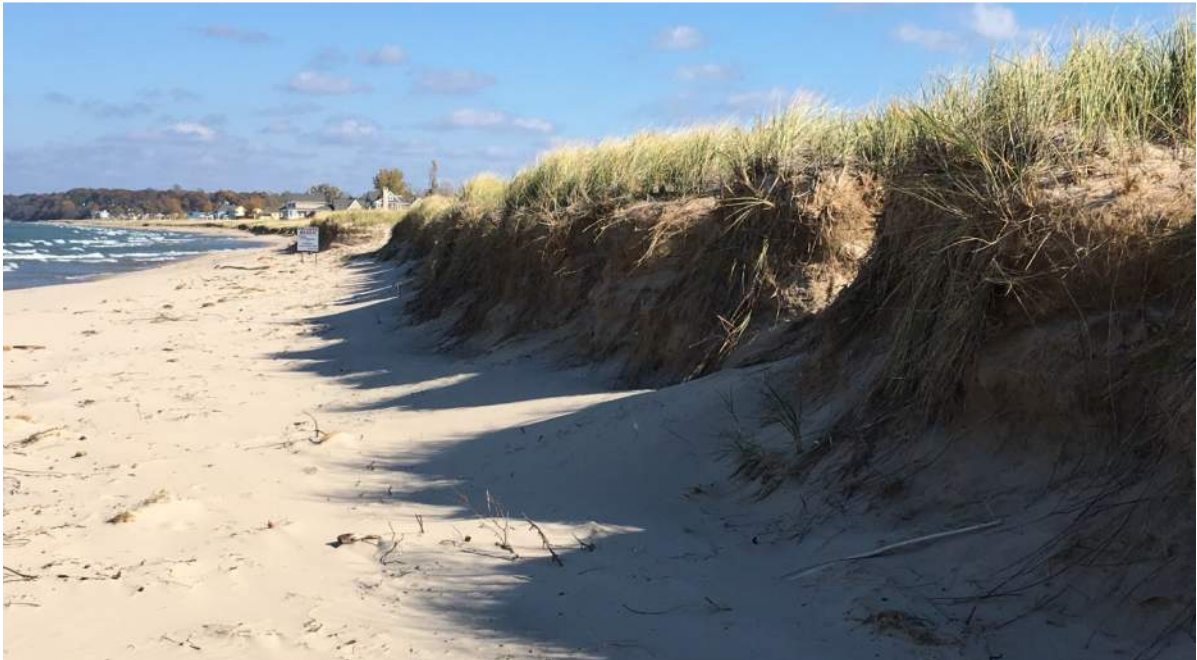
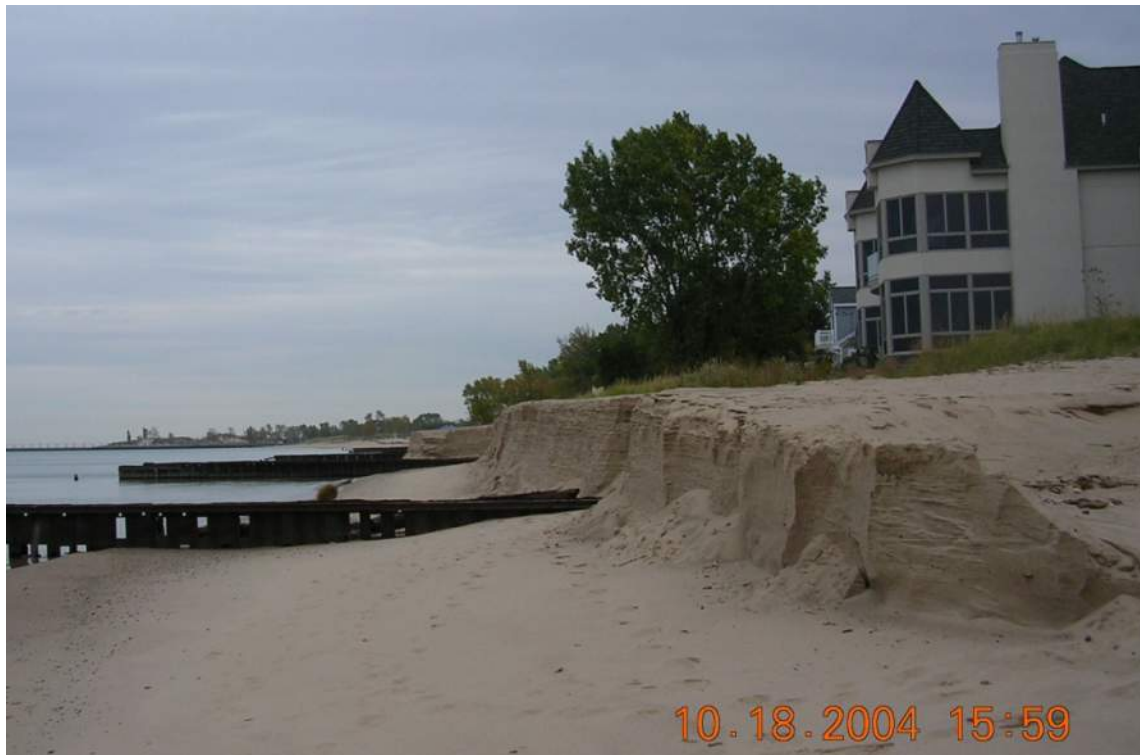
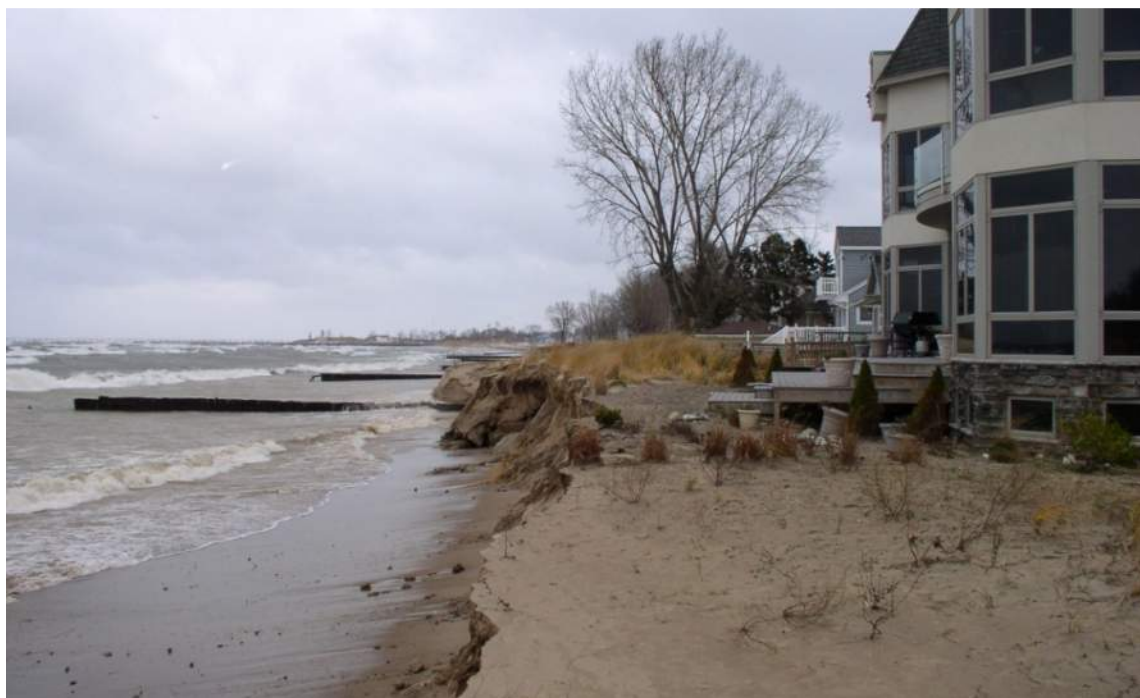
Immediately north of the St. Joseph River, sand accumulates via littoral drift, creating an accretion zone. The piers act as a barrier, interrupting sediment as it is moved along the coast in a southerly direction. This accretion zone exhibited growth during the nearly 15-year period of low lake levels from 1999 to 2014. This area, as well as Area 2, experiences short term erosion during significant storm events and has experienced erosion during the recent transition period from low to high water conditions (Figures 19-22).

**Figure 19: November, 2017 - Area 1 foredune erosion**

Figure 20: November, 2017 - Area 2 foredune erosion

Figure 21: October, 2004 - Area 2 short term erosion

Figure 22: December, 2004, Area 2 short term erosion (Note the amount material lost from in front of the house in approximately two months when compared to Figure 21)

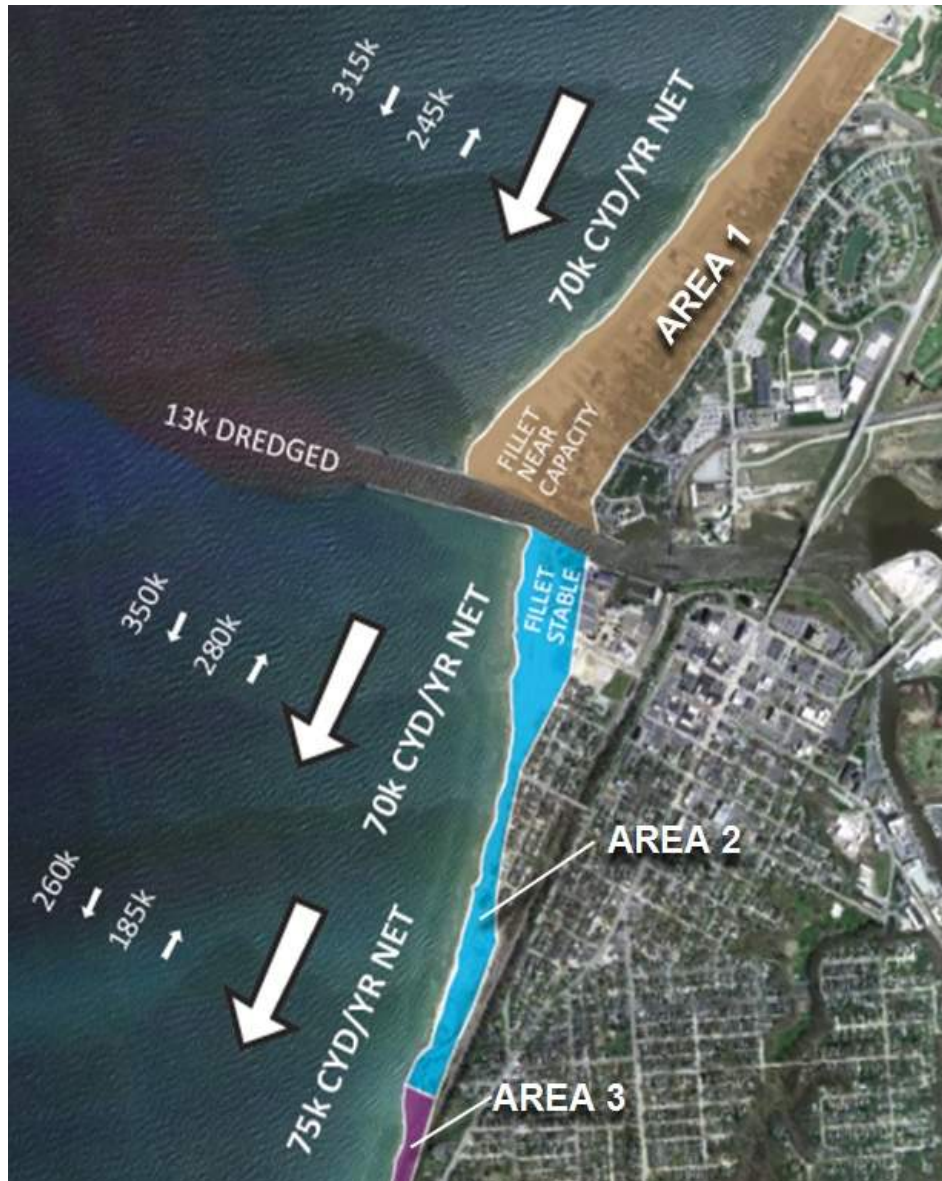
Figure 23: Graphic representation of longshore sediment transport

Based on the 1997 USACE study, "Effectiveness of Beach Nourishment on Cohesive Shores, St. Joseph, Lake Michigan", Figure 23 illustrates the modeled longshore transport of sediment during the early 1990s. Net transport quantities are depicted, along with northerly and southerly components.

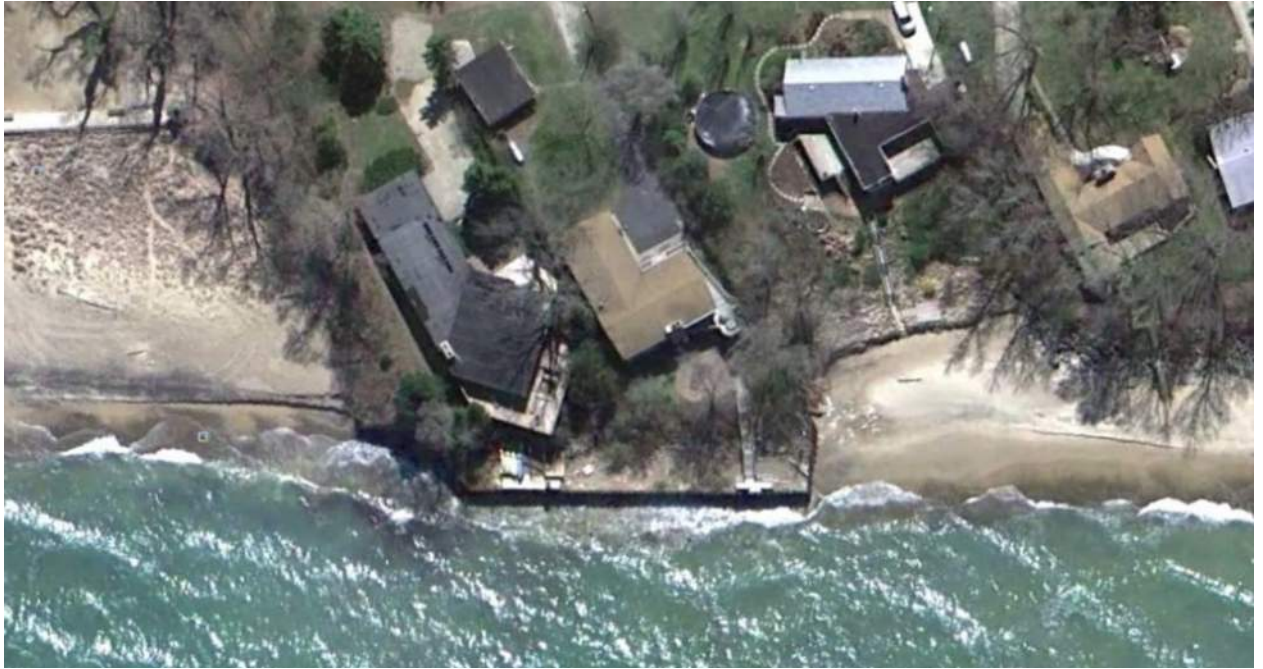
Figure 34: Example of flanking in southern Berrien County. Note how this failure has resulted in the loss of the public trust property lakeward of the structure and public passage is only possible in the lake itself.

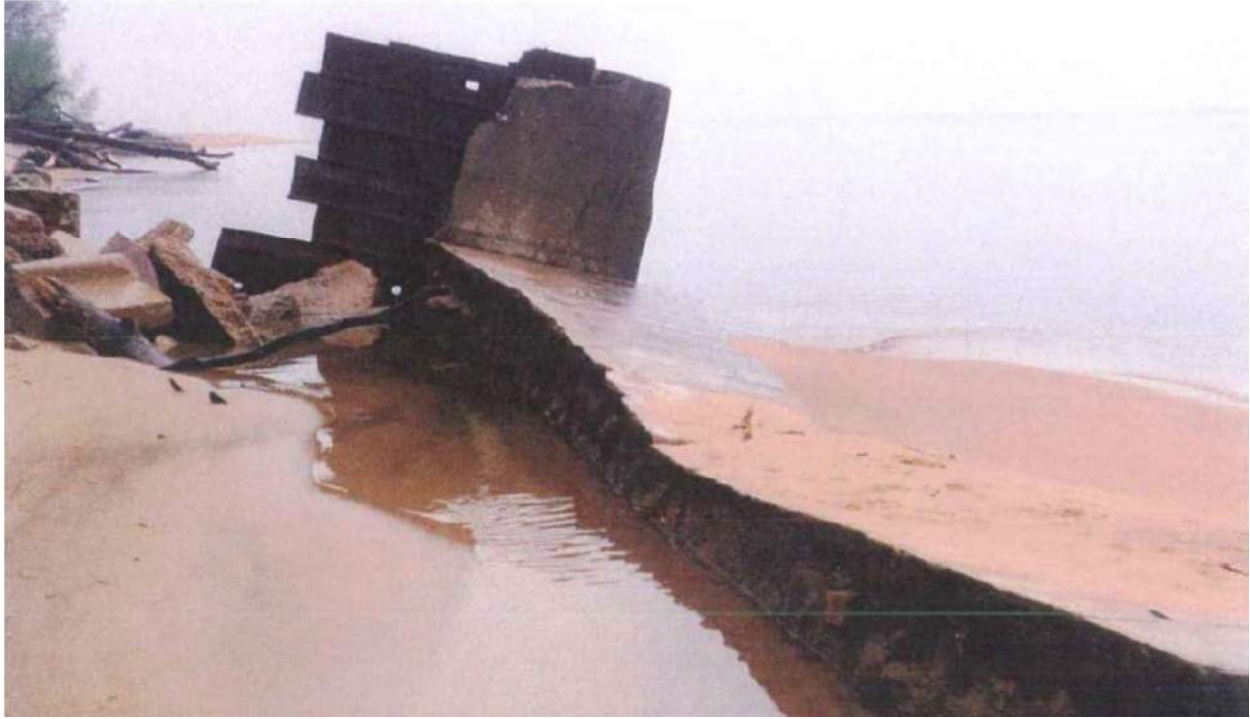
Figure 35: USACE CEM Photo, “A toppled concrete seawall along the Lake Michigan coast of Berrien County. Failure probably resulted from undermining of the underlying glacial till foundation, April 1991.”

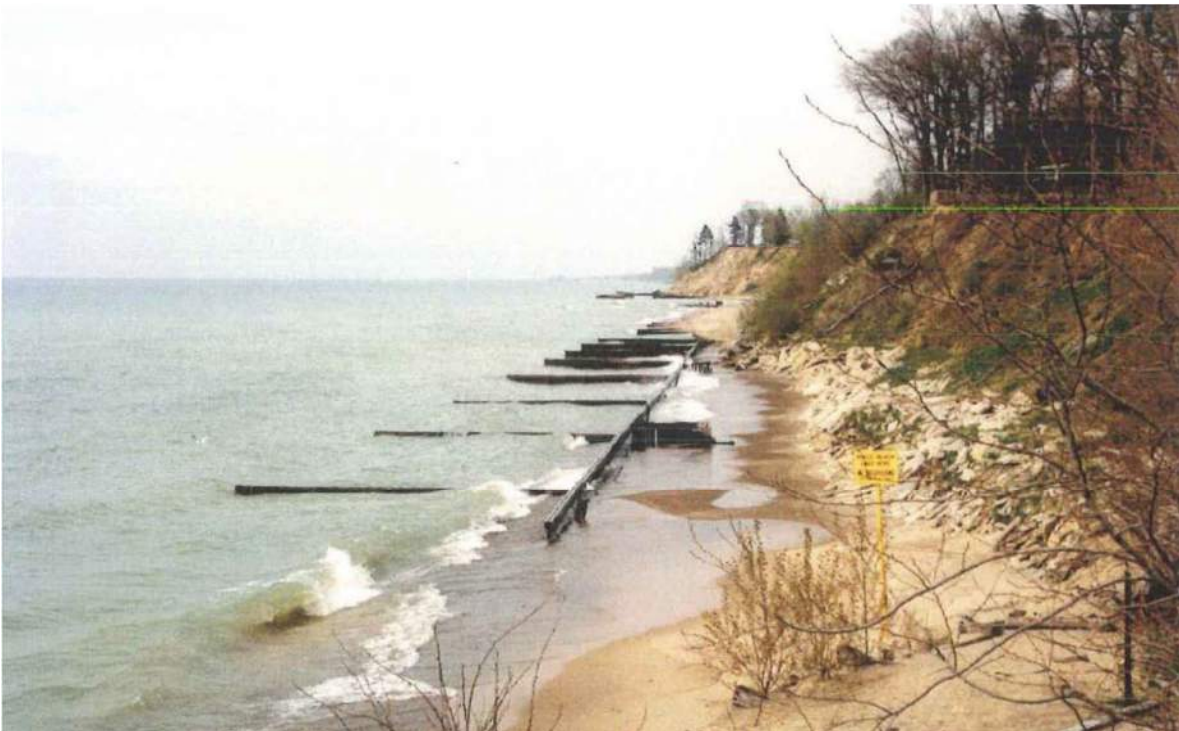
Figure 36: USACE CEM Photo, “A steel sheet-pile wall and groin field has been ineffective at protecting this section of cohesive shore along the Berrien County shore of Lake Michigan, south of the town of St. Joseph, April 1994.”

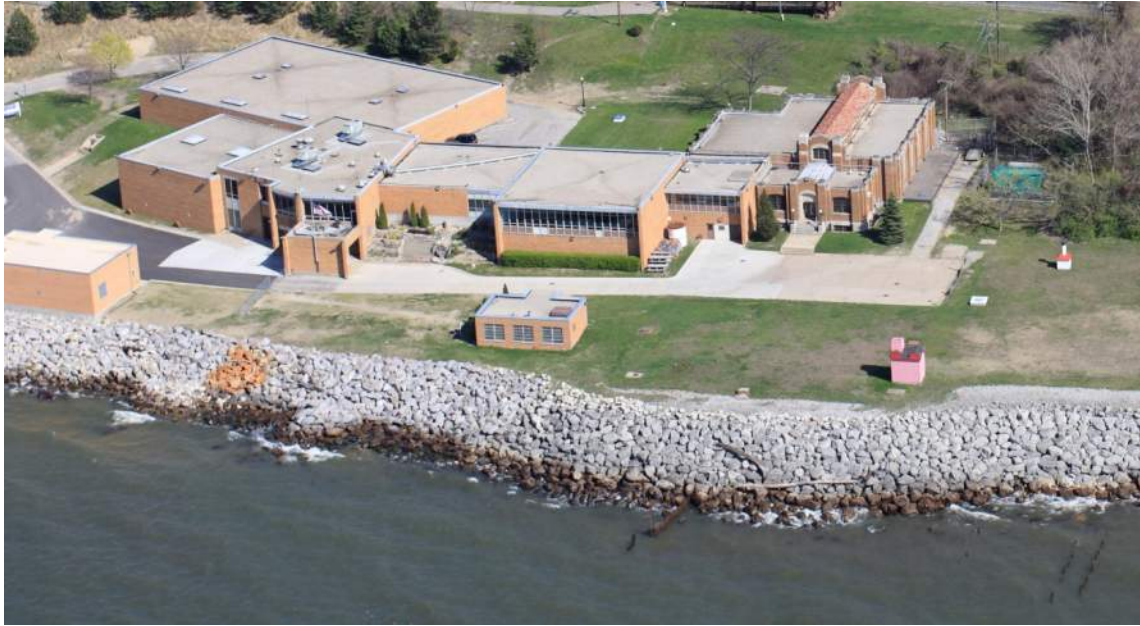
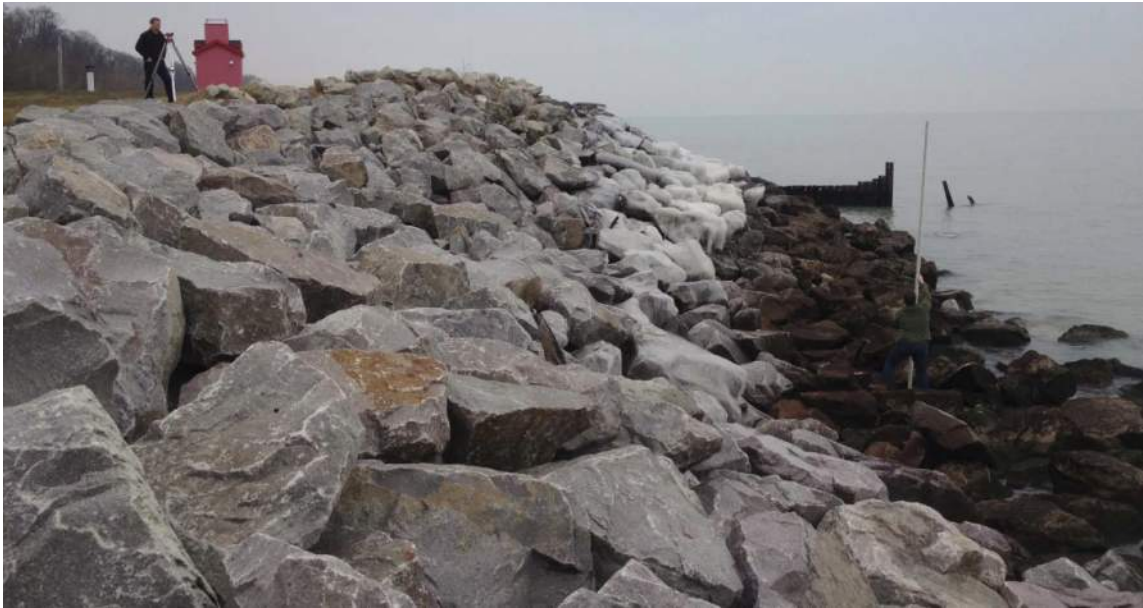
Within the study area, two successful examples of shore protection have been identified. The first is the shoreline that borders the St. Joseph Water Plant, located at the north end of Area 3. The structure consists of armor stone, laid on a slope of 1 vertical on 2 horizontal to a minimum top elevation of 591.20 feet. The toe of the revetment extends several feet below the lake bottom to prevent scour.

Figure 37: St. Joseph Water Plant Revetment Oblique Photo (U.S. Army Corps of Engineers)

Figure 38: St. Joseph Water Plant Revetment, spring 2012

While both of these stone revetments have been successful in protecting upland infrastructure from erosion, they have had a dramatic effect on the public trust property along the shoreline.

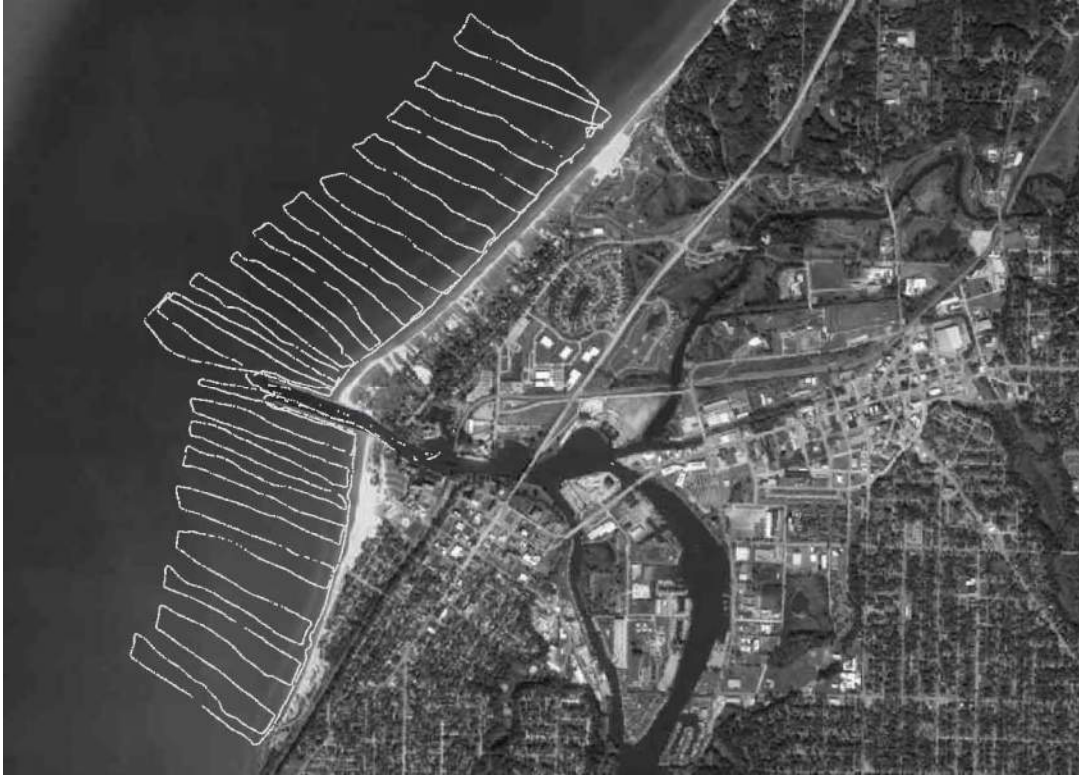
Figure 40: Bathymetric data points map, plan view (Aerial Image Credit: Google Earth)

Topographic and bathymetric surveys were completed in May of 2017 in Areas 1 and 2. Bathymetric data was collected by boat using a global positioning system (GPS) and a single-beam sonar. Topographic data was collected using GPS. Both datasets were combined into a single surface model intended to inform the planning-level analysis found herein. The combined set of geospatial data was produced per Federal Geospatial Data Committee (FGDC) metadata standards and will be made available to users.

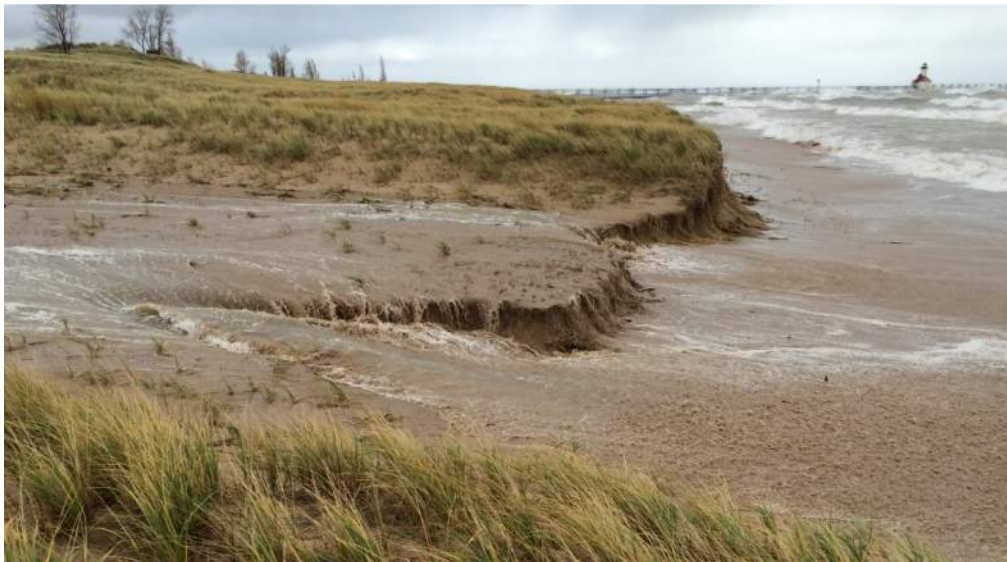
Figure 45: Wave runup where beach/dune grading was done (October 31, 2014)

As exhibited below in Section No. 19 (Figure 44), grading activities have reduced the height of the foredune by five feet or more in some cases. As a foredune is lowered, the risk that wave runup will reach further inland is increased. During a severe storm on October 31, 2014, the impacts of grading were observed first hand (Figure 45)
