# City of St. Joseph Coastal Engineering Study Update 2017

**FINAL**

**December 21, 2017**

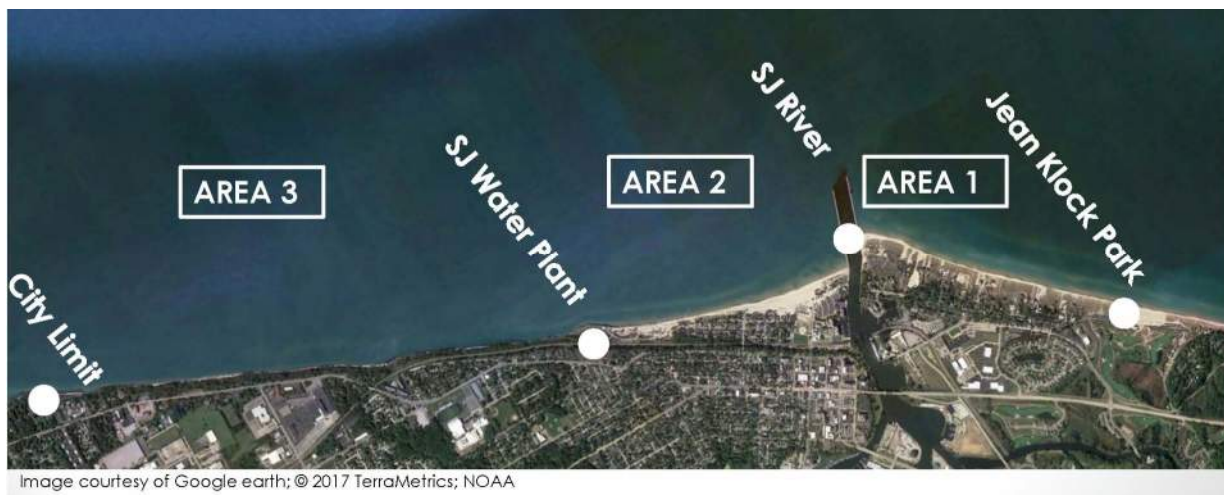
Figure 1: Project Overview Map

The 2012 study divided the City's shoreline into three areas of distinguishable characteristics. This update includes re-evaluation of conditions within all three Areas.

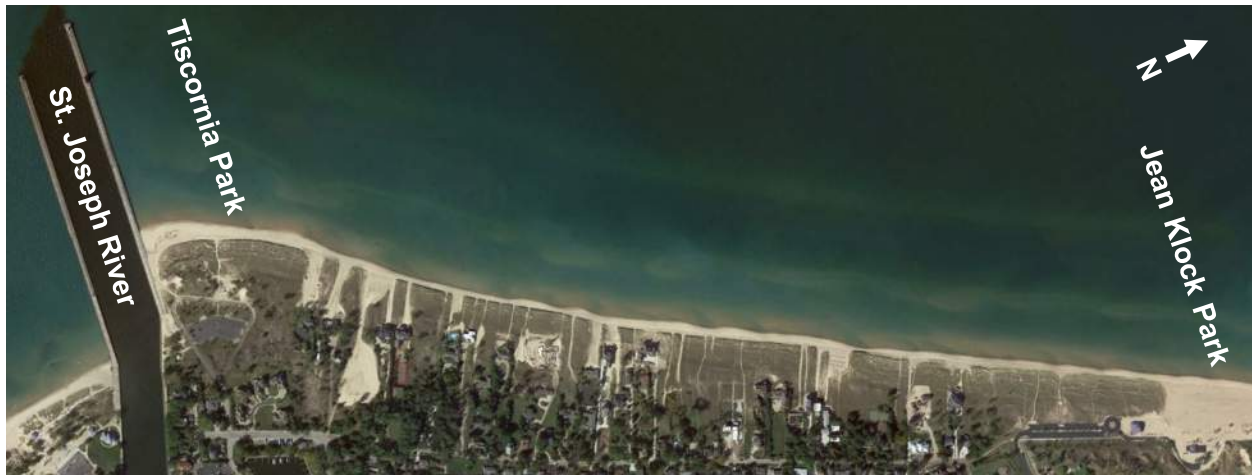
Figure 2: 2016 Area 1 Aerial (Google Earth, Terrametrics)

Area 1 is bordered on both ends by public parks, with Jean Klock Park to the north and Tiscornia Beach to the south. Between the parks, private properties exist and many of the lots extend several hundred feet southeast to Ridgeway. Currently, no shoreline protection structures exist within Area 1, apart from the federal navigation structure at the southerly limit of the area. The entire shoreline here is sandy beach with dune grass vegetation established in the foredune areas. Due to the interaction of the Northern USACE jetty with the typical movement of sand along the lakeshore, Area 1 is typically an accretion zone especially at its southerly end, but is subject to erosion at times of higher than average water levels.

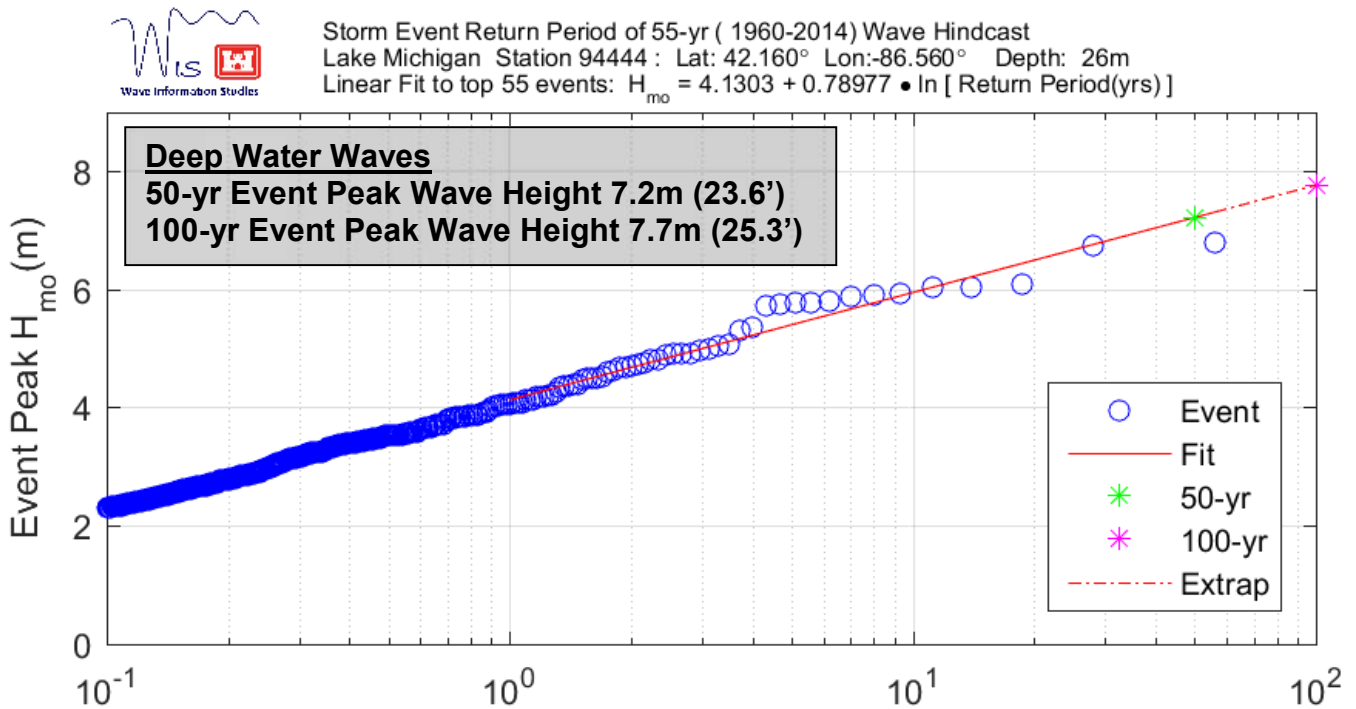
Figure 6: U.S. Army Corps of Engineers WIS Data

These wave heights are derived by the USACE assuming that the waves develop in deep water conditions with deep enough water depths that the bottom does not affect the height of the waves. As waves move toward land, the water depth becomes shallower and limits the possible height of the waves. In order to account for this relationship, deep water waves are transformed into nearshore waves using current lake bed bathymetry and applicable wave transformation equations to estimate the size of waves that reach the shore. Current observations and predictions of coastal conditions around the Great Lakes region indicate that weather patterns will continue to become more variable with a broader range of extremes. For this reason, the 100-year wave events were used a basis for analysis in this study update while the original study analysis was performed using the 50-year event data.

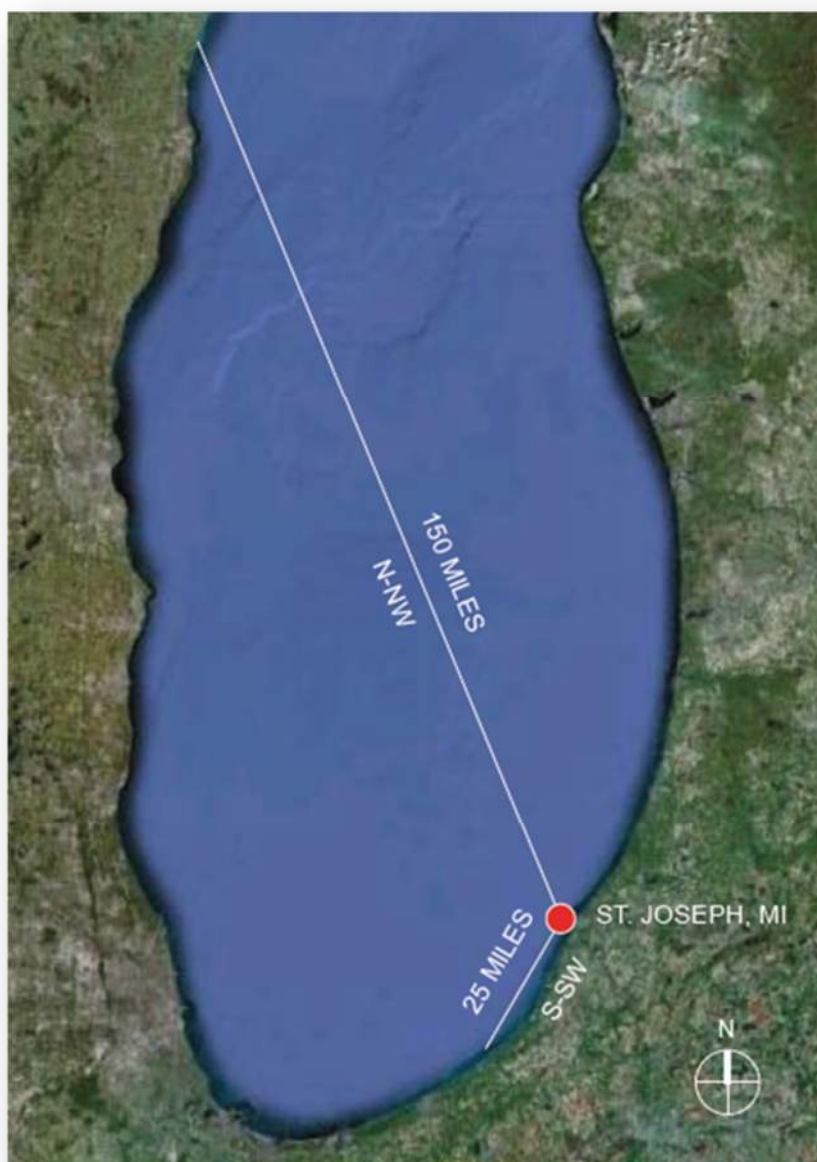
Figure 9: Fetch Distances for St. Joseph

Wave fetch is the distance which wave-generating winds travel over water. In St. Joseph, although winds come from the south-southwest most frequently, the fetch in that direction is only 25 miles, so waves have a relatively short distance to form. This relatively short fetch means that the duration of the wind event needs to be significant to generate waves and the waves that are generated have a smaller significant wave height due to the limited amount of force transferred to the water. When winds come from the north-northwest, the fetch distance is 150 miles and extreme waves can be generated due to the longer duration of wind and water contact to allow for the transfer of more energy. Figure 9 illustrates the St. Joseph fetch distances for each of the two most predominant wind directions.

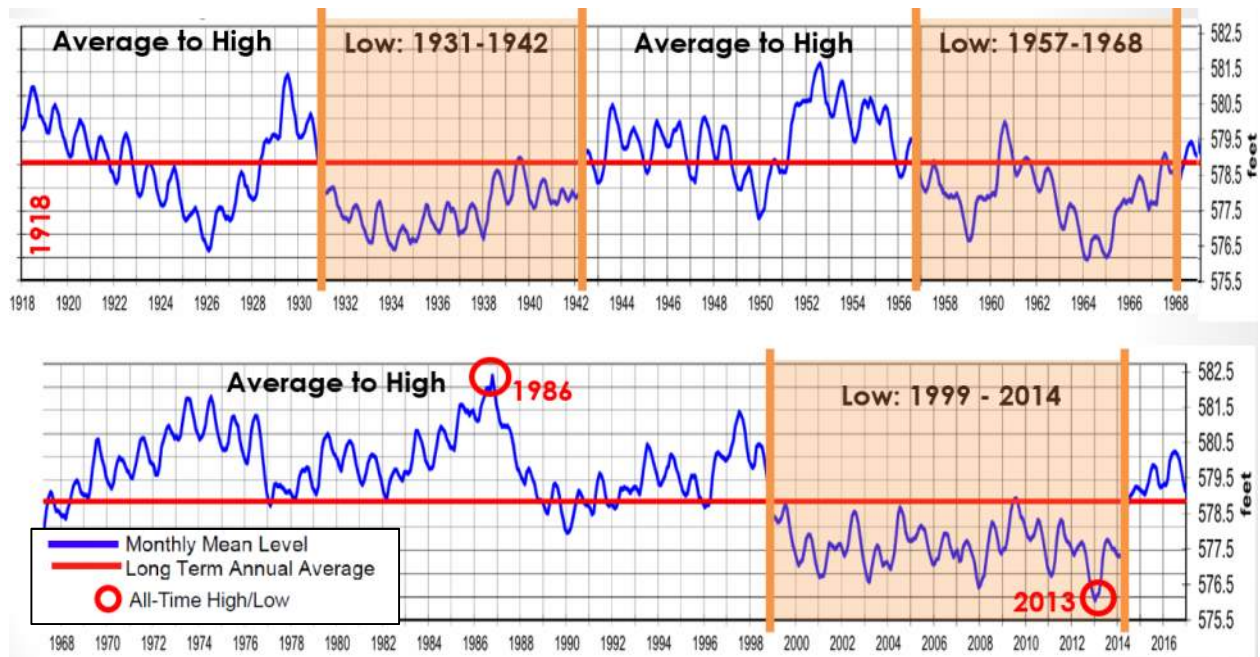
Figure 13: U.S. Army Corps of Engineers long term water level chart

Since 1918, Lake Michigan water levels have exhibited three 10-year periods of low lake level, in which water levels are at least one foot below the long-term annual average (Figure 13). These periods occurred from approximately 1931 to 1942, from 1957 to 1967, and from 1999 to 2014. Each of the previously recorded low-level periods was followed by high water levels. Based on the long term fluctuations of the Lake Michigan water level, average to above-average water levels can be expected to continue for several years.

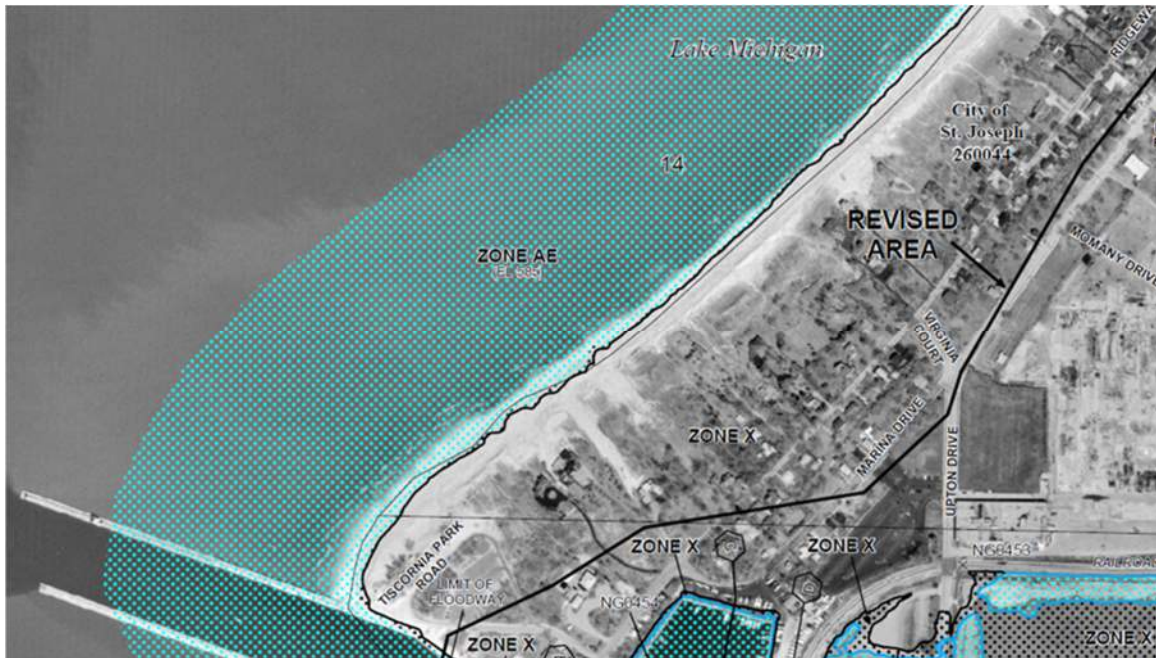
**Figure 15: Part of FEMA Flood Insurance Rate Map Number 26021C0101C, Revised March 1, 2007**

Number 26021C0101C, revised March 1, 2007, indicates a Base Flood Elevation of 584.0' IGLD 1985 (converted from 585.0' NGVD 1929) along the shoreline, within the study limits. This map is shown as Figure 15.

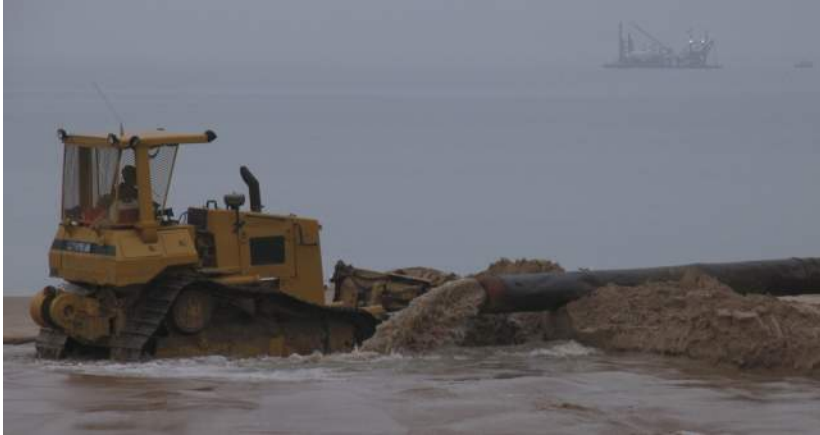
Near the City of St. Joseph, the lake bed is comprised of cohesive material with a cohesionless surface layer with varying thickness of 0-4 meters (0-13 feet). Large deposits of sand accumulate near the mouth of the harbor and are dredged on a regular basis. Since the 1970s, this material has been deposited as beach nourishment on the designated feeder beach south of the St. Joseph River, typically south of Park Street, as shown in Figure 18. This material helps to protect the existing cohesive sub layer; however, since it is primarily fine to very fine grain, it is easily eroded by coastal forces. The quantity of dredging that is completed per year ranges from 20,000 to 150,000, cubic yards, although not all of the material is used for beach nourishment. It is important to consider that USACE funding is often an issue and that beach nourishment may not always be available. A summary of dredging quantities by year is included in Appendix 3.

**Figure 18: 2012 photo of beach nourishment south of Park Street showing the dredge in background**

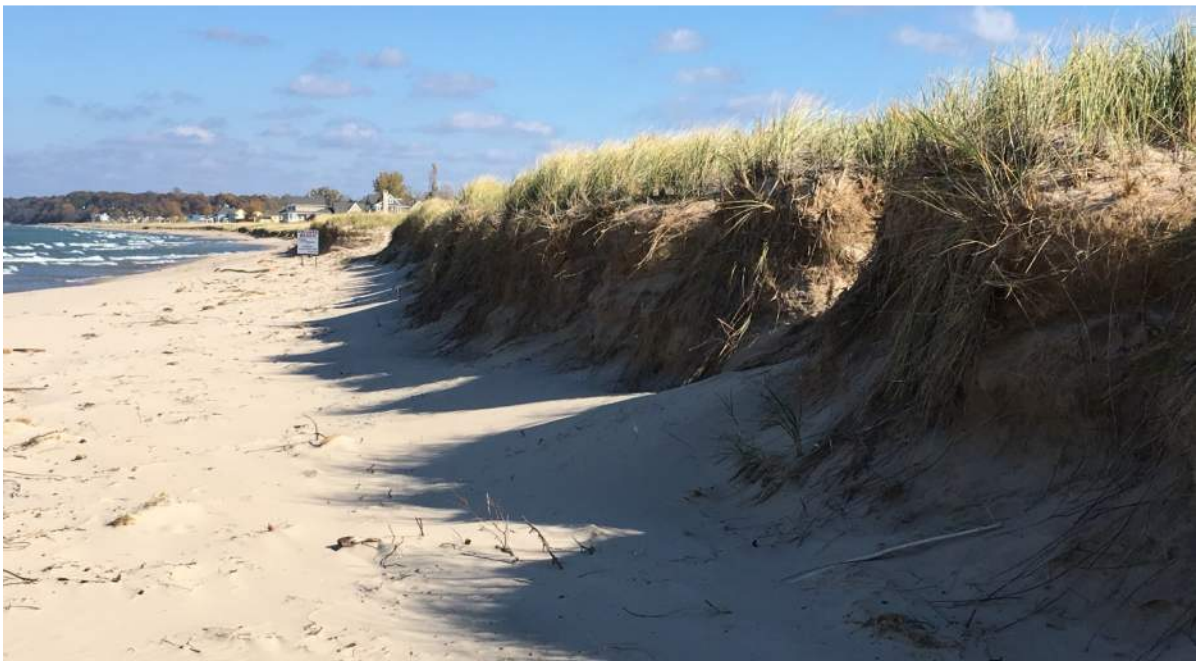
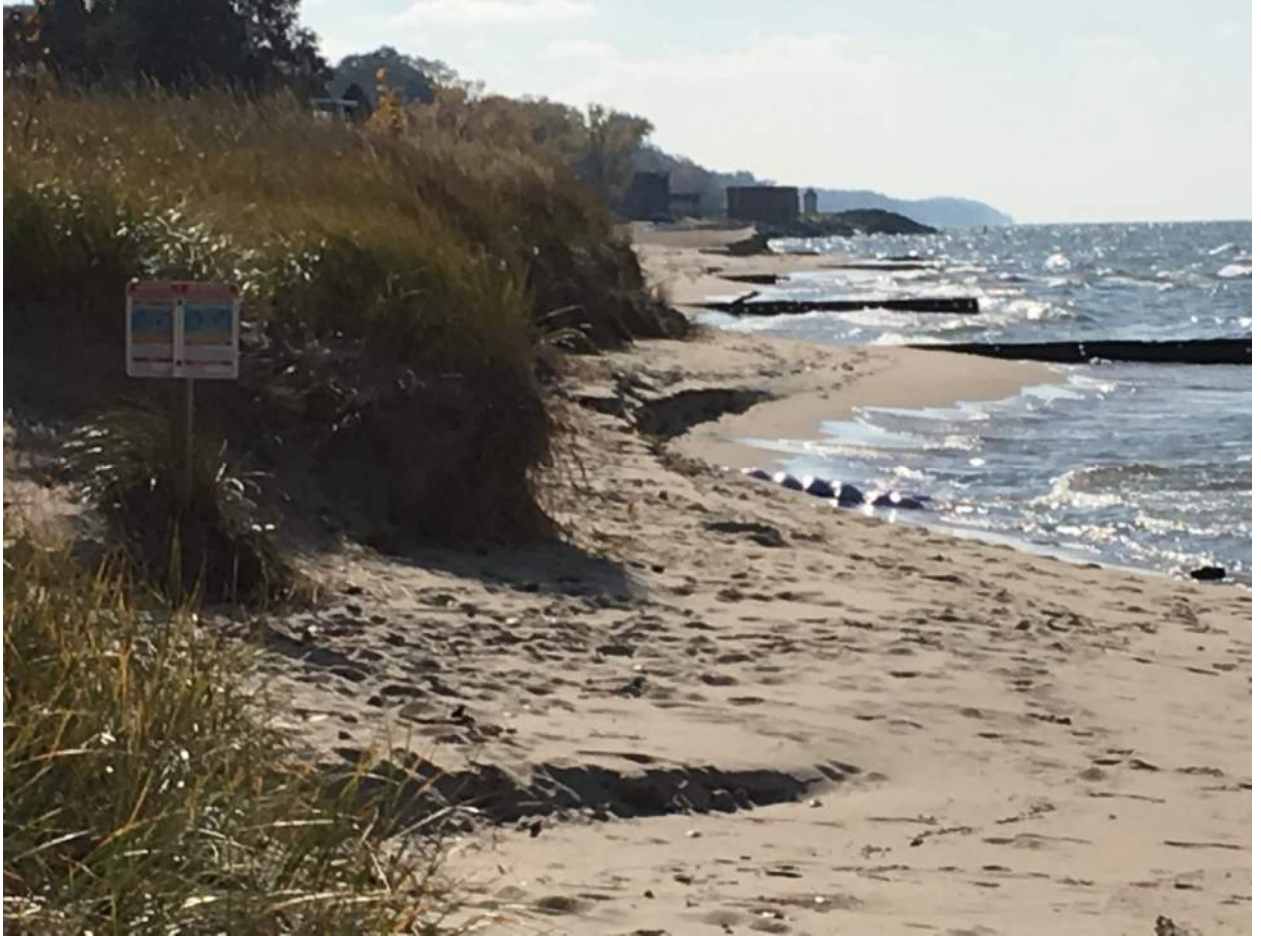
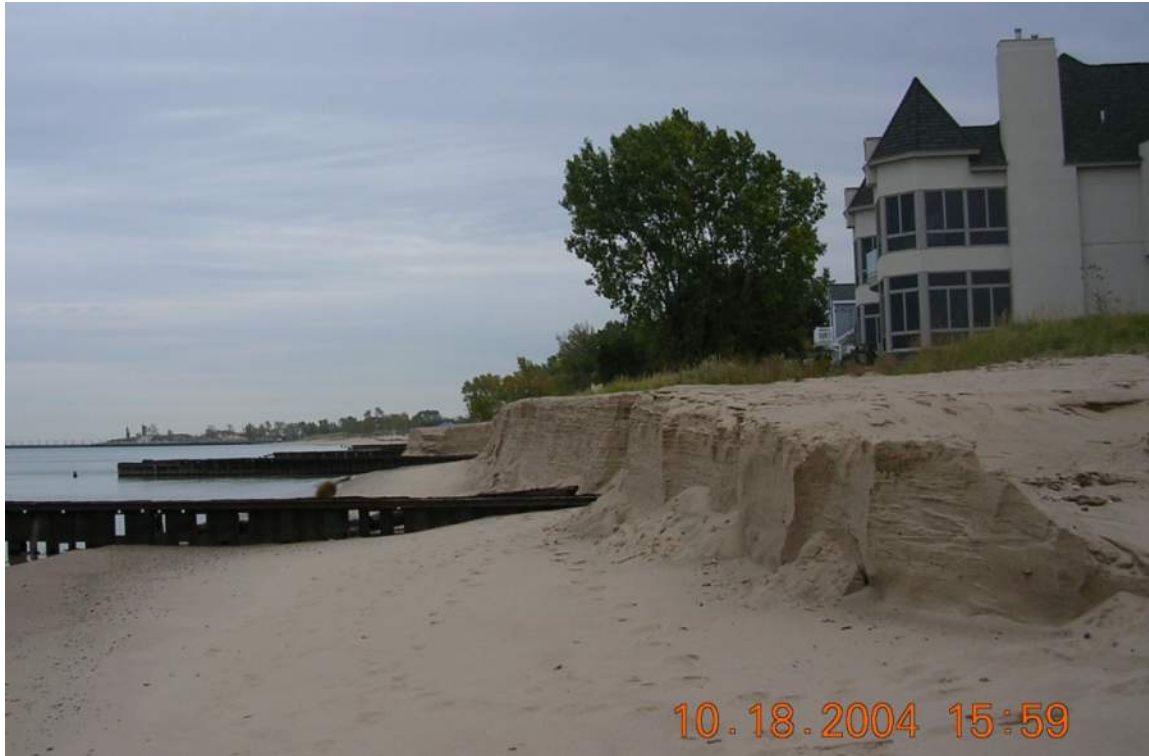
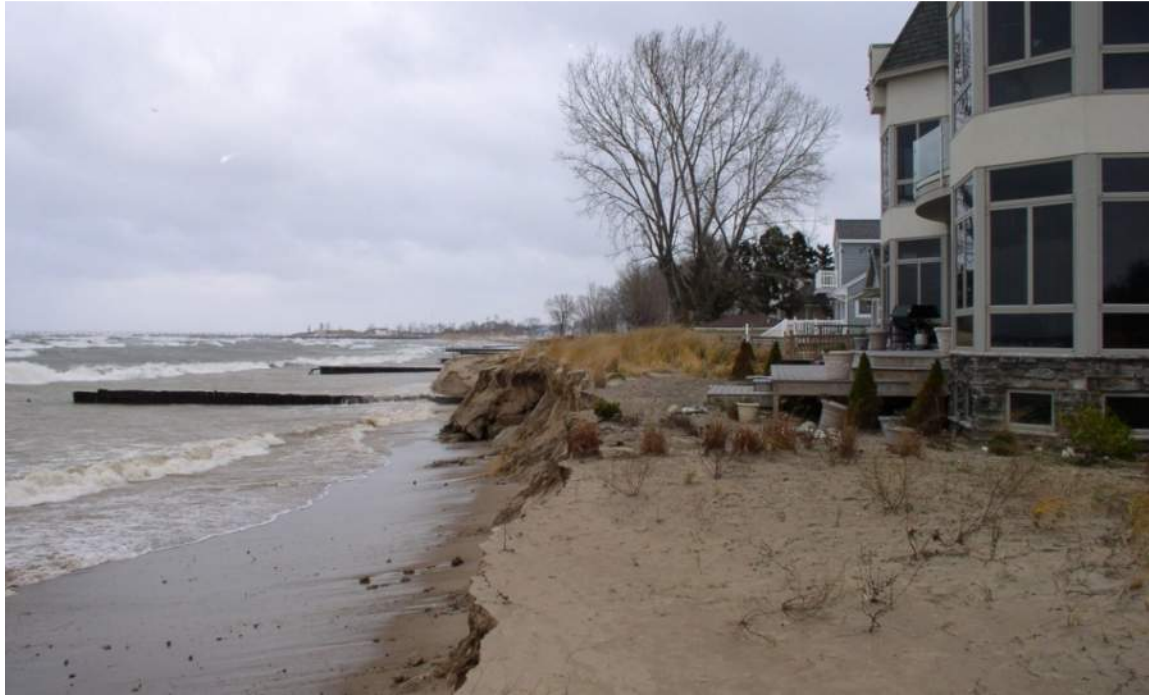
Immediately north of the St. Joseph River, sand accumulates via littoral drift, creating an accretion zone. The piers act as a barrier, interrupting sediment as it is moved along the coast in a southerly direction. This accretion zone exhibited growth during the nearly 15-year period of low lake levels from 1999 to 2014. This area, as well as Area 2, experiences short term erosion during significant storm events and has experienced erosion during the recent transition period from low to high water conditions (Figures 19-22).

**Figure 19: November, 2017 - Area 1 foredune erosion**

Figure 20: November, 2017 - Area 2 foredune erosion

Figure 21: October, 2004 - Area 2 short term erosion

Figure 22: December, 2004, Area 2 short term erosion (Note the amount material lost from in front of the house in approximately two months when compared to Figure 21)

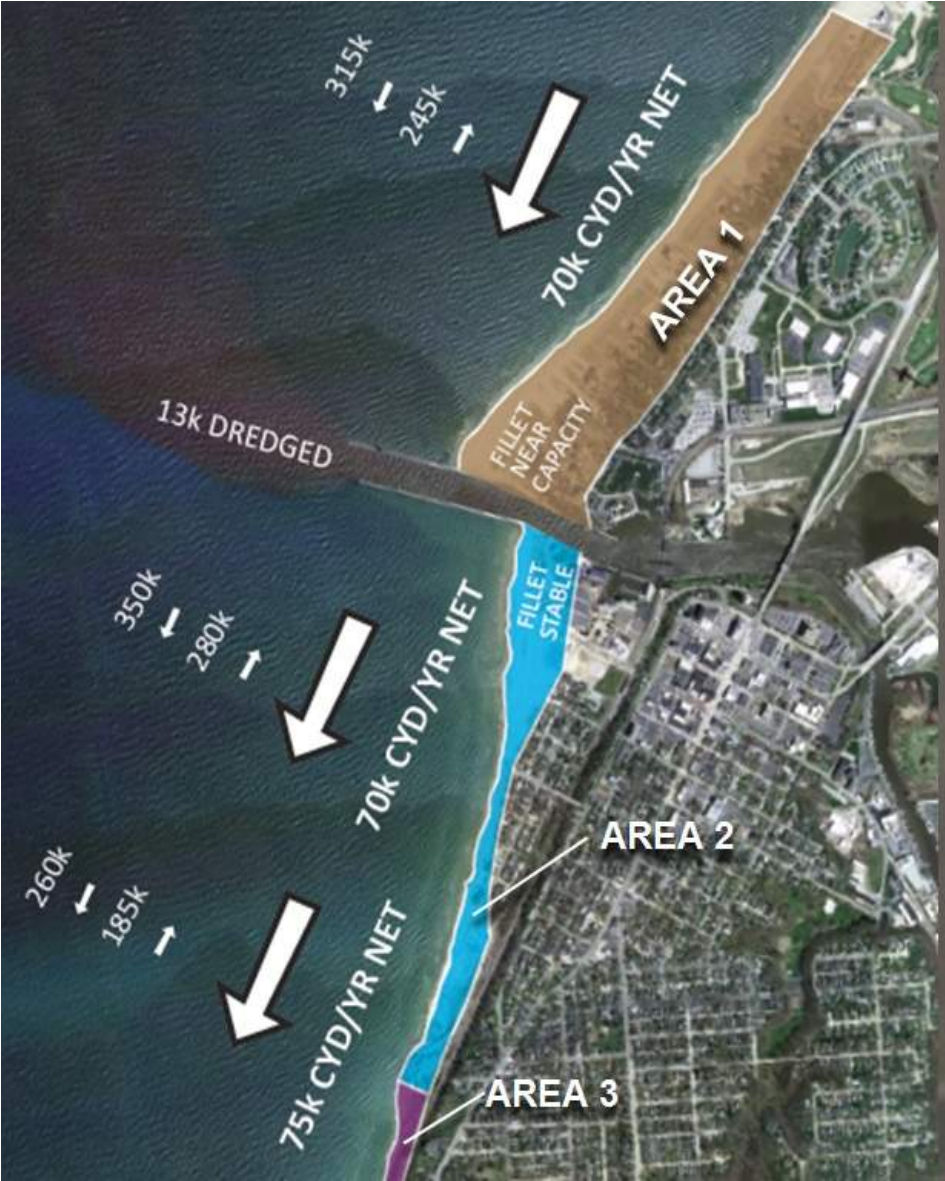
Figure 23: Graphic representation of longshore sediment transport

Based on the 1997 USACE study, "Effectiveness of Beach Nourishment on Cohesive Shores, St. Joseph, Lake Michigan", Figure 23 illustrates the modeled longshore transport of sediment during the early 1990s. Net transport quantities are depicted, along with northerly and southerly components.

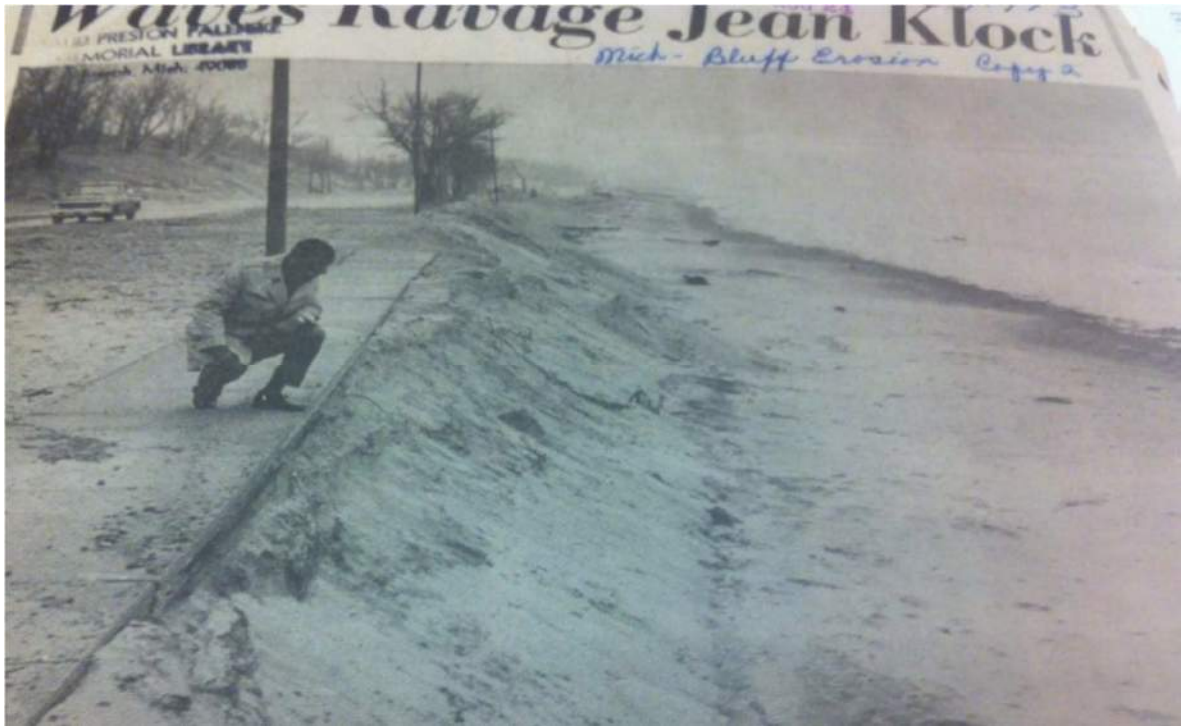
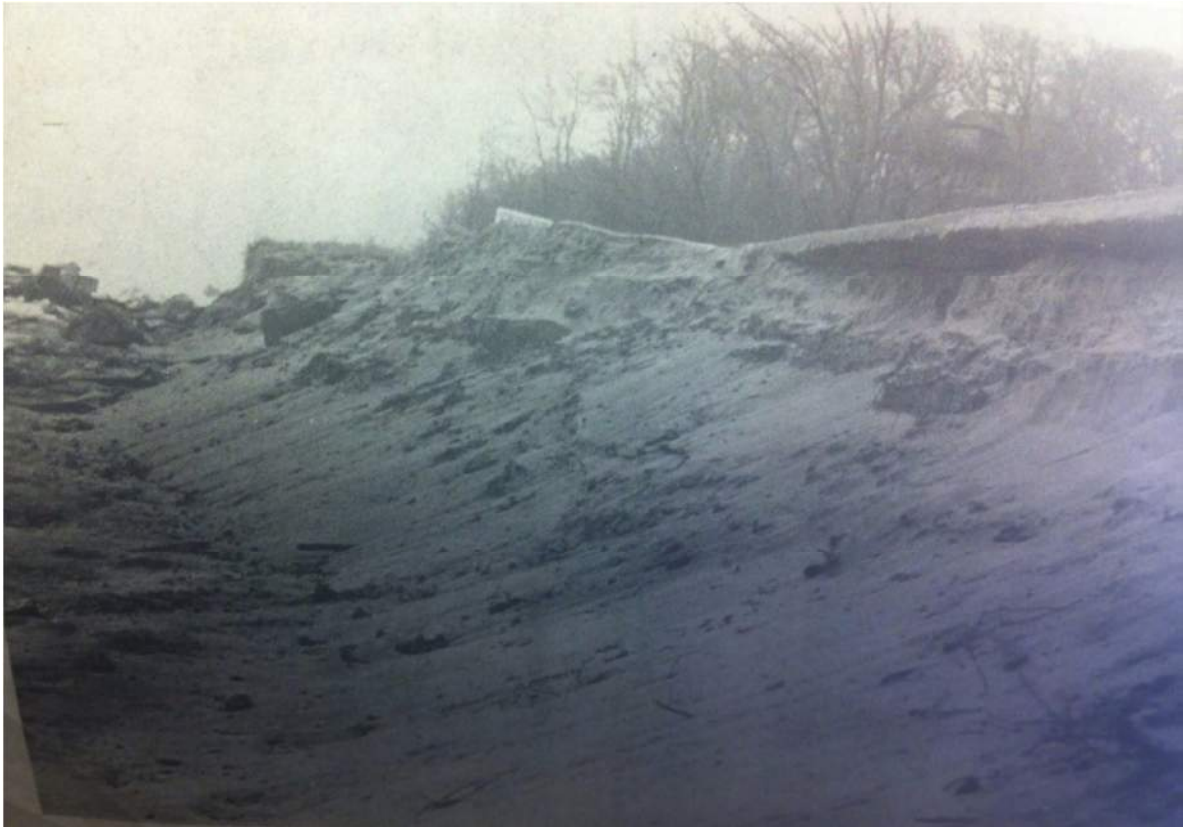
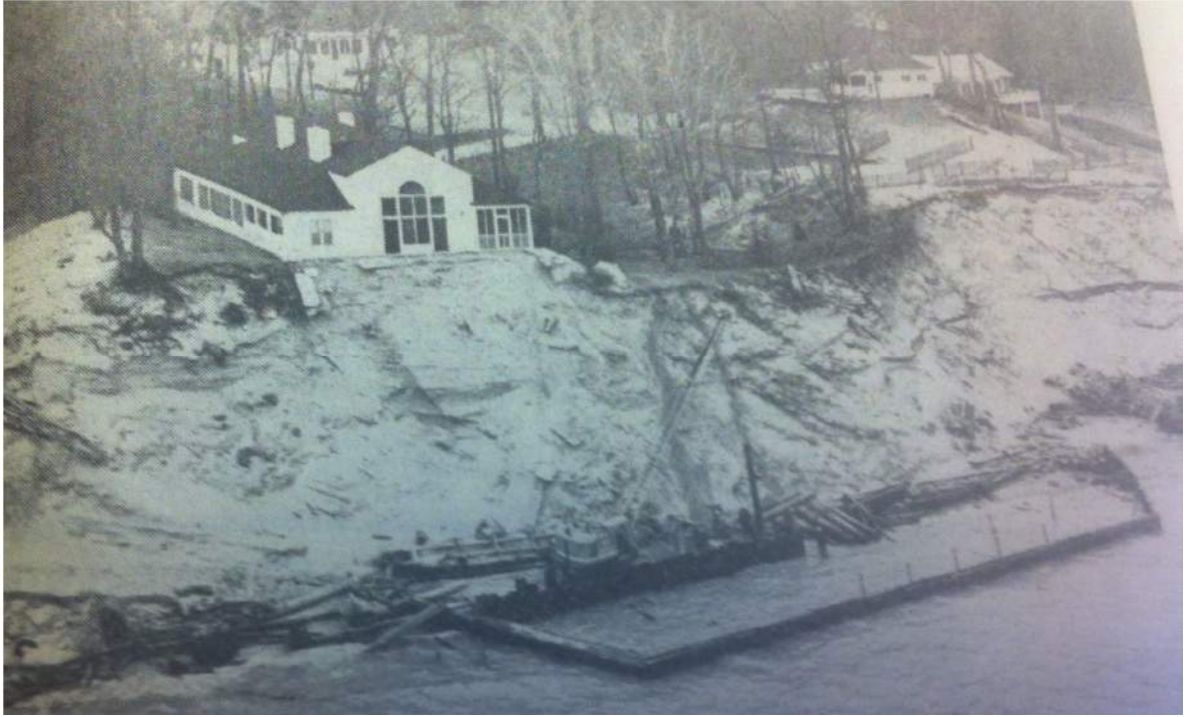
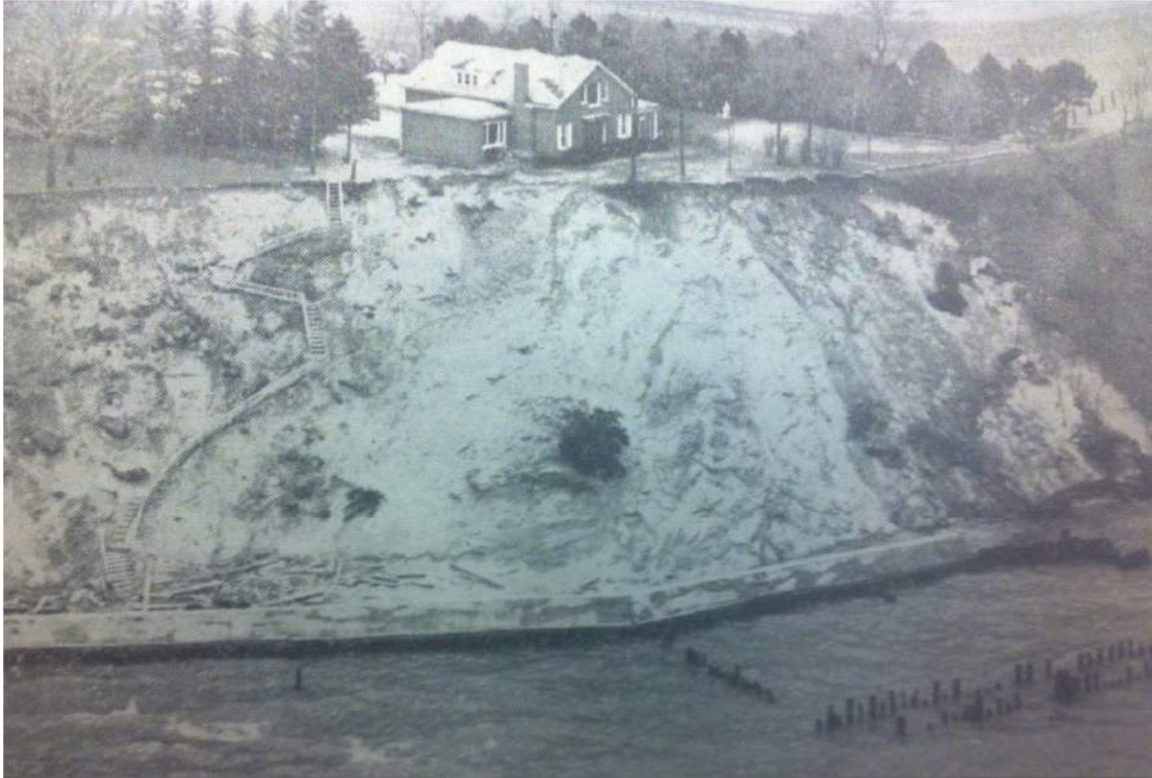
High water conditions and severe storms culminated in 1973, when President Nixon declared Berrien County a disaster area, according to articles from the Herald Palladium. Damage that occurred during the early 1970s included the loss of beach, bluff erosion, damage to structures, and the loss of structures. Figures 26-29 illustrate some of the damage that occurred.

Figure 26: 1973 Herald Palladium photo of Jean Klock Park

Figure 27: 1973 Herald Palladium photo of Jean Klock Park sidewalk

Figure 28: 1970s Herald Palladium photo of bluff erosion south of St. Joseph, MI

Figure 29: 1970s Herald Palladium photo of bluff erosion south of St. Joseph, MI

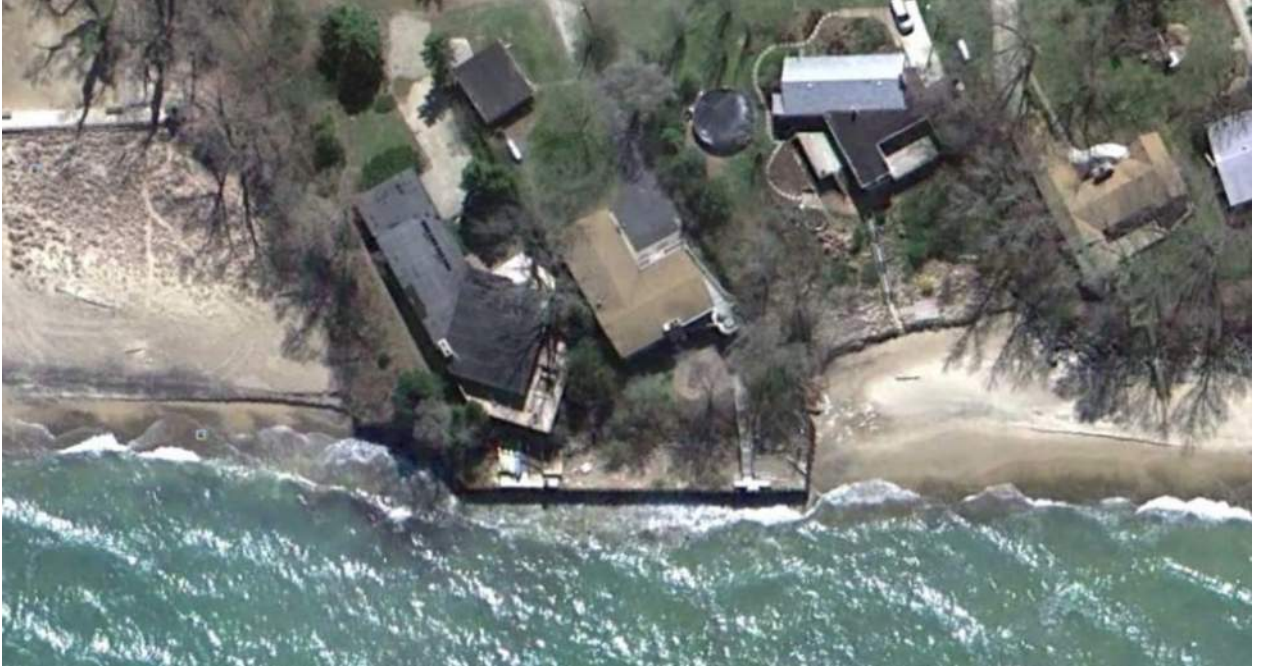
Figure 34: Example of flanking in southern Berrien County. Note how this failure has resulted in the loss of the public trust property lakeward of the structure and public passage is only possible in the lake itself.

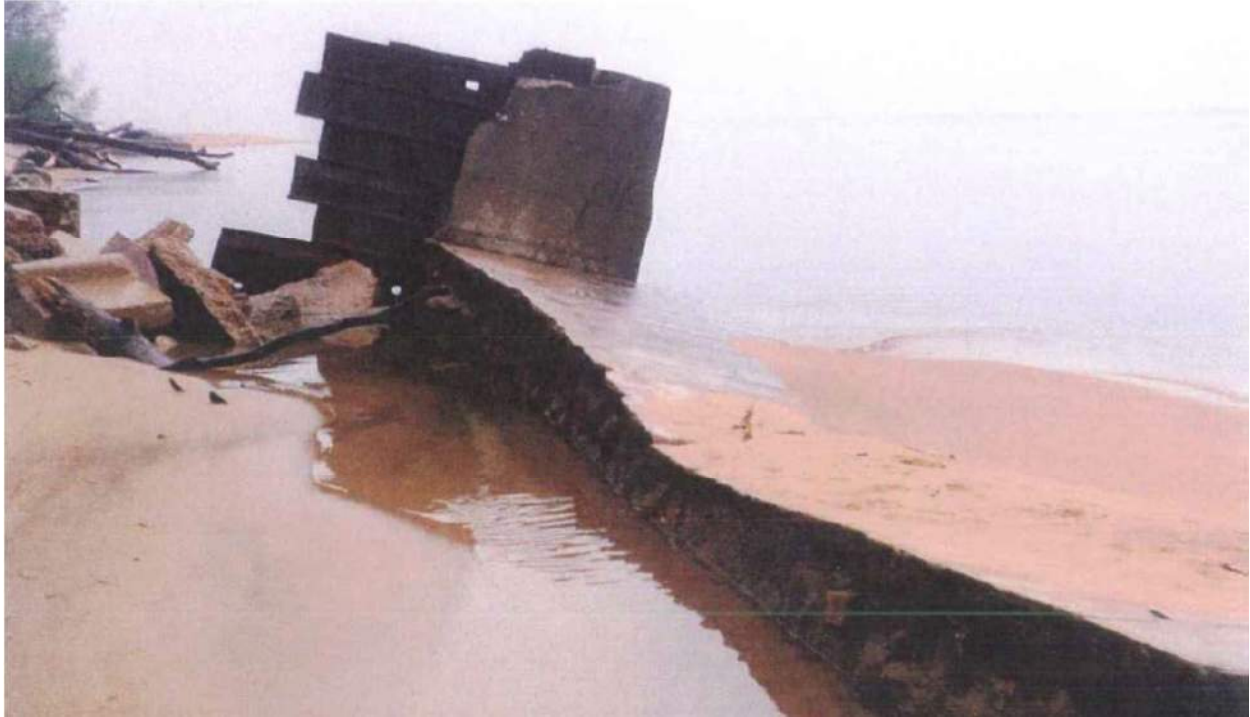
Figure 35: USACE CEM Photo, “A toppled concrete seawall along the Lake Michigan coast of Berrien County. Failure probably resulted from undermining of the underlying glacial till foundation, April 1991.”

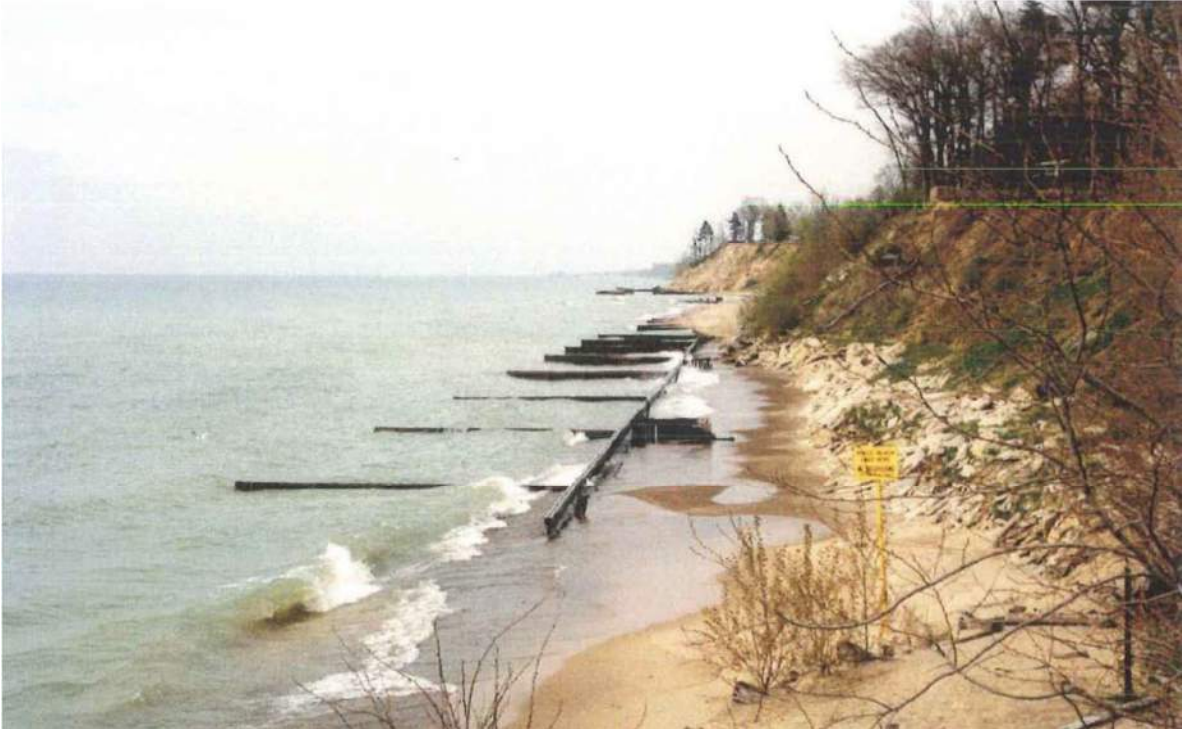
Figure 36: USACE CEM Photo, “A steel sheet-pile wall and groin field has been ineffective at protecting this section of cohesive shore along the Berrien County shore of Lake Michigan, south of the town of St. Joseph, April 1994.”

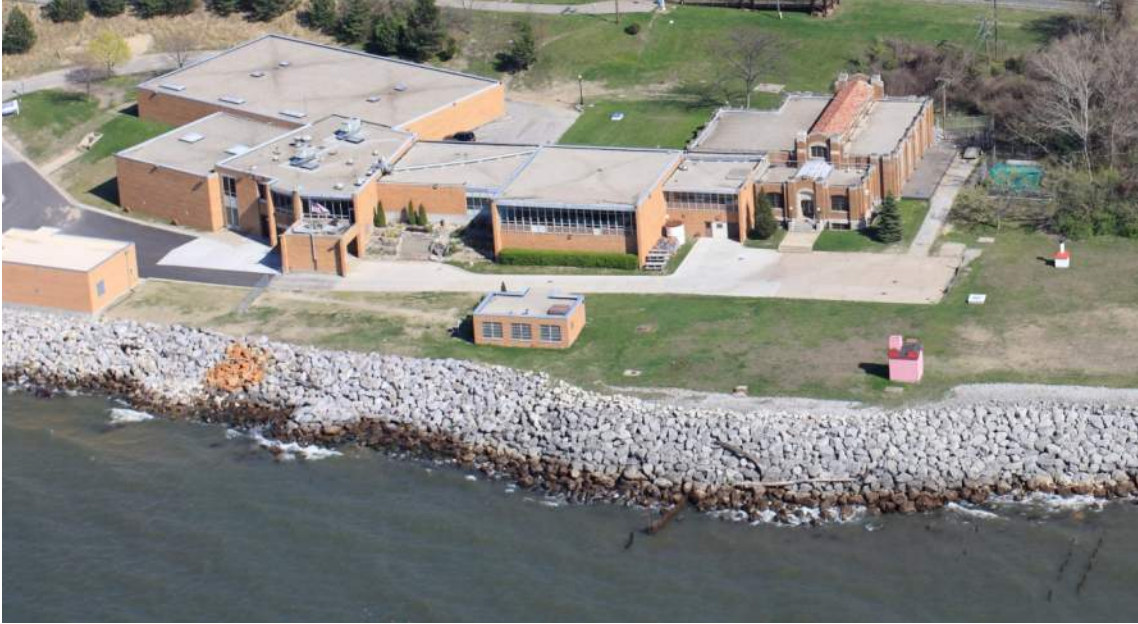
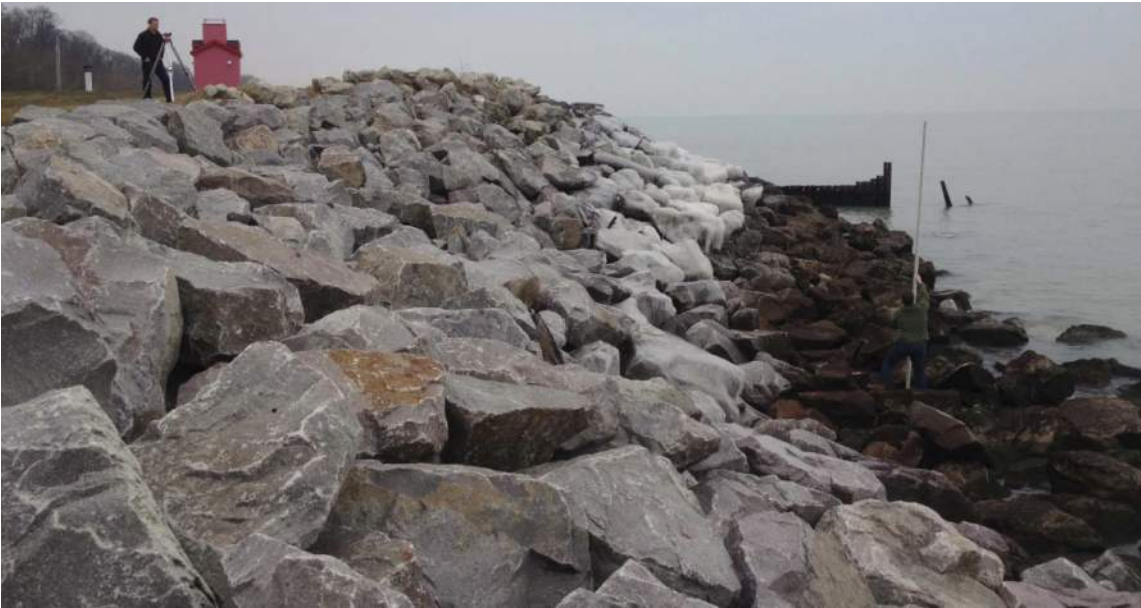
Within the study area, two successful examples of shore protection have been identified. The first is the shoreline that borders the St. Joseph Water Plant, located at the north end of Area 3. The structure consists of armor stone, laid on a slope of 1 vertical on 2 horizontal to a minimum top elevation of 591.20 feet. The toe of the revetment extends several feet below the lake bottom to prevent scour.

Figure 37: St. Joseph Water Plant Revetment Oblique Photo (U.S. Army Corps of Engineers)

Figure 38: St. Joseph Water Plant Revetment, spring 2012

While both of these stone revetments have been successful in protecting upland infrastructure from erosion, they have had a dramatic effect on the public trust property along the shoreline.

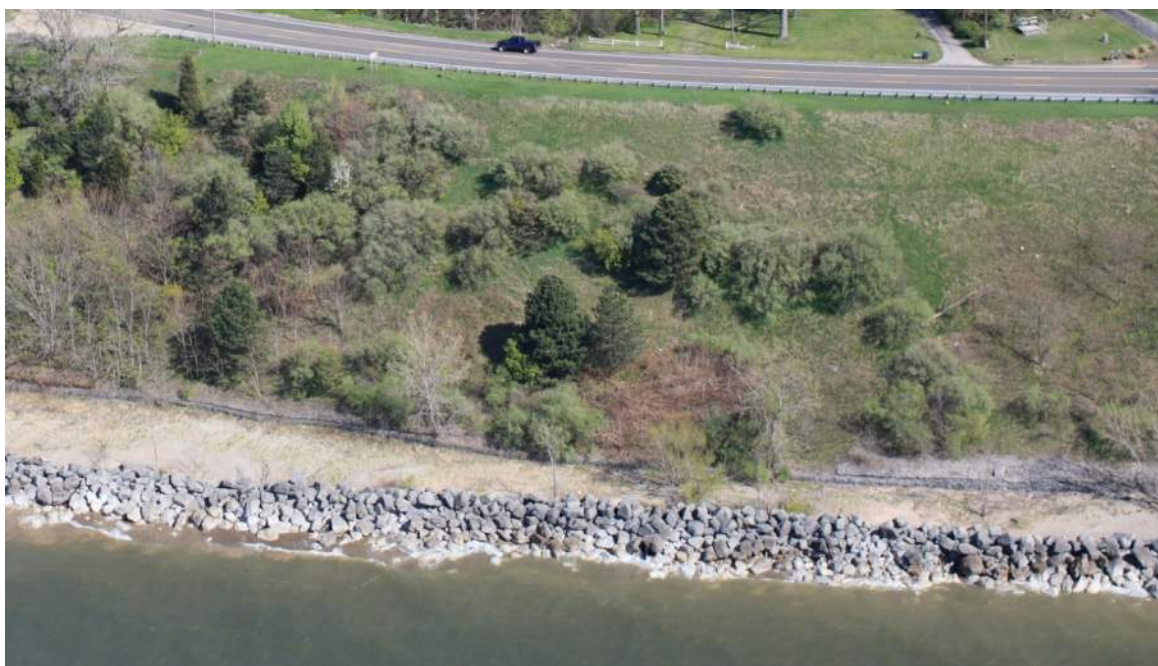
Portions of the stone revetment along South Lakeshore Drive provide another example of a successful shoreline protection structure. Sections of this revetment are comprised of armor stone set at a slope of approximately 1 vertical on 2 horizontal. These revetments protect the high bluffs on which South Lakeshore Drive is constructed.

Figure 39: Stone Revetment along South Lakeshore Drive Oblique Photo

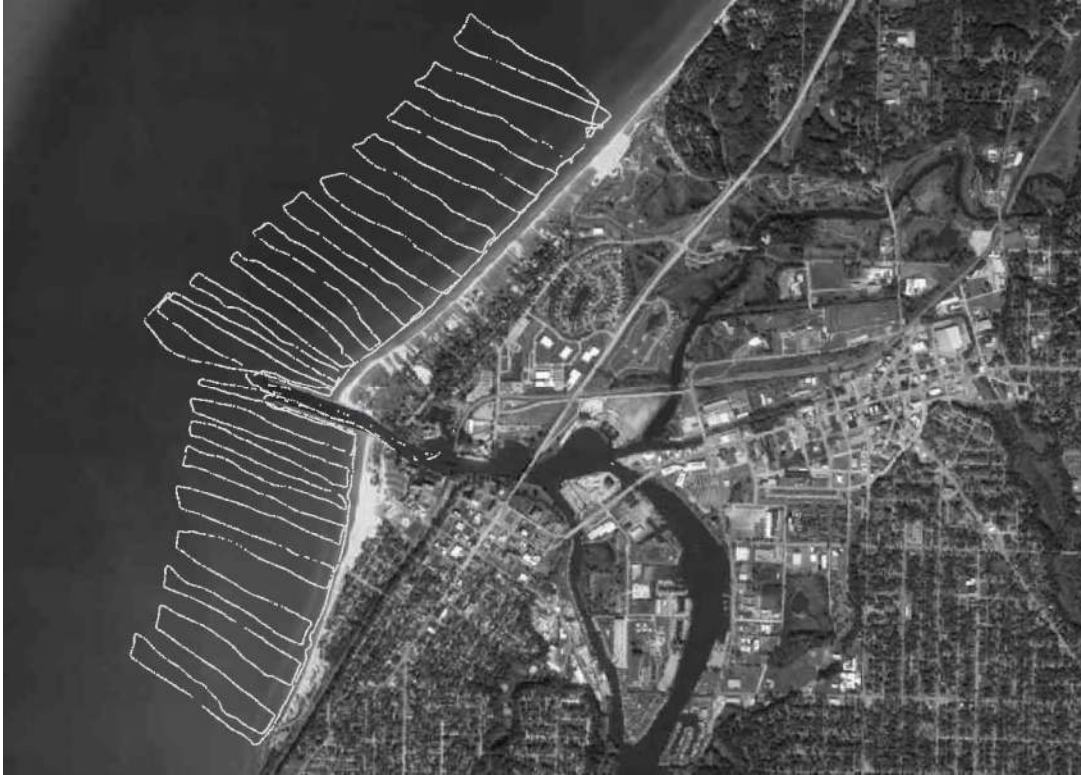
Figure 40: Bathymetric data points map, plan view (Aerial Image Credit: Google Earth)

Topographic and bathymetric surveys were completed in May of 2017 in Areas 1 and 2. Bathymetric data was collected by boat using a global positioning system (GPS) and a single-beam sonar. Topographic data was collected using GPS. Both datasets were combined into a single surface model intended to inform the planning-level analysis found herein. The combined set of geospatial data was produced per Federal Geospatial Data Committee (FGDC) metadata standards and will be made available to users.

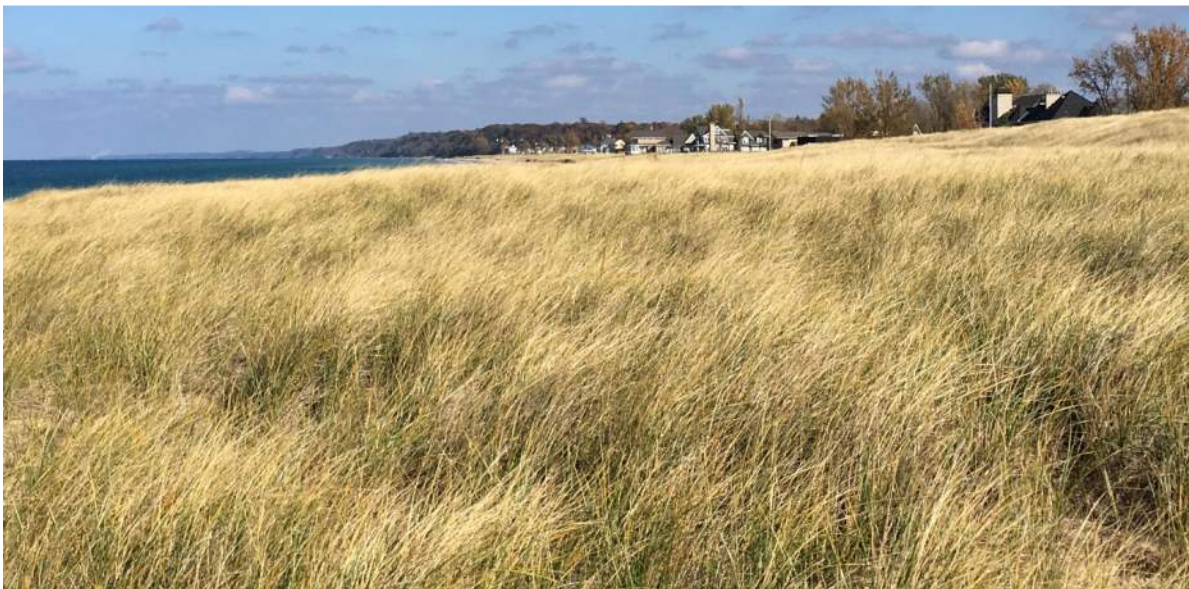
- Nearly all sections exhibited local erosion in the vicinity of the still water line between 2012 and 2017
- Many sections exhibited foredune growth, likely due to the accretion of wind-blown sand within vegetated areas, containing mostly dune grass (Figure 42)
- Several sections exhibited apparent grading activities; overall loss of material and lowering of foredune aligning with aerial images where bare/non-vegetated areas were observed

Figure 42: Area 1 dune grass (November, 2017)
