# City of St. Joseph Coastal Engineering Study Update 2017

**FINAL**

**December 21, 2017**

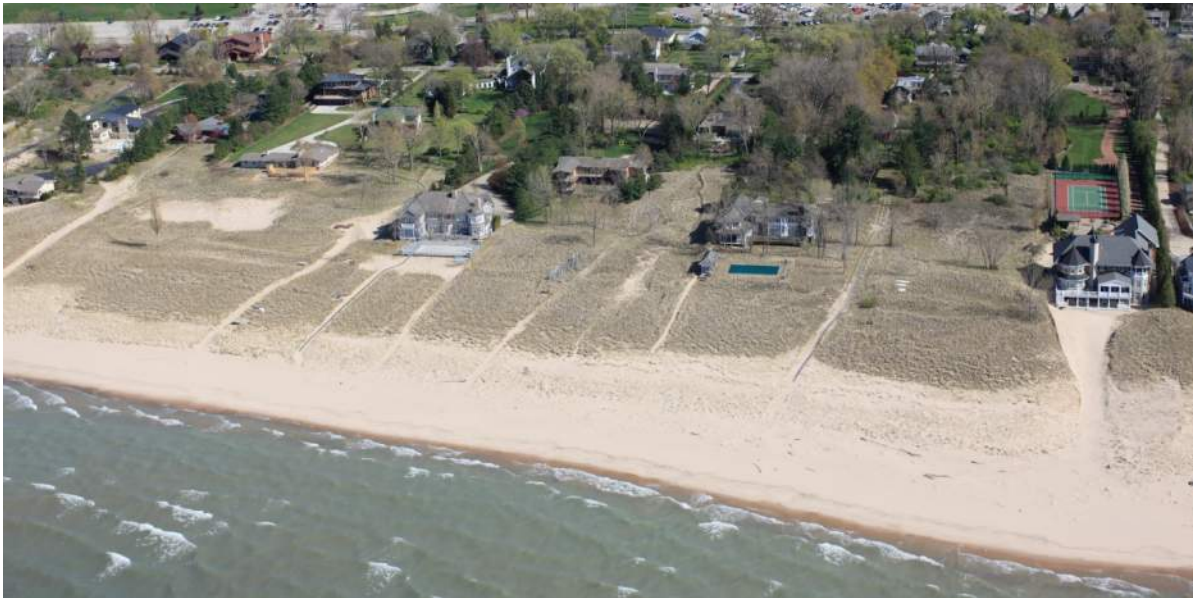
Area 1 is bordered by Jean Klock Park to the north and Tiscornia Beach to the south. Between the parks, private properties exist and many of the lots extend several hundred feet from the street known as Ridgeway to Lake Michigan. Currently, no shore protection structures exist within Area 1. The entire shoreline is sandy beach. The southern half of Area 1 is typically an accretion zone, but subject to erosion as well. The public trust property in this area varies in width and extends from the water line to the NOHWM, connecting the public parks.

Figure 43: Area 1 typical shoreline during a low water condition (2012 USACE Oblique photo)

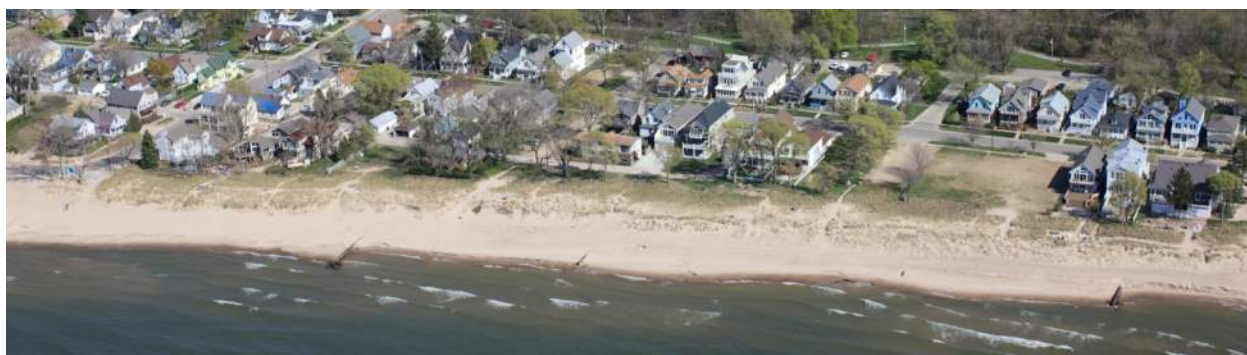
Area 2 is fully-developed by homes along the shoreline, with the exception of the two public parks at its ends. Under most lake levels, the entire shoreline is publicly-owned and consists of a sandy beach. Area 2 is primarily an erosion zone, but typically receives beach nourishment from the USACE on an annual basis. Existing structures are built on shallow lots that do not allow structures to move significantly closer or further from Lake Michigan. In order to protect structures, in reasonably foreseeable coastal conditions, shore protection may be required because limited lot sizes restrict private property owners' options.

Figure 48: Area 2 typical shoreline (2012 USACE Oblique Image)

Area 2 consists of a sandy beach containing some coarse fill from past beach nourishment projects. This area receives beach nourishment from federal dredging operations on a regular basis, typically annually, through Section 111 (Rivers and Harbors Act of 1968) measures and because it is subject to erosion. Based upon U.S. Army Corps of Engineers records, well over 300,000 cubic yards of beach nourishment has been placed in Area 2 since 2012.

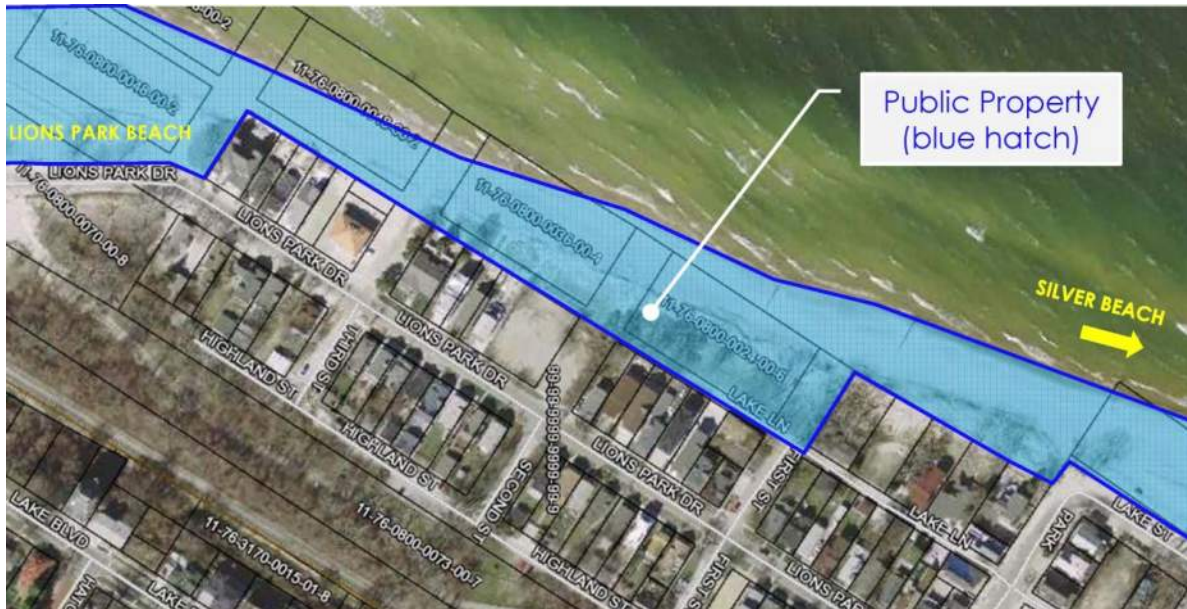
**Figure 49: Area 2 Public Property**

Public access along the public trust property can vary, depending on lake conditions, erosion, and beach nourishment. Private properties that border Area 2 between Silver Beach and Lions Park Beach are fully developed and parcels are typically very shallow in comparison to those in Area 1, none exceeding 132 feet in depth.

The narrowest of these parcels are located between Lion’s Park and Park Street. These parcels are currently dependent upon the annual beach nourishment to maintain a buffer of sacrificial sand between the Lake and their properties. The southernmost 5 properties have installed a revetment shoreline protection system to mitigate erosion of their properties once the annual nourishment material has dissipated. Due to the close proximity of the home on these parcels, the revetments were constructed at the back property line, as close to the lake as possible. During late winter and early spring, prior to the year’s nourishment, public property in this area can become restricted as the previously placed nourishment erodes and the waterline reaches private property. The shoreline at southern end of the private properties along Lions Park Drive in particular, where these revetments exist, can become impassable as the beach can be eroded all the way back to the shoreline protection system.

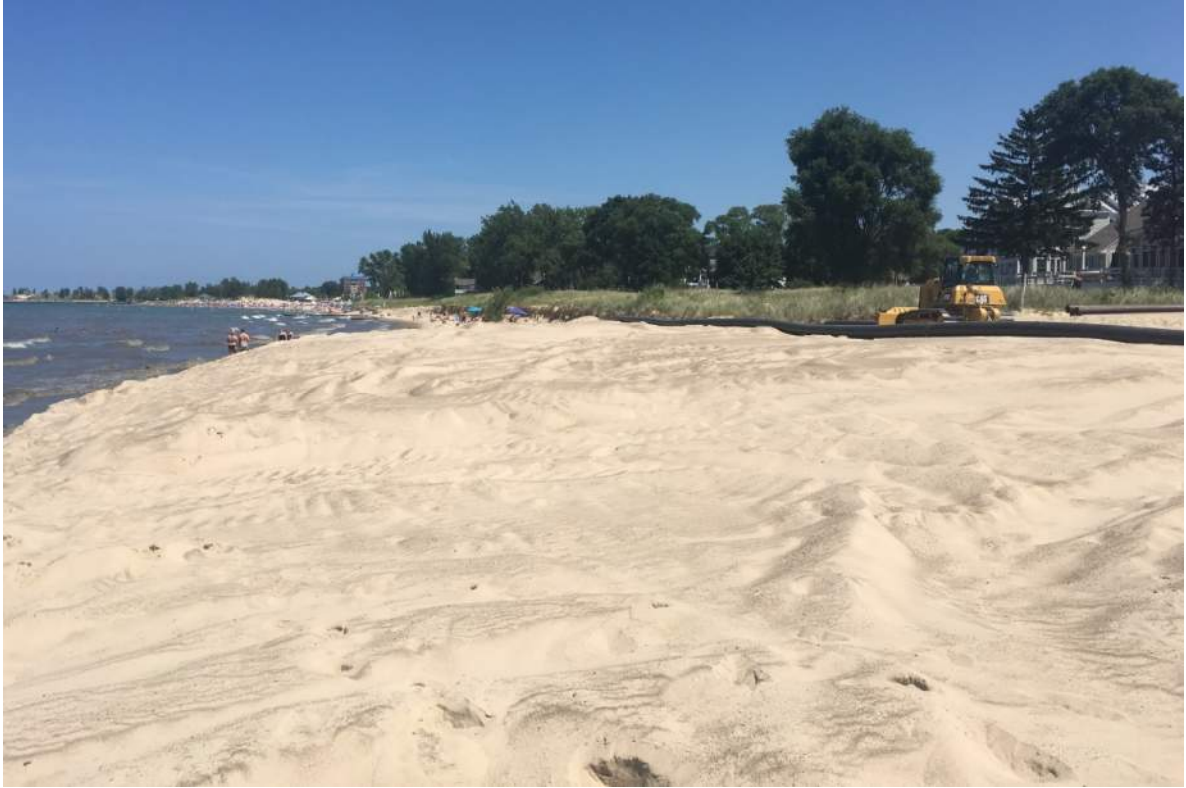
- Two new structures (homes)
- One reconstructed structure (home)
- Approximately 130 linear feet of new/reconstructed shoreline protection
- Beach nourishment (See below)

Figure 51: 2017 Beach nourishment in Area 2

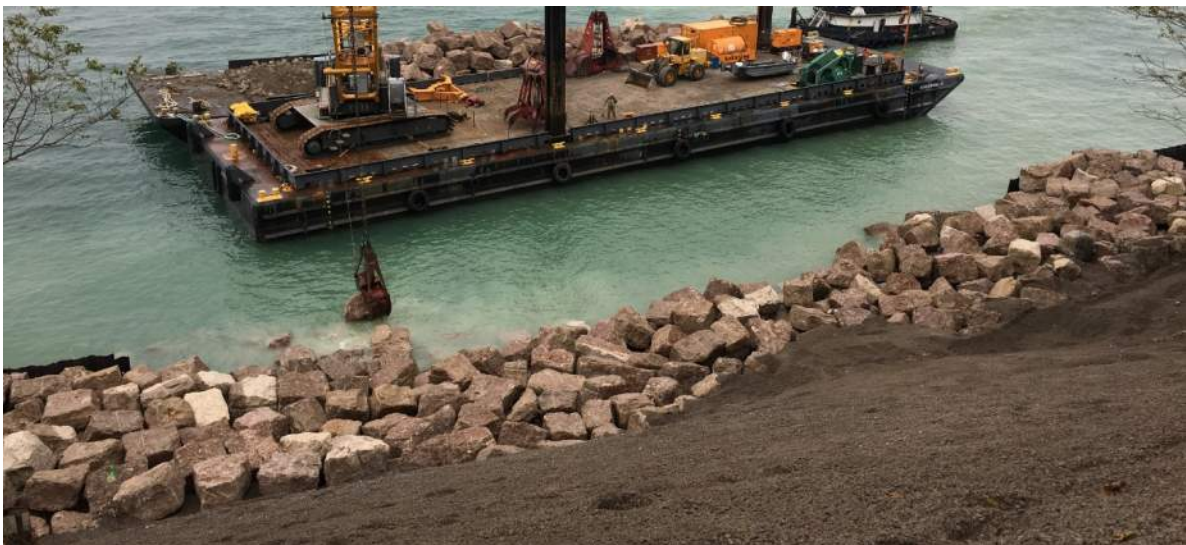
Figure 54: Area 3 CSX Shore Protection Project – placement of armor stone

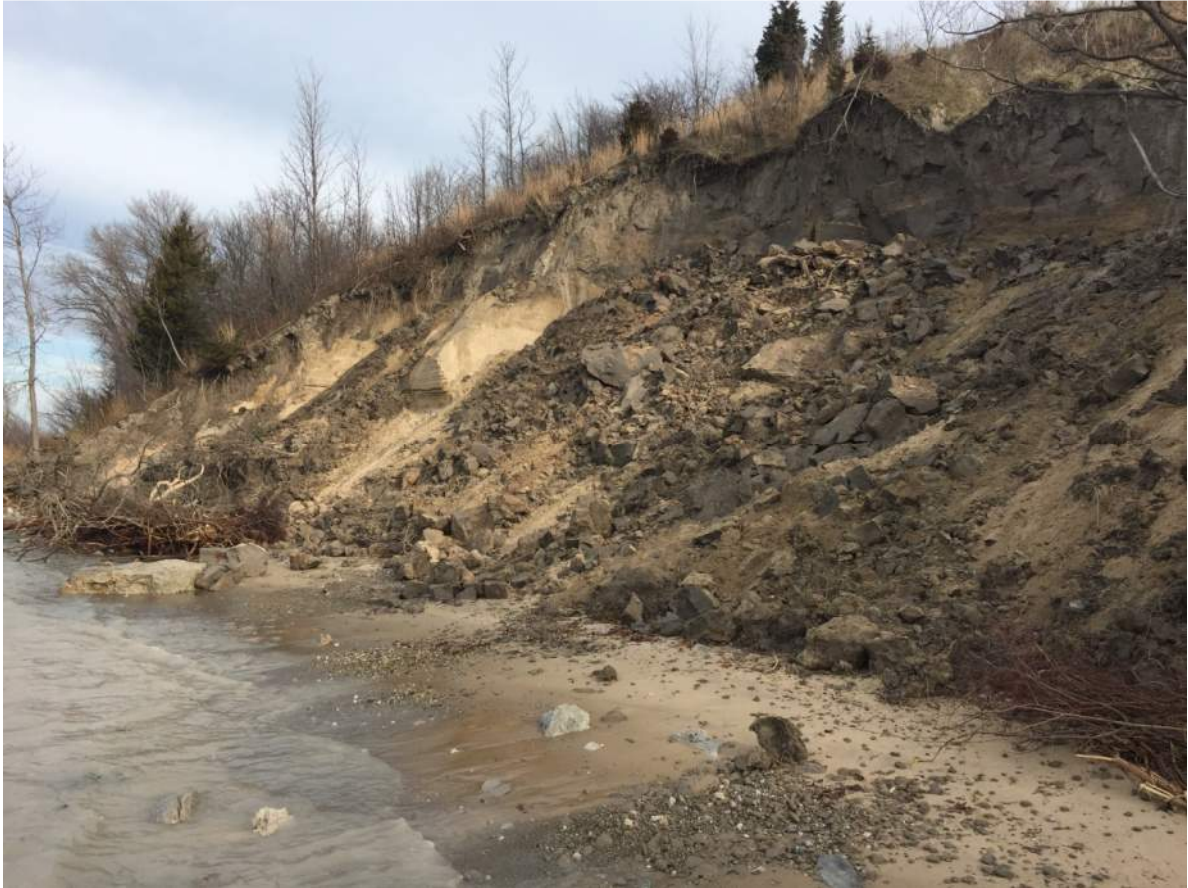
Figure 55: Area 3 – cohesive bluff erosion
