*Strategic Capital Improvement Plan*

# Drinking Water System

Prepared for  
City of St. Joseph,  
Michigan

November 2014

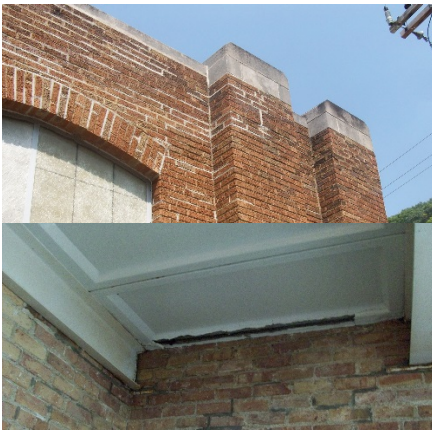
<p>Replace East Section of 1931 Building</p>	<p>Replace east section of existing 1931 building with a new pump station. Demolish existing east section of the 1931 building that houses the pumps and filters.</p>	<p>The east section of the 1931 building is severely deteriorated and would cost more to repair than to replace</p>

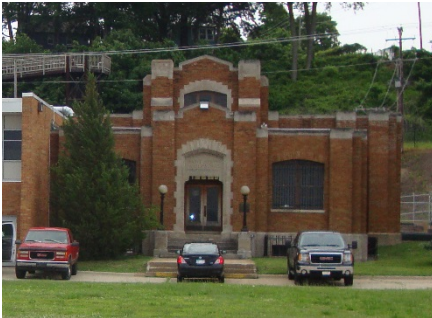
<p>Renovate West Section of 1931 Building</p>	<p>Replace 4 existing windows with aluminum windows. Add new east concrete and masonry wall with 3 new aluminum windows. Renovate interior as required for new uses.</p>	<p>Windows are deteriorated and energy inefficient. Need to close off building with east wall after demolition</p>

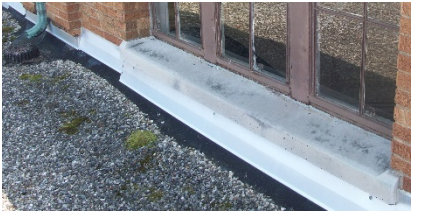
<p>Roofing Replacement</p>	<p>Replace gravel surfaced built-up roofing, insulation (R-30), vapor retarder and flashing in the next 2-12 years.</p>	<p>Roofing will be at the end of useful life and replacement will avoid leaks and damage to the building and contents.</p>

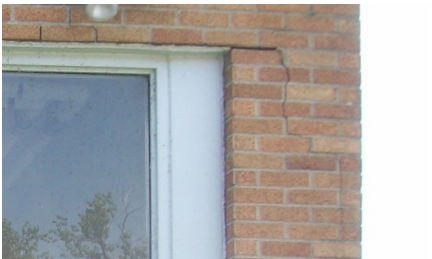
<p>Seal Cracks in Brick</p>	<p>Install backer rod and sealant in cracks in brick wall at the corner of north storefront door in the 1974 addition, south side of 1958 Conditioning Basin Room, and corner of double door in 1958 Vestibule.</p>	<p>Crack in wall needs to be filled to help prevent water intrusion and further damage to wall</p>

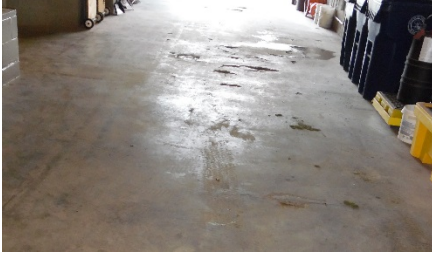
<p>Patch 1974 Concrete Floor</p>	<p>Concrete floor in by overhead door of Chemical Storage has gouges out it and need patching</p>	<p>Concrete deterioration need to be fixed to prevent further damage</p>

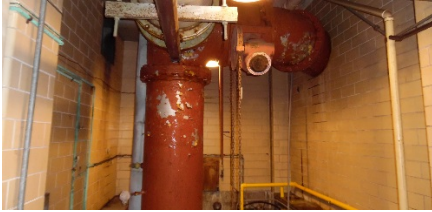
<p>Piping and Structural Steel Corrosion</p>	<p>Paint piping in 1974 Clarifier Pipe Gallery and Filter Pipe Gallery and 1958 Filter Basement, Pipe Gallery, and Sludge Blow-Off Room. Add dehumidification units. Paint structural steel columns and beams in 1958 Filter Operating Room and Conditioning Basin Room.</p>	<p>Condensation causing pipe corrosion.</p>
 	<p>Replace Doors and Louver</p>	<p>Replace 1974 north aluminum storefront door and louver, 1958 Filter Operating Room, Conditioning Basin Room, Shop, and Museum double doors.</p>	<p>Doors and frames are deteriorated and are not to code</p>

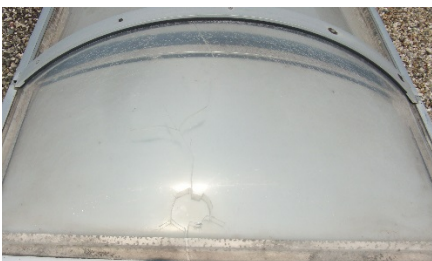
<p>Replace 1974 Skylights</p>	<p>Replace 9 skylights with insulated translucent panel skylights</p>	<p>Skylights are cracked with holes, energy inefficient, and safety hazard</p>

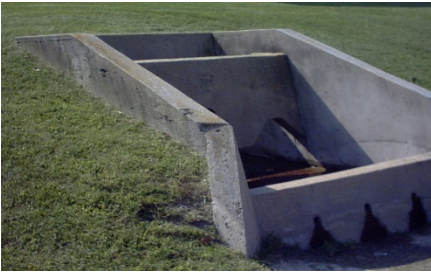
Overflow Handrail	Add 3'-6" high guardrail to concrete overflow walls.	Code required fall protection

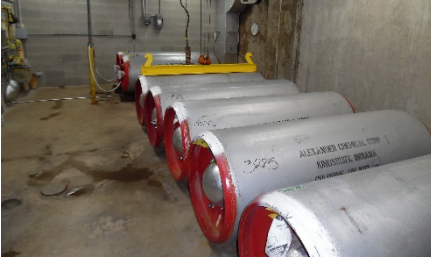
New Sodium Hypochlorite System	Replace existing chlorine system with new code compliant sodium hypochlorite system including sprinkler system, occupancy fire separation from the rest of the building, leak detection and safety shower/eyewash.	Chlorine room is dangerous and not code compliant

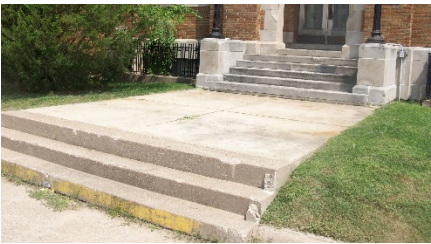
Aluminum Handrail	Add aluminum handrails to the following : 4 Conditioning Basin stairs in 1974 addition, Filter Operating Room stairs in 1958 addition, wood platform and stairs in 1958 Filter Basement, ramps in the north end of the Pipe Gallery and middle of Passage in 1958 addition ramp in 1931 Pipe Gallery, and 2 exterior stairs to 1931 entry.	Code requirement for handrails on ramps and stairs

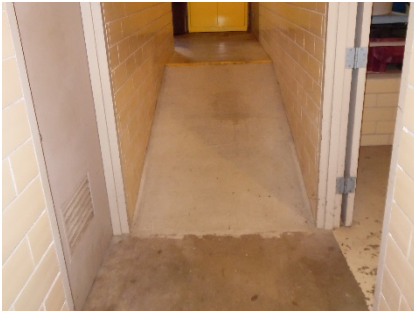
<p>Ramps Replace the ramp in 1958 Passage with new concrete ramp with 1:10 min. slope. Remove wood ramp at the bottom of stairs between 1958 and 1931 sections.</p>	<p>Ramp in Passage is steeper than allowed by code along an egress route. Wood ramp is a tripping hazard and does not meet code</p>
<p>Water Plant Lab</p>	<p>Improve HVAC for new ventilation hood. Upgrade plumbing and water sampling. New cabinets and countertops. Upgrade electrical outlets. Add new instruments for algae, UV 254 on line.</p>	<p>Meet new building codes for labs. Improve sampling and water analysis.</p>

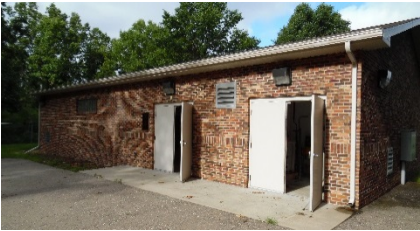
Roof Replacement In about 13 years, replace the roofing with new shingles, underlayment, ice and weather shield and exterior grade plywood sheathing.	Roofing will be at the end of useful life and replacement will avoid leaks and damage to the building and contents.

**Roof:** The original asphalt shingle roofing is in good condition, and there are no signs of leaking. The aluminum facial, soffit, gutters and downspouts are in good condition. The 1/2-inch OSB roof sheathing shown on the Record Drawings is not a long lasting material which will need to be replaced if damaged or deteriorated. There is no indication on the Record Drawings that ice and weather shield membrane was installed to prevent ice damming from causing water damage. In about 13 years, the roof should be replaced with new shingles, underlayment, ice and weather shield and exterior grade plywood sheathing.

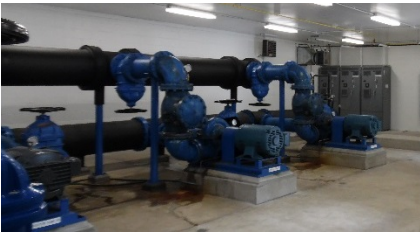
Repaint Piping and Equipment Remove insulation, clean off rust and surface prepare steel, and repaint with coating compatible with existing finish.	Piping and equipment rusting and corroding.

**Piping and Equipment:** The piping, motors and valves were covered with insulation that trapped in moisture and caused the steel to corrode. The insulation should be removed and piping and equipment be repainted.

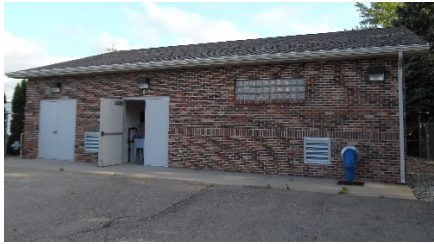
Roof Replacement In about 13 years, replace the roofing with new shingles, underlayment, ice and weather shield and exterior grade plywood sheathing.	Roofing will be at the end of useful life and replacement will avoid leaks and damage to the building and contents.

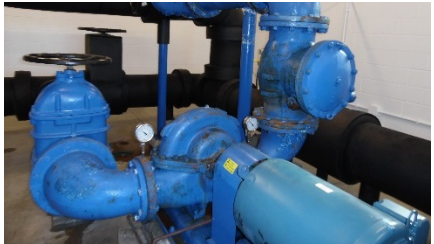
Repaint Piping and Equipment Remove insulation, clean off rust and surface prepare steel, and repaint with coating compatible with existing finish.	Piping and equipment rusting and corroding.

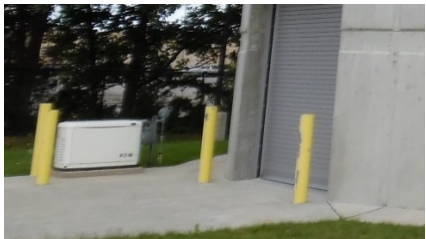
**Exterior Walls:** Steel tank and concrete support structure are in good condition. The paint on the exterior guard posts is peeling off.

Guard Post Painting Remove loose paint, prepare, prime and paint 4 guard posts with paint compatible with existing paint over galvanized steel.	Paint peeling off.

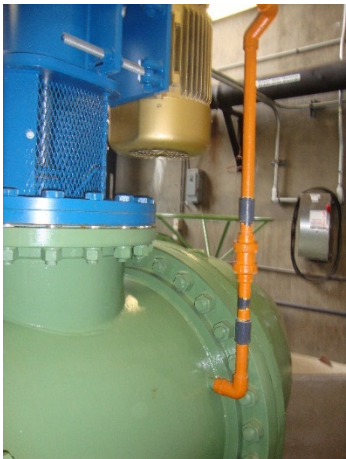
Primary Alum Feed Point Into Rapid Mixer

The alum storage tanks are over 40 years old and beyond their predicted useful life. The alum storage area does not have containment and several critical pumps are nearby. The rotodip feeders are obsolete and spare parts are not available.

A new alum system is recommended to meet current chemical system standards, improve accuracy, and reduce O&M requirements. New bulk tanks, transfer pumps, day tanks, metering pumps, and flow meters are recommended. A containment curb should be installed around the bulk storage tanks and transfer pumps. The alum day tanks and metering pumps could be placed where the existing fluoride storage system is currently located. Fluoride is recommended to be moved as well (see below). In addition, a flow meter should be added to the raw water line to ensure accuracy of the alum feed. Exhibit 5-16 summarizes issues with the existing alum system.

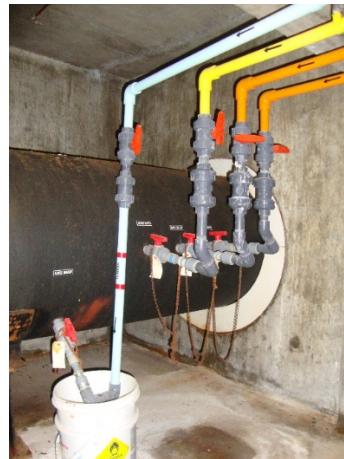
Secondary Alum Feed Point Into 30-Inch Raw Water Main

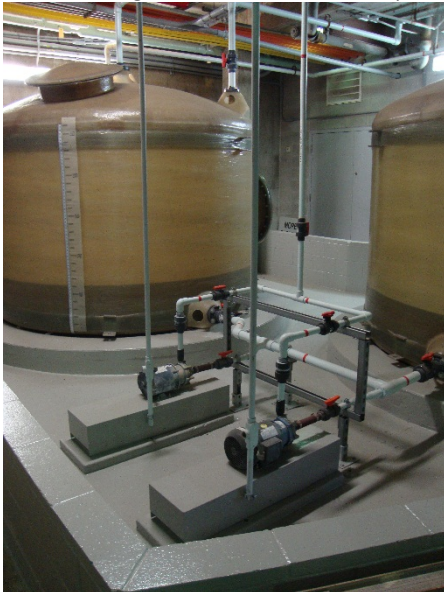
Bulk Storage Tanks and Transfer Pumps

The existing bulk storage tanks and transfer pumps are relatively new and in good condition, but do not meet building code requirements (see Architectural condition assessment). The fluoride feed system is old and has minimal containment. This system also does not meet current codes.

A new fluoride storage and feed system is recommended. A new fluoride bulk tank storage area outside the main plant entrance could be constructed. The existing tanks and pumps can be moved to that area. If chlorine gas is replaced with sodium hypochlorite, the chlorine storage room could be converted into a fluoride feed room. If chlorine gas remains, a new fluoride storage and feed facility could be constructed with the new high service pump station.

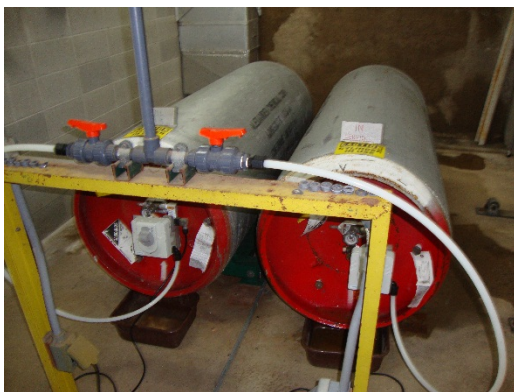
Gas chlorine is stored in 1-ton cylinders in a secured room. The gas storage room is in adequate condition, but does not meet building code requirements (see Architectural Condition Assessment). The City maintains a Risk Management Plan (RMP) for gas chlorine, but no chlorine gas scrubber is installed. Chlorine gas is fed under vacuum into water using Wallace and Tiernen V-notch chlorinators. The typical dose to achieve the desired free chlorine residual is 3.5 mg/L. This equates to about 30 days of active chlorine storage at average day water demand. Additional storage is provided with standby gas cylinders. Regulated disinfection by-products are typically not an issue since organic levels are relatively low. At times, the St. Joseph River influences the raw water intake. This can increase the chlorine demand and generate higher levels of DBPs.

Gas chlorine 1-ton cylinders

Issue	Recommendation
1-ton chlorine gas cylinders pose a health and safety risk for operators and public.	Install a new sodium hypochlorite system.

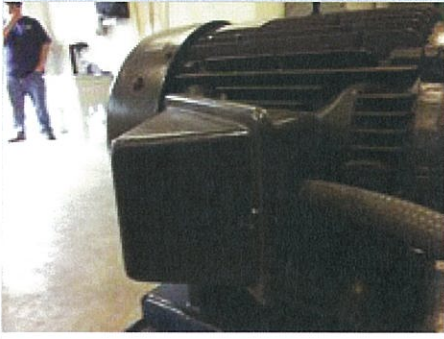
Asset Description	<b>Booster Pump Motor 2</b>	System	<b>Distribution</b>
Asset Type	<b>MOTOR</b>	Location	<b>Hilltop Booster Station</b>
Asset ID	<b>1181</b>	Inspection Date	<b>7/23/2014</b>
Comments	<b>Safety issue with poor connection to motor junction box</b>	Flag

Conduit not sealed in motor junction box. Safety issue

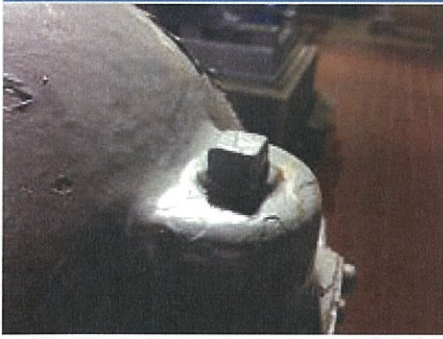
Asset Description	<b>B.W. Pump # 1 Pump</b>	System	<b>Water Treatment Plant</b>
Asset Type	<b>PUMP-CENT</b>	Location	<b>Backwash System</b>
Asset ID	<b>1095</b>	Inspection Date	<b>7/22/2014</b>
Comments	<b>Small oil leak on inboard bearing. Appears to be coming from drain plug. Rebuilt in May 2000.</b>	Flag

Bearing fill plug is still painted over

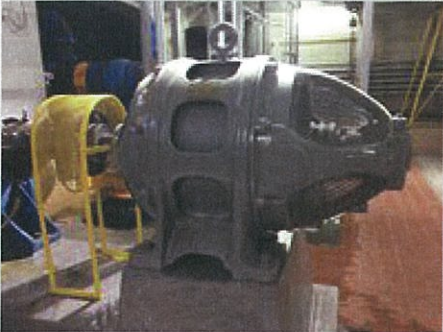
Older motor (1931)

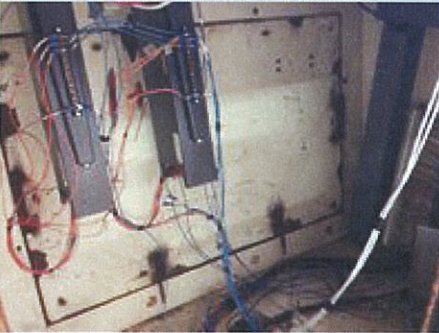
Poor wire labeling, debris

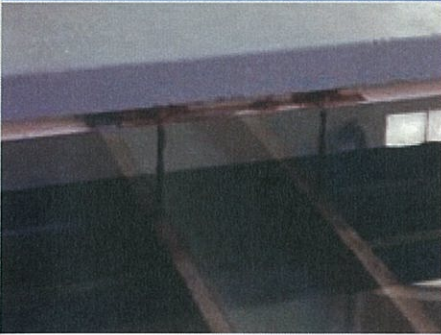
Typical of all trough supports

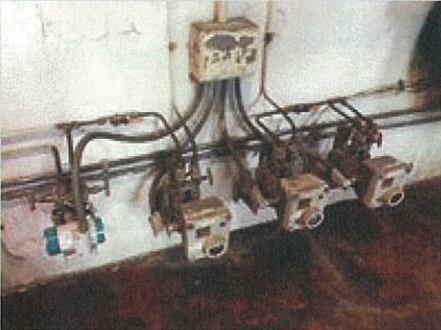
Instrumentation old.

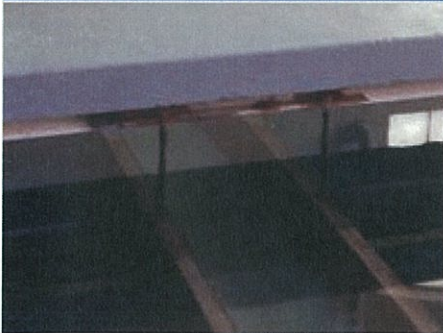
Typical of all supports

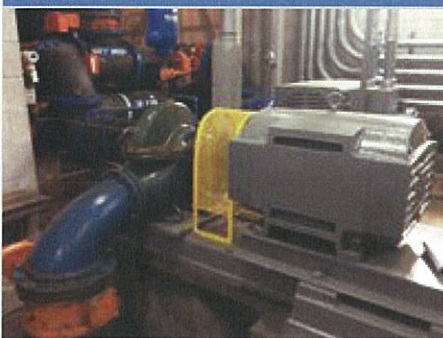
Asset Description **High Service Pump # 2 (3 MGD) Motor** System **Water Treatment Plant**  
 Asset Type **MOTOR** Location **High Service Pumps**  
 Asset ID **1138** Inspection Date **7/22/2014**  
 Comments **1726 rpm. Appears to have bad bearings based on BDU readings** Flag

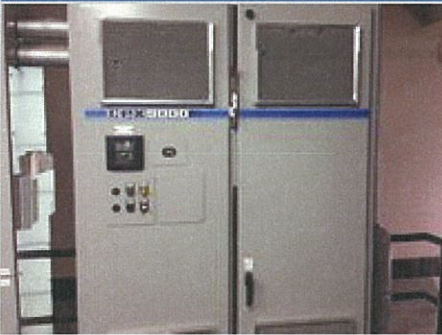
No cooling fans for VFD. Line reactor cooling only.

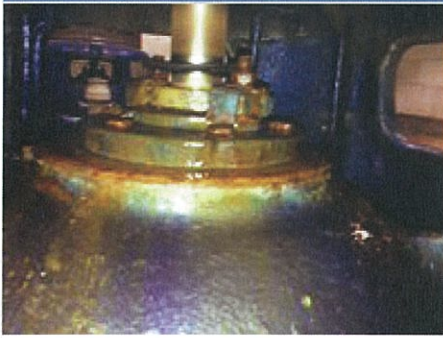
Packing gland almost homed out

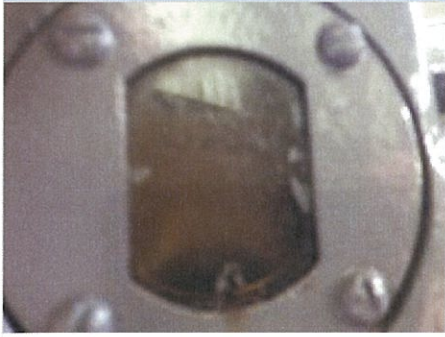
Sapponification

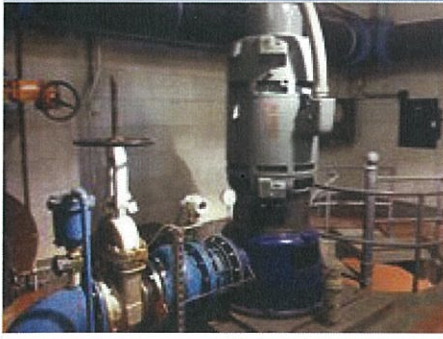
Asset Description **High Service Pump # 5 (5 MGD) Motor** System **Water Treatment Plant**  
 Asset Type **MOTOR** Location **High Service Pumps**  
 Asset ID **1147** Inspection Date **7/22/2014**  
 Comments **Could not run unit due to failed VFD. Motor rebuilt June 2012** Flag **Partially Evaluated**
